INSPECTION REPORT
Sedimentation Structure
N10-A
Kayenta Mine
Navajo County, Arizona
for
PEABODY COAL COMPANY

Dames & Moore
10139-011-22

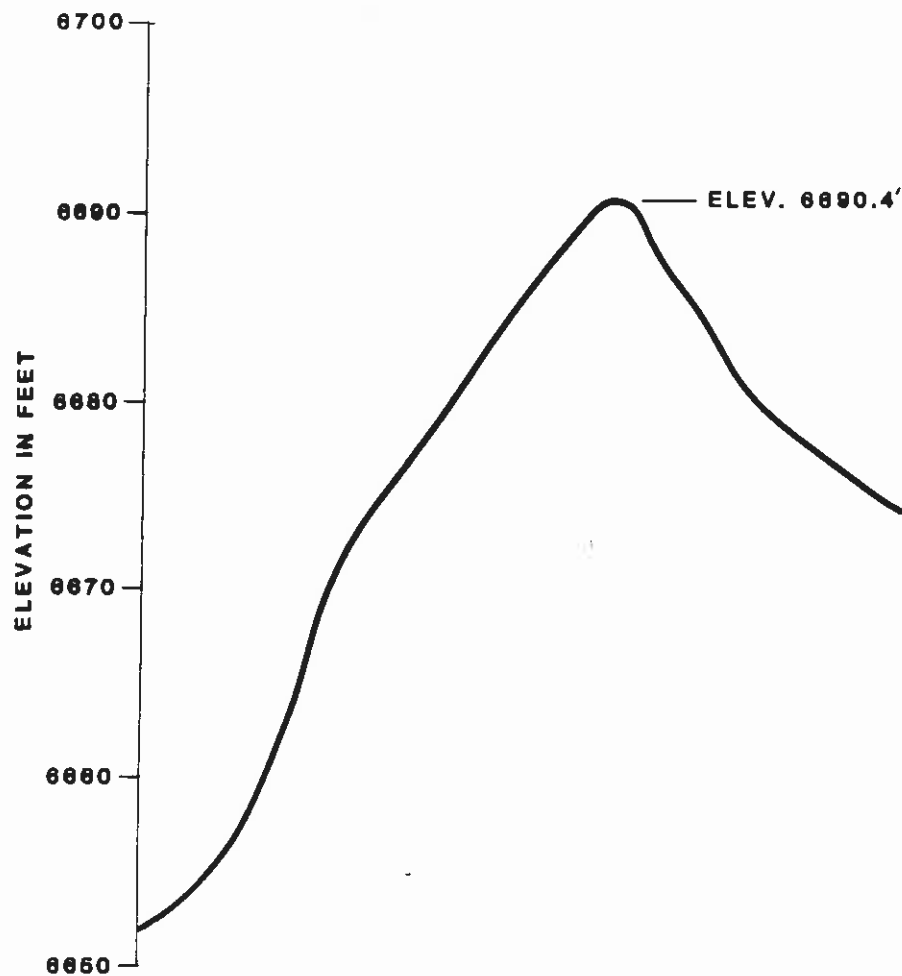
Plate 2

Structure N10-A is a homogeneous earthen embankment classified as a cross-valley embankment. Physical characteristics of the embankment are listed in the following table:

Embankment	Mine Waste
Foundation	Sandstone
Right Abutment	Residual Shale Soils
Left Abutment	Mine Waste
Height	14.6 ft
Crest Width	15 ft
Upstream Slope	4.0 H : 1 V
Downstream Slope	3.5 H : 1 V

EXISTING
MAXIMUM CROSS-SECTION
A-A'
N10-A

The inspection of Structure N10-A indicated that geotechnical problems consist of rill erosion on the upstream and downstream slopes and a 30-foot-long crack on the crest and downstream slope of the embankment near the left abutment. Correction of erosion is considered a periodic maintenance task and does not require remedial action. Extensive reconstruction of the embankment is recommended to repair the cracking evident near the left abutment. At that time the embankment can be classified and safe slopes selected.

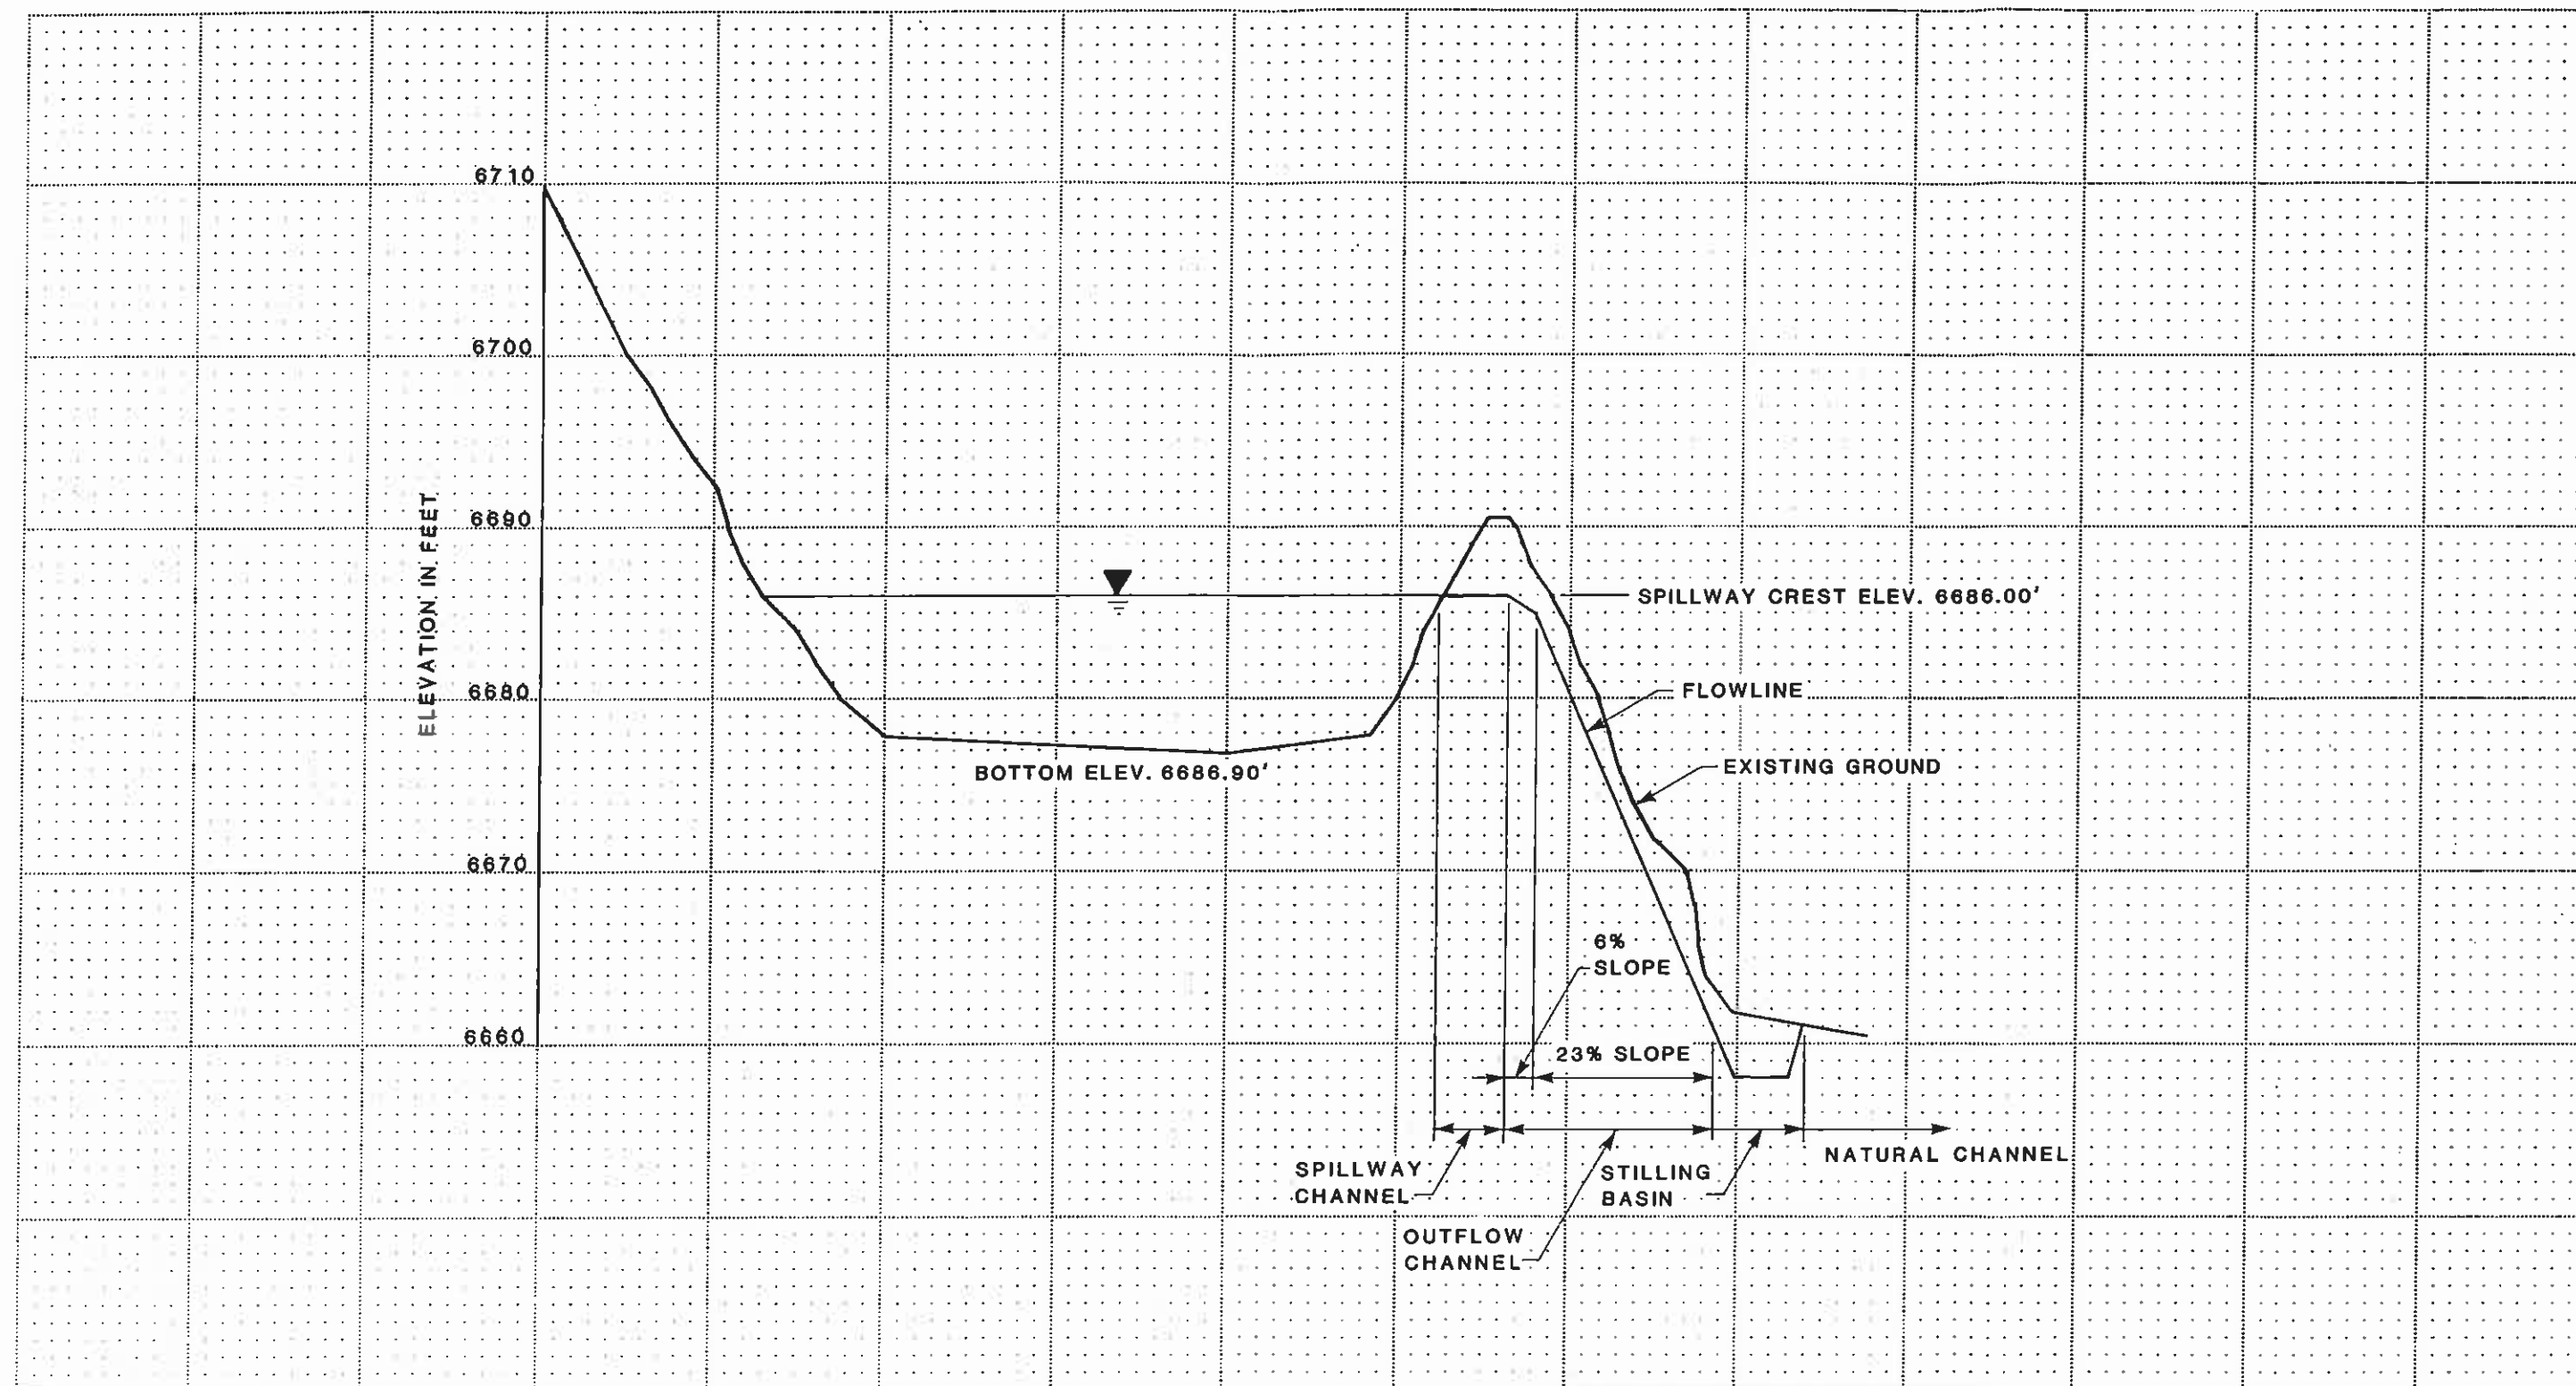
Plate 4

CHANNEL PROFILE B-B'
N10-A

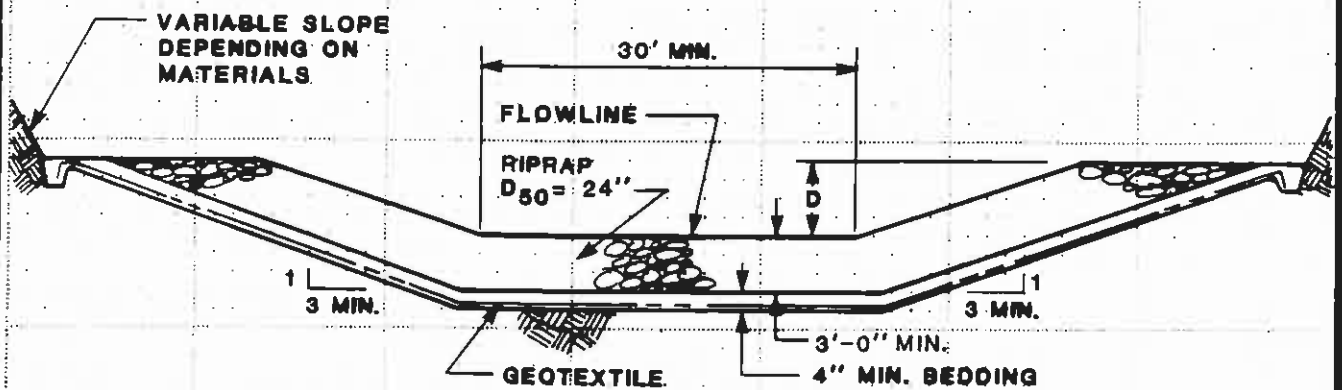
**SPILLWAY AND
OUTFLOW CHANNEL
CROSS SECTION
N10-A**

SPILLWAY CHANNEL

$D = 4.4'$

LENGTH = 40'

FLOWLINE ELEV. = 6686.0'

OUTFLOW CHANNEL

$D = 2.5'$

Structure N10-A has sufficient storage capacity but it does not have a spillway or outflow channel. A trapezoidal spillway channel should be constructed at elevation 6686.0 feet. A trapezoidal outflow channel with the same bottom width as the spillway should be constructed along the alignment shown in Plate 1. The spillway, outflow channel and stilling basin profile is shown in Plate 4 and the required dimensions are shown in Plate 5 and Plate 6. Both the spillway and outflow channel should be protected against erosion using geotextile and riprap as shown in Plate 5.

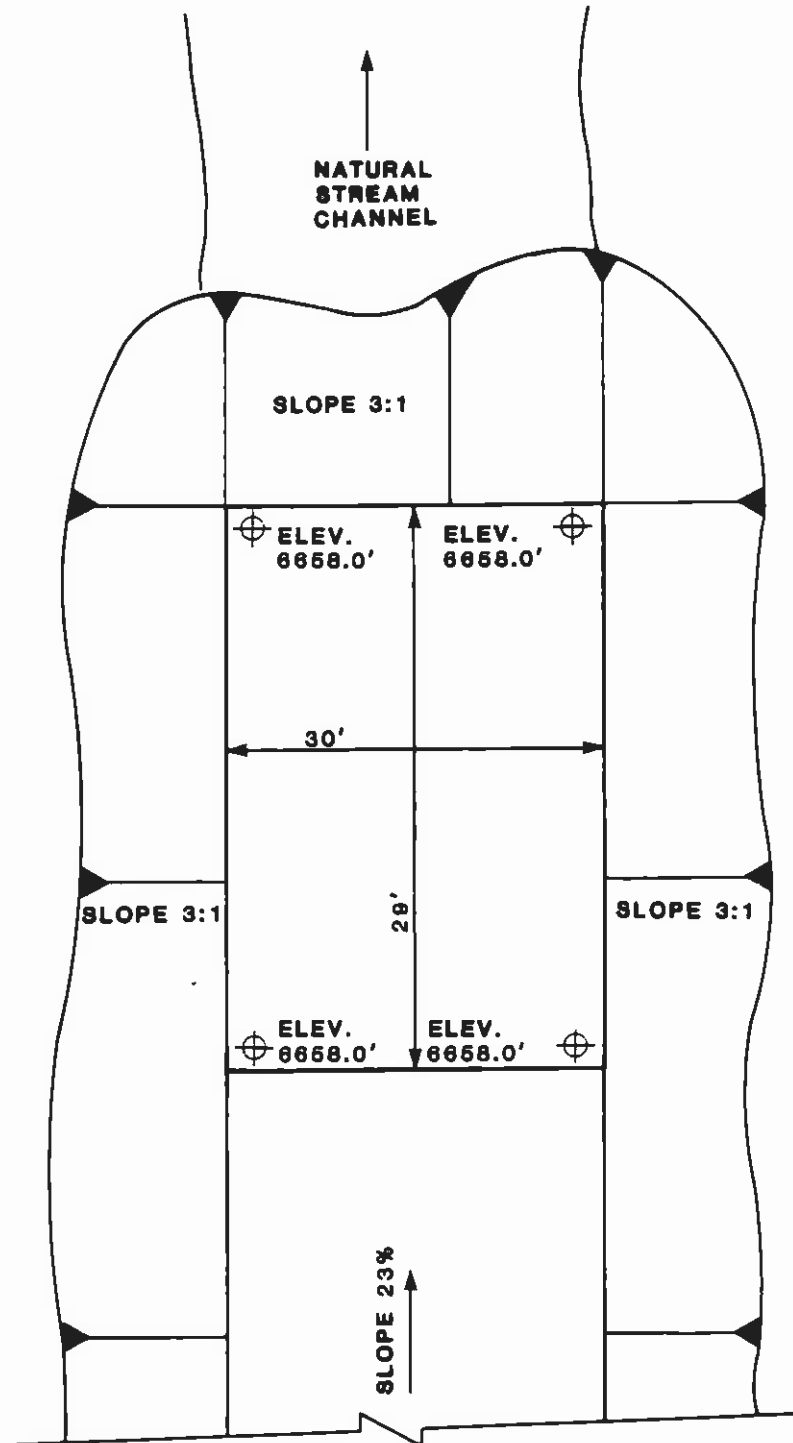
SPILLWAY STILLING BASIN PLAN N10-A

MINIMUM HEIGHT OF RIPRAP
ALONG SIDEWALLS ABOVE
THE BASIN FLOOR = 7.8'

MINIMUM DEPTH OF BASIN FLOOR
BELOW NATURAL STREAMBED = 4.2'
