INSPECTION REPORT  
Sedimentation Structure  
N10-B  
Kayenta Mine  
Navajo County, Arizona  
for  
PEABODY COAL COMPANY

Dames & Moore  
10139-011-22

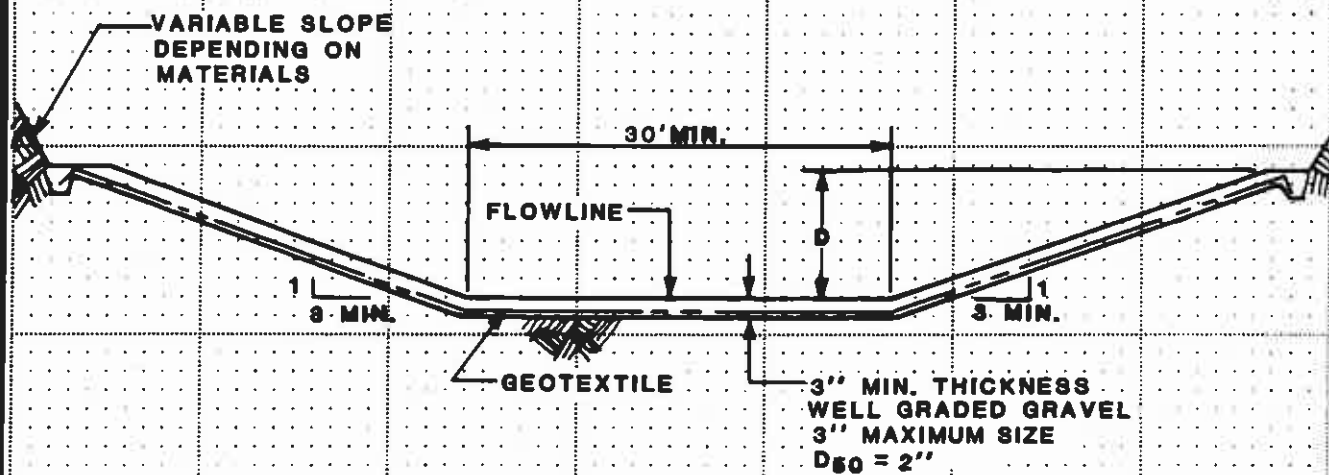
**SPILLWAY AND  
 OUTFLOW CHANNEL  
 CROSS SECTION  
 N10-B**

There is presently no erosion protection within the channel.

The structure presently has no outflow channel.

The storage capacity and spillway capacity of Structure N10-B are adequate; however, the spillway does not have an outflow channel or adequate erosion protection. A trapezoidal outflow channel should be constructed along the alignment B-B' shown in Plate 1. The channel profile is shown in Plate 4 and the required dimensions are shown in Plate 5. Both the spillway and outflow channel should be protected against erosion using geotextile and gravel as shown in Plate 5.
