INSPECTION REPORT
Sedimentation Structure
N10-B1
Kayenta Mine
Navajo County, Arizona
for
PEABODY COAL COMPANY

Dames & Moore
10139-011-22

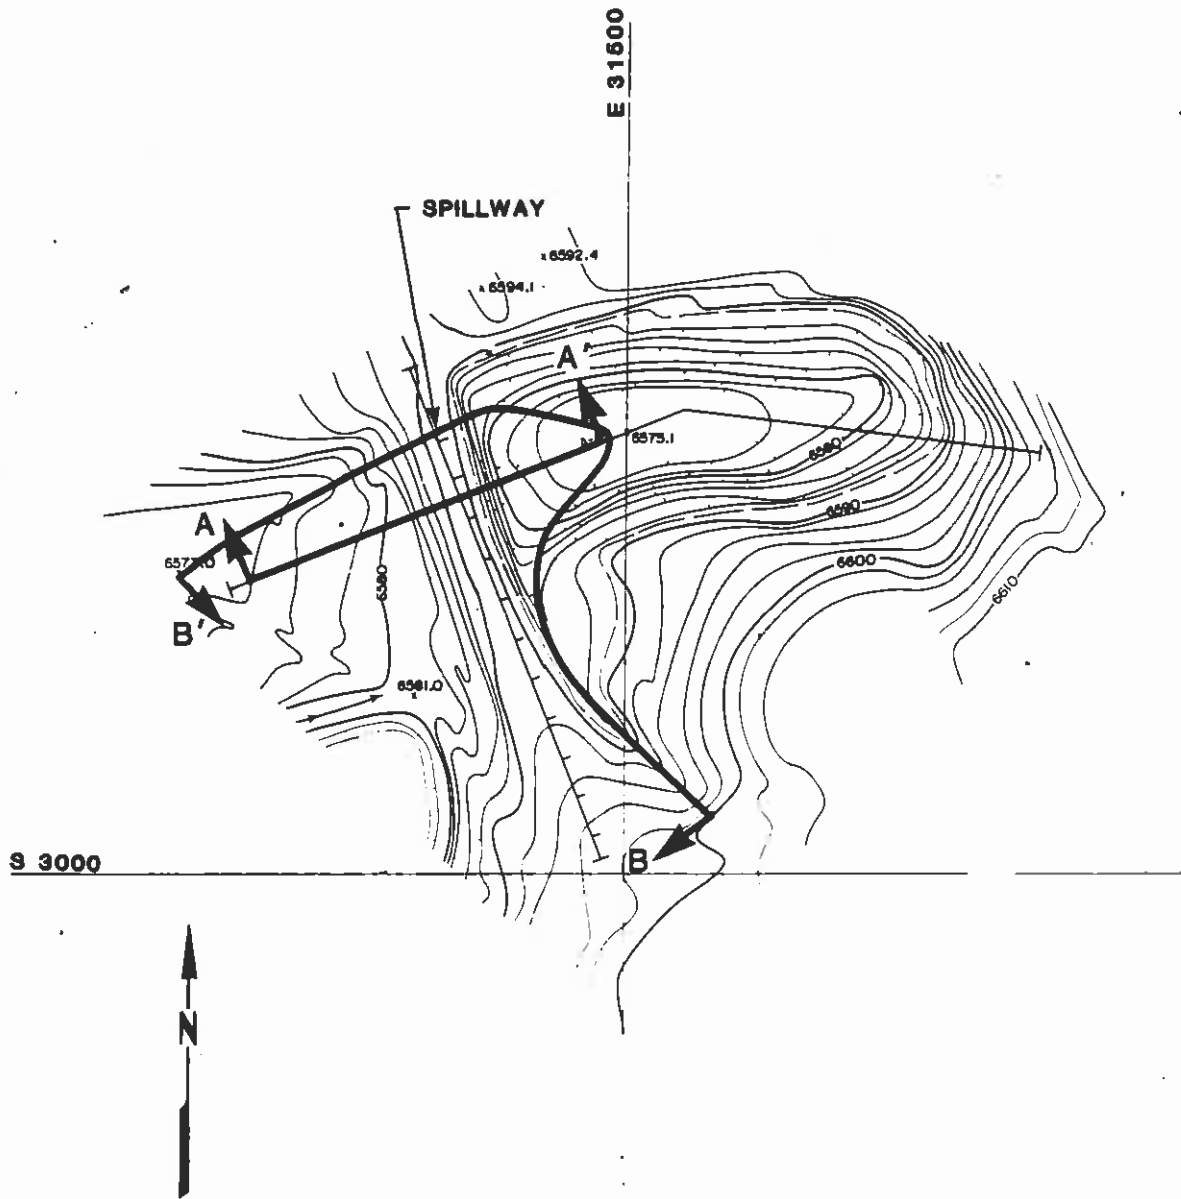
SITE PLAN N10-B1

The storage capacity and spillway capacity of Structure N10-B1 are adequate; however, the spillway does not have an adequate outflow channel. A trapezoidal outflow channel should be constructed along the alignment B-B' shown in Plate 1. The channel profile is shown in Plate 4 and the required dimensions are shown in Plate 5. The outflow channel should be protected against erosion using geotextile and gravel as shown in Plate 5.

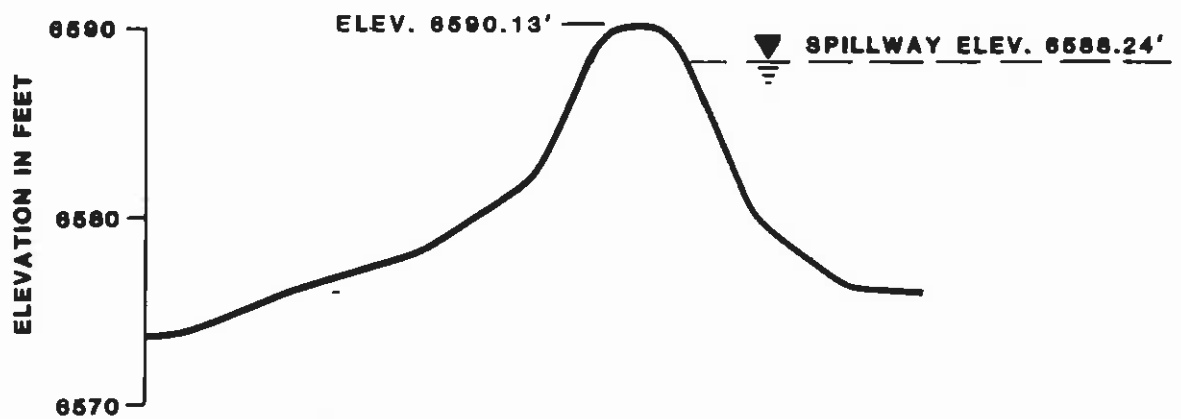
EXISTING
MAXIMUM CROSS-SECTION
A-A'
N10-B1

The N10-B1 embankment is lower in height; however, the downstream slope is steeper than the category standard; therefore, the embankment has factors of safety less than the design minimum.

The inspection of Structure N10-B1 indicated that the only geotechnical problem is rill erosion on the upstream and downstream slopes. Correction of erosion is considered a periodic maintenance task and does not require remedial action. The downstream slope should be flattened to 3.25 horizontal to 1 vertical to meet stability requirements.
