INSPECTION REPORT
Sedimentation Structure
N10-C
Kayenta Mine
Navajo County, Arizona

for
PEABODY COAL COMPANY

Dames & Moore
10139-011-22

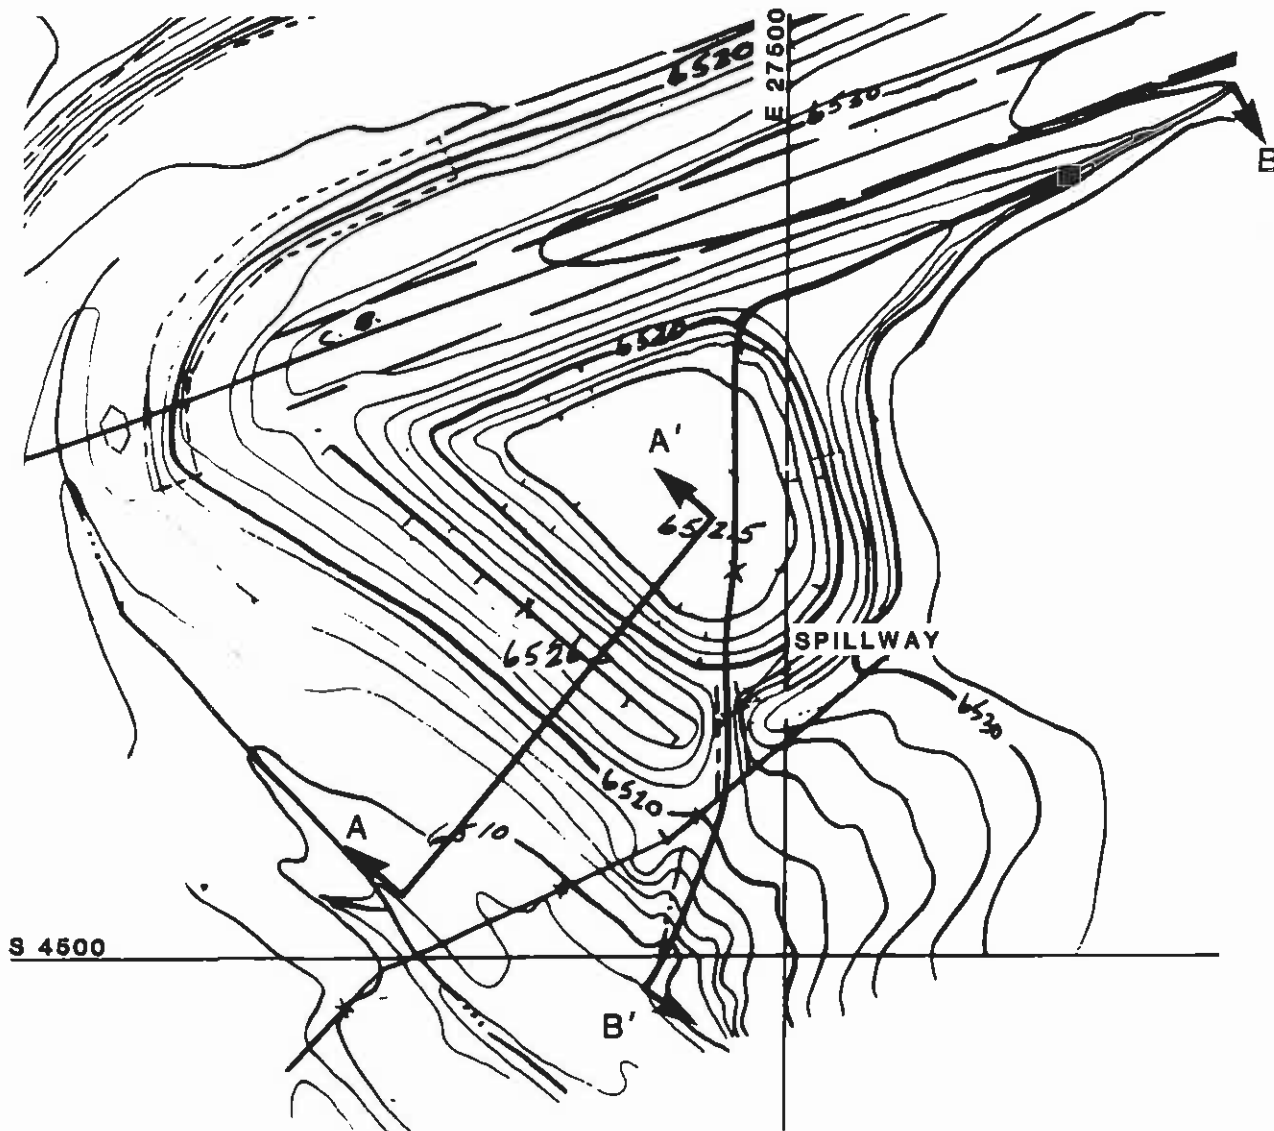
Plate 1

SITE PLAN N10-C

The storage capacity and spillway capacity of Structure N10-C are adequate; however, the spillway does not have an outflow channel or adequate erosion protection. A trapezoidal outflow channel should be constructed along the alignment B-B' shown in Plate 1. The channel profile is shown in Plate 4 and the required dimensions are shown in Plate 5. Both the spillway and outflow channel should be protected against erosion using geotextile and gravel as shown in Plate 5.

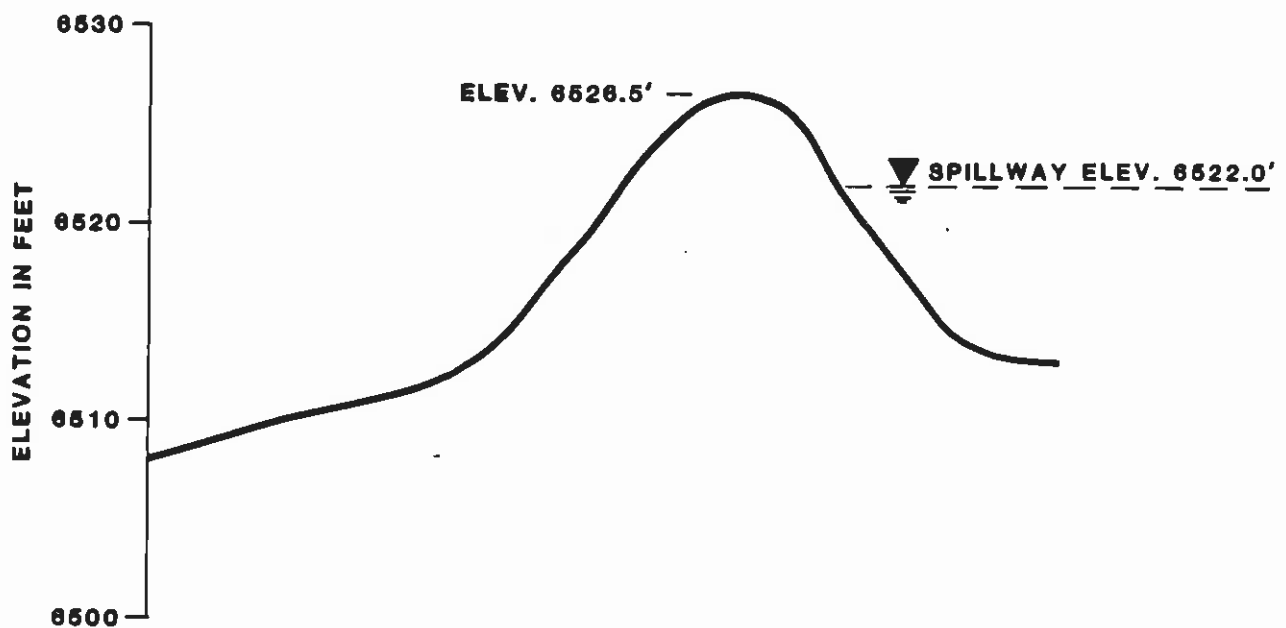
Plate 2

A cross-section of the embankment is shown on Plate 2, Existing Maximum Cross Section N10-C, A-A'. Grass provides erosion protection on the upstream and downstream slopes of the embankment.

The N10-C embankment is lower in height; however, the downstream slope is steeper than the category standard; therefore, the embankment has factors of safety less than the design minimum.

EXISTING
MAXIMUM CROSS-SECTION
A-A'
N10-C

The inspection of Structure N10-C indicated that the only geotechnical problem is rill erosion on the upstream and downstream slopes and the side slopes of the spillway channel. Correction of erosion is considered a periodic maintenance task and does not require remedial action. The downstream slope should be flattened to 3.25 horizontal to 1 vertical to meet stability requirements.

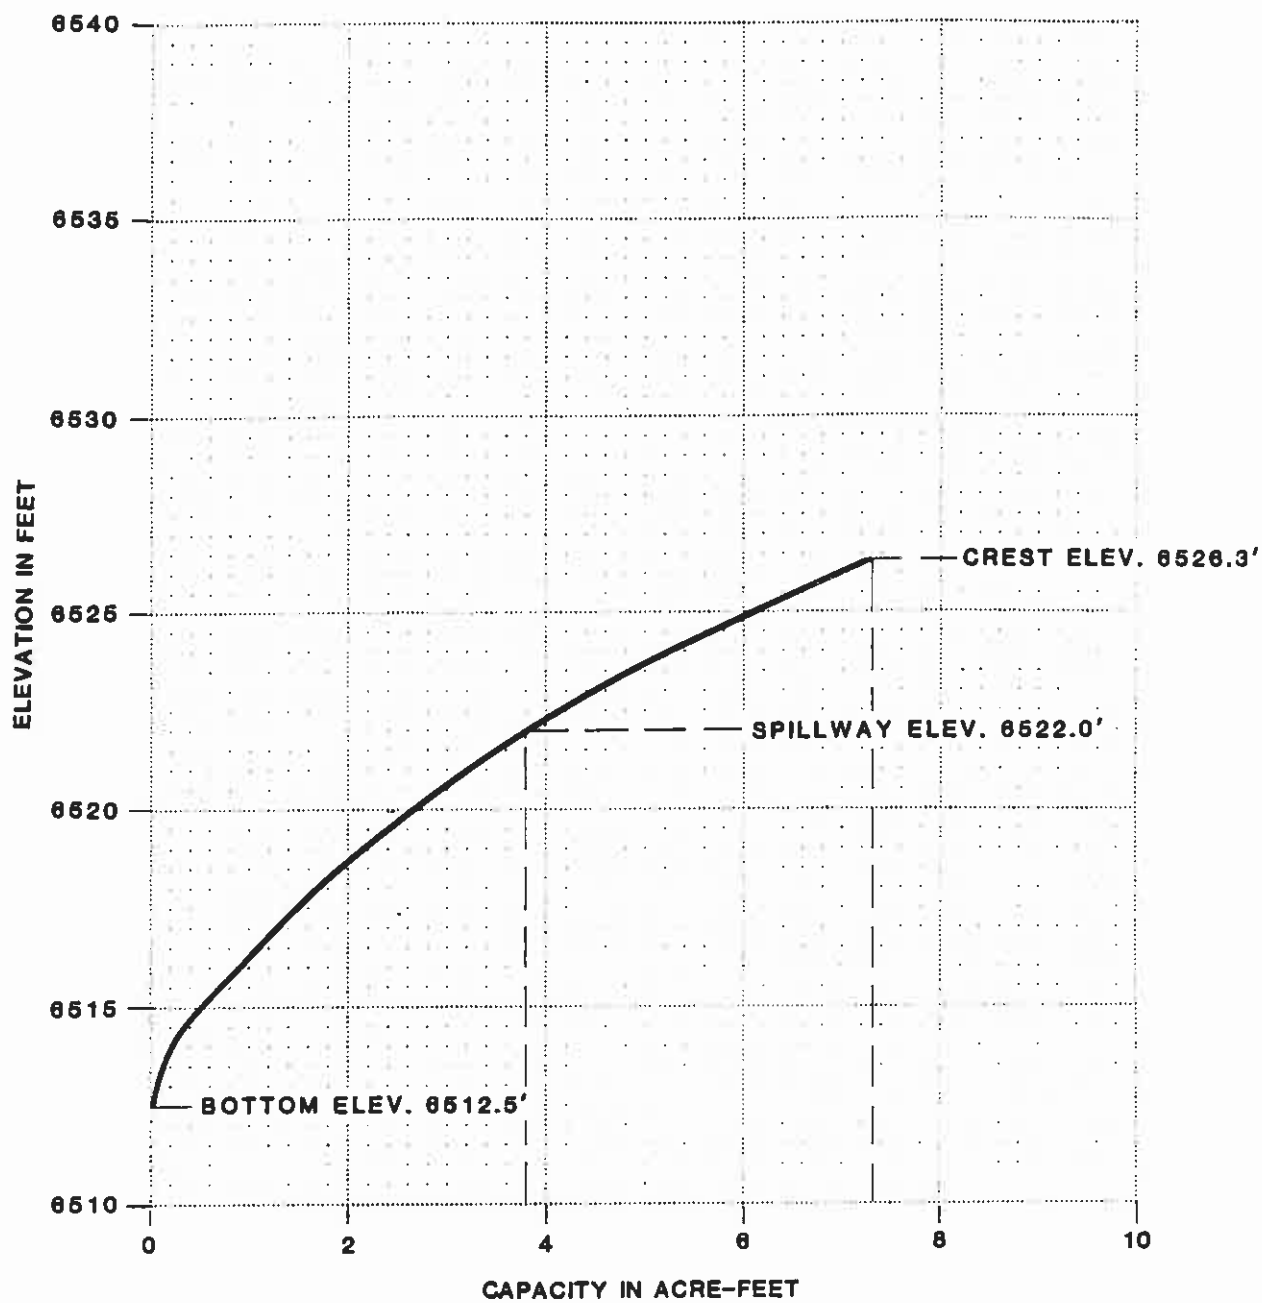
The impoundment volume-elevation curve is based on site specific surveys conducted for Peabody Coal Company's August 1984 inspection, and 1985 resurveys, where available. Additionally, the most current topographic maps available were used in developing Plate 3, Volume-Elevation Curve, N10-C.

VOLUME-ELEVATION
CURVE
N10-C

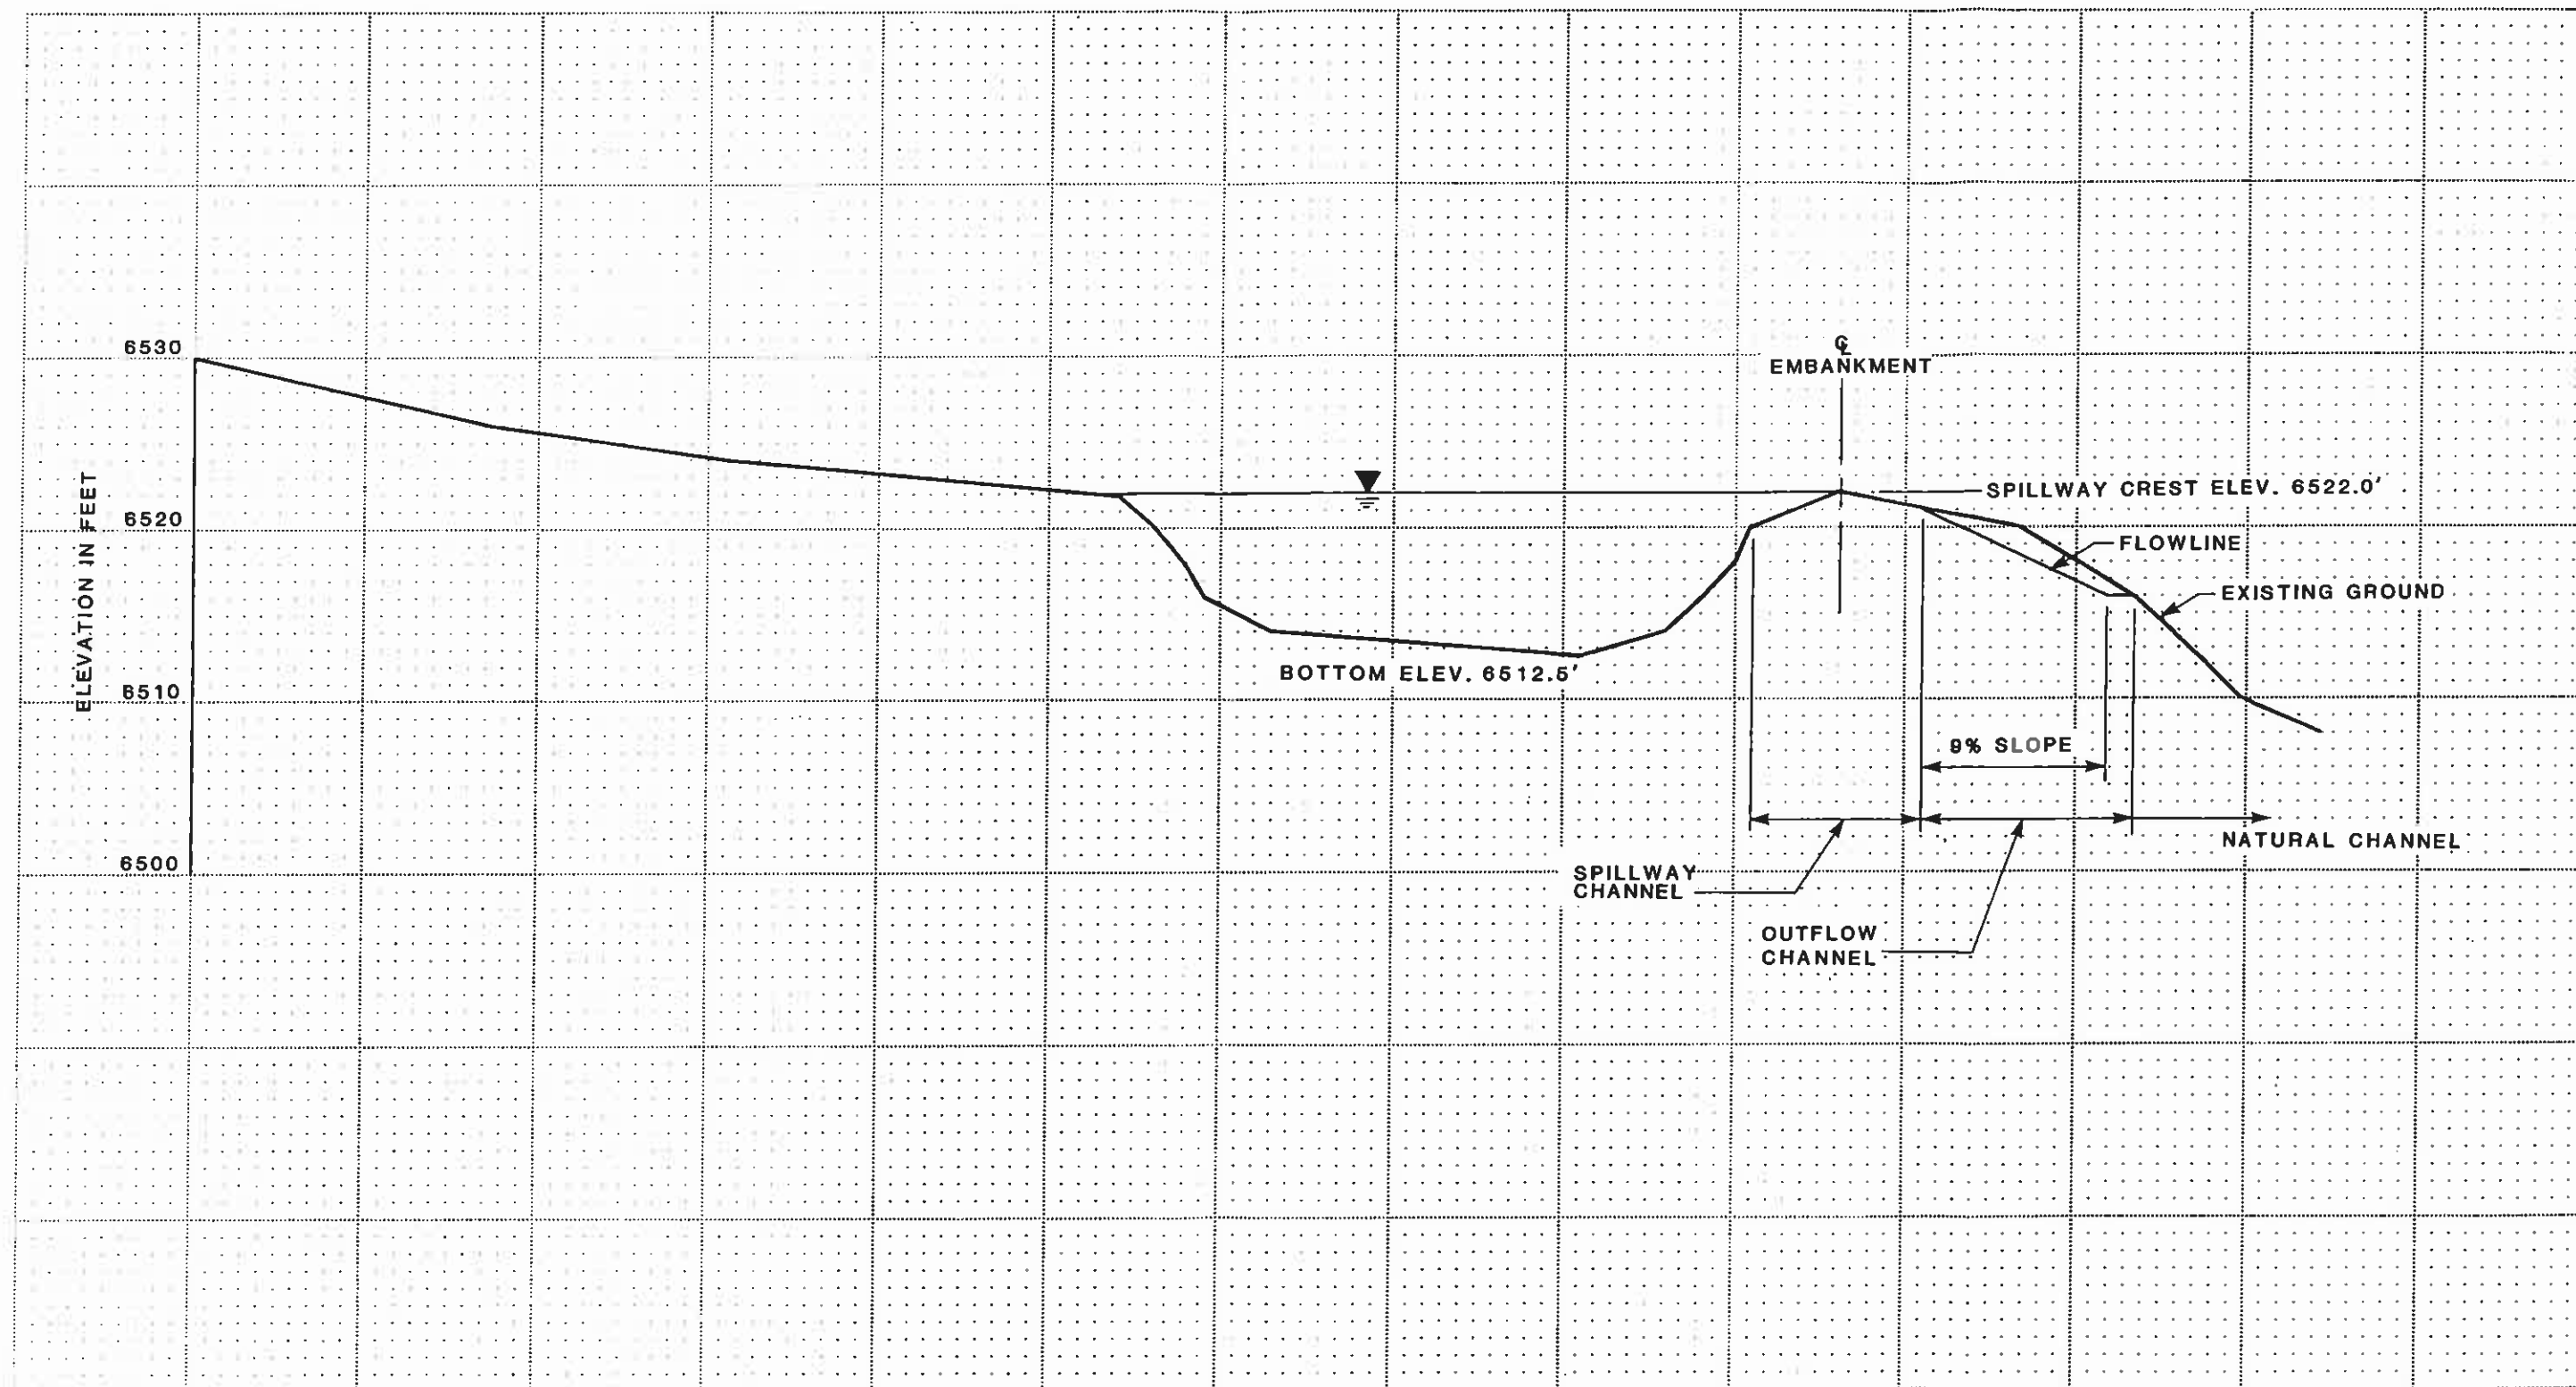
Plate 4

CHANNEL PROFILE B-B'
N10-C

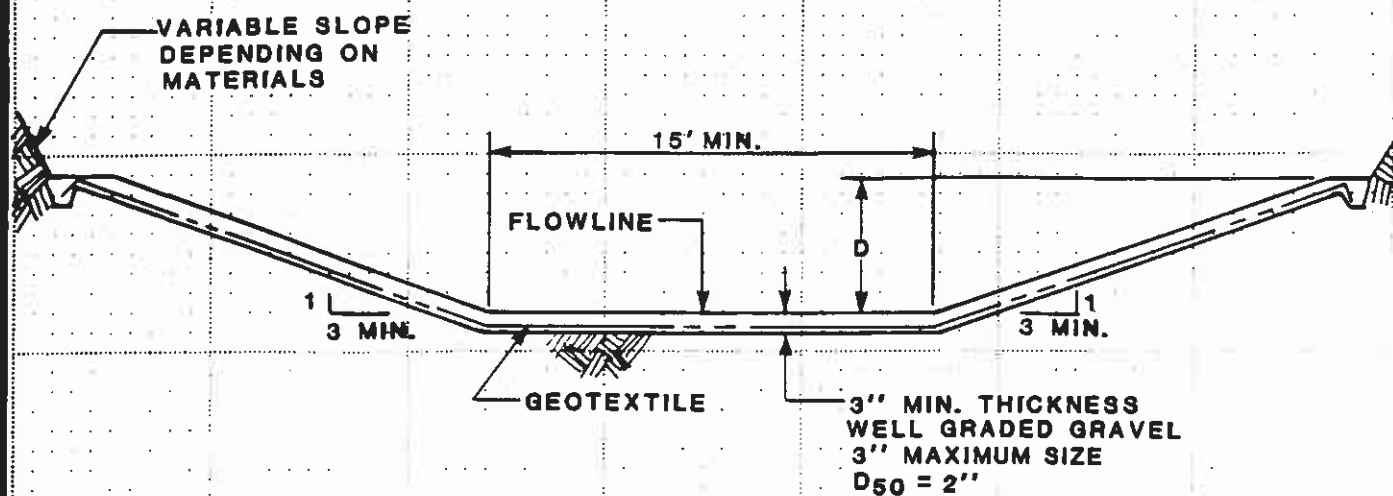
There is presently no erosion protection within the channel.

The structure presently has no outflow channel.

**SPILLWAY AND
OUTFLOW CHANNEL
CROSS SECTION
N10-C**
