INSPECTION REPORT
Sedimentation Structure
N10-D
Kayenta Mine
Navajo County, Arizona

for
PEABODY COAL COMPANY

Dames & Moore
10139-011-22

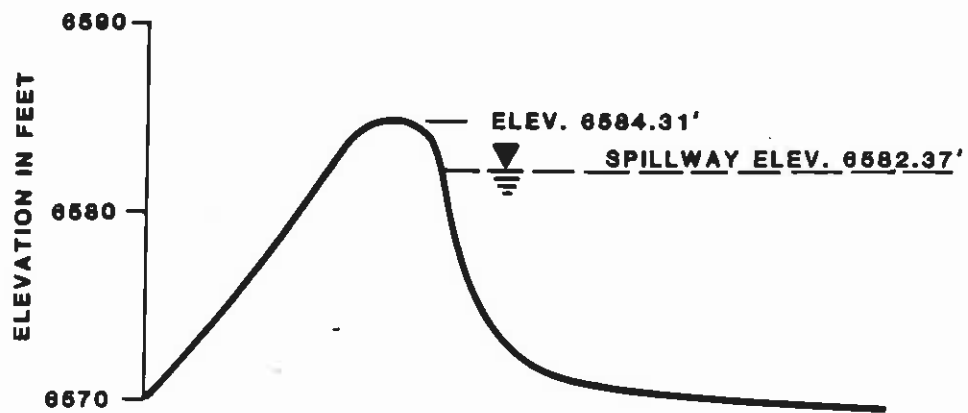
Plate 2

The inspection of Structure N10-D indicated that the geotechnical problems consist of rill erosion on the upstream and downstream slopes and an uneven embankment crest and downstream slope. Correction of erosion is considered a periodic maintenance task and does not require remedial action. The crest and the downstream slope should be trimmed level and smooth, respectively, to prevent masking of potential future problems.

EXISTING
MAXIMUM CROSS-SECTION
A-A'
N10-D

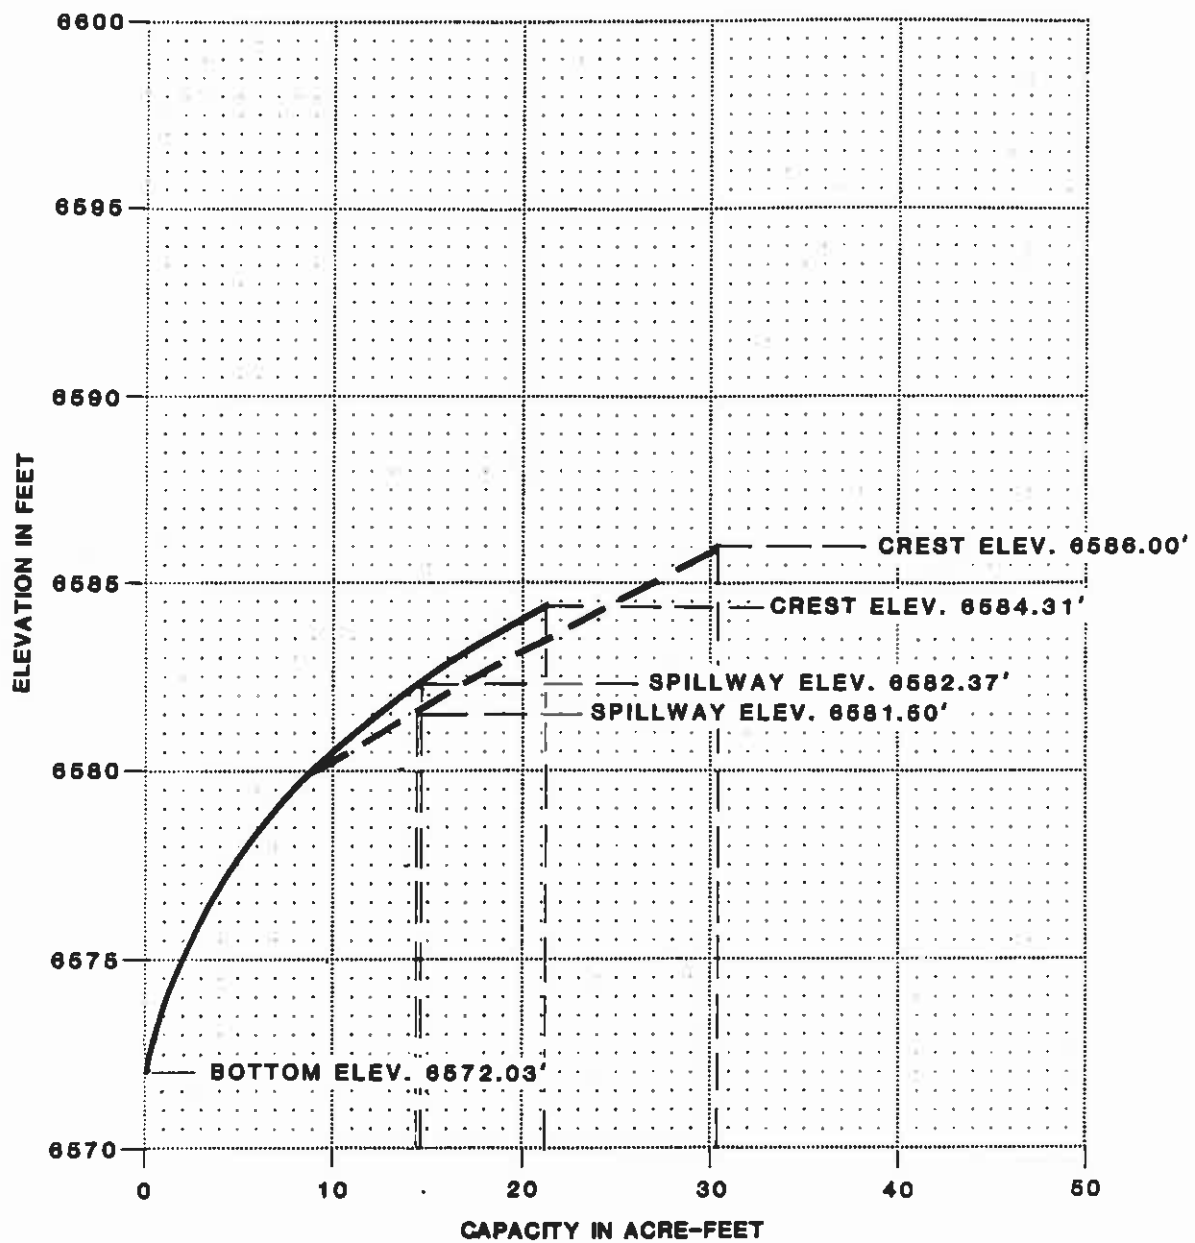
VOLUME-ELEVATION CURVE N10-D

The impoundment volume-elevation curve is based on site specific surveys conducted for Peabody Coal Company's August 1984 inspection, and 1985 resurveys, where available. Additionally, the most current topographic maps available were used in developing Plate 3, Volume-Elevation Curve, N10-D.

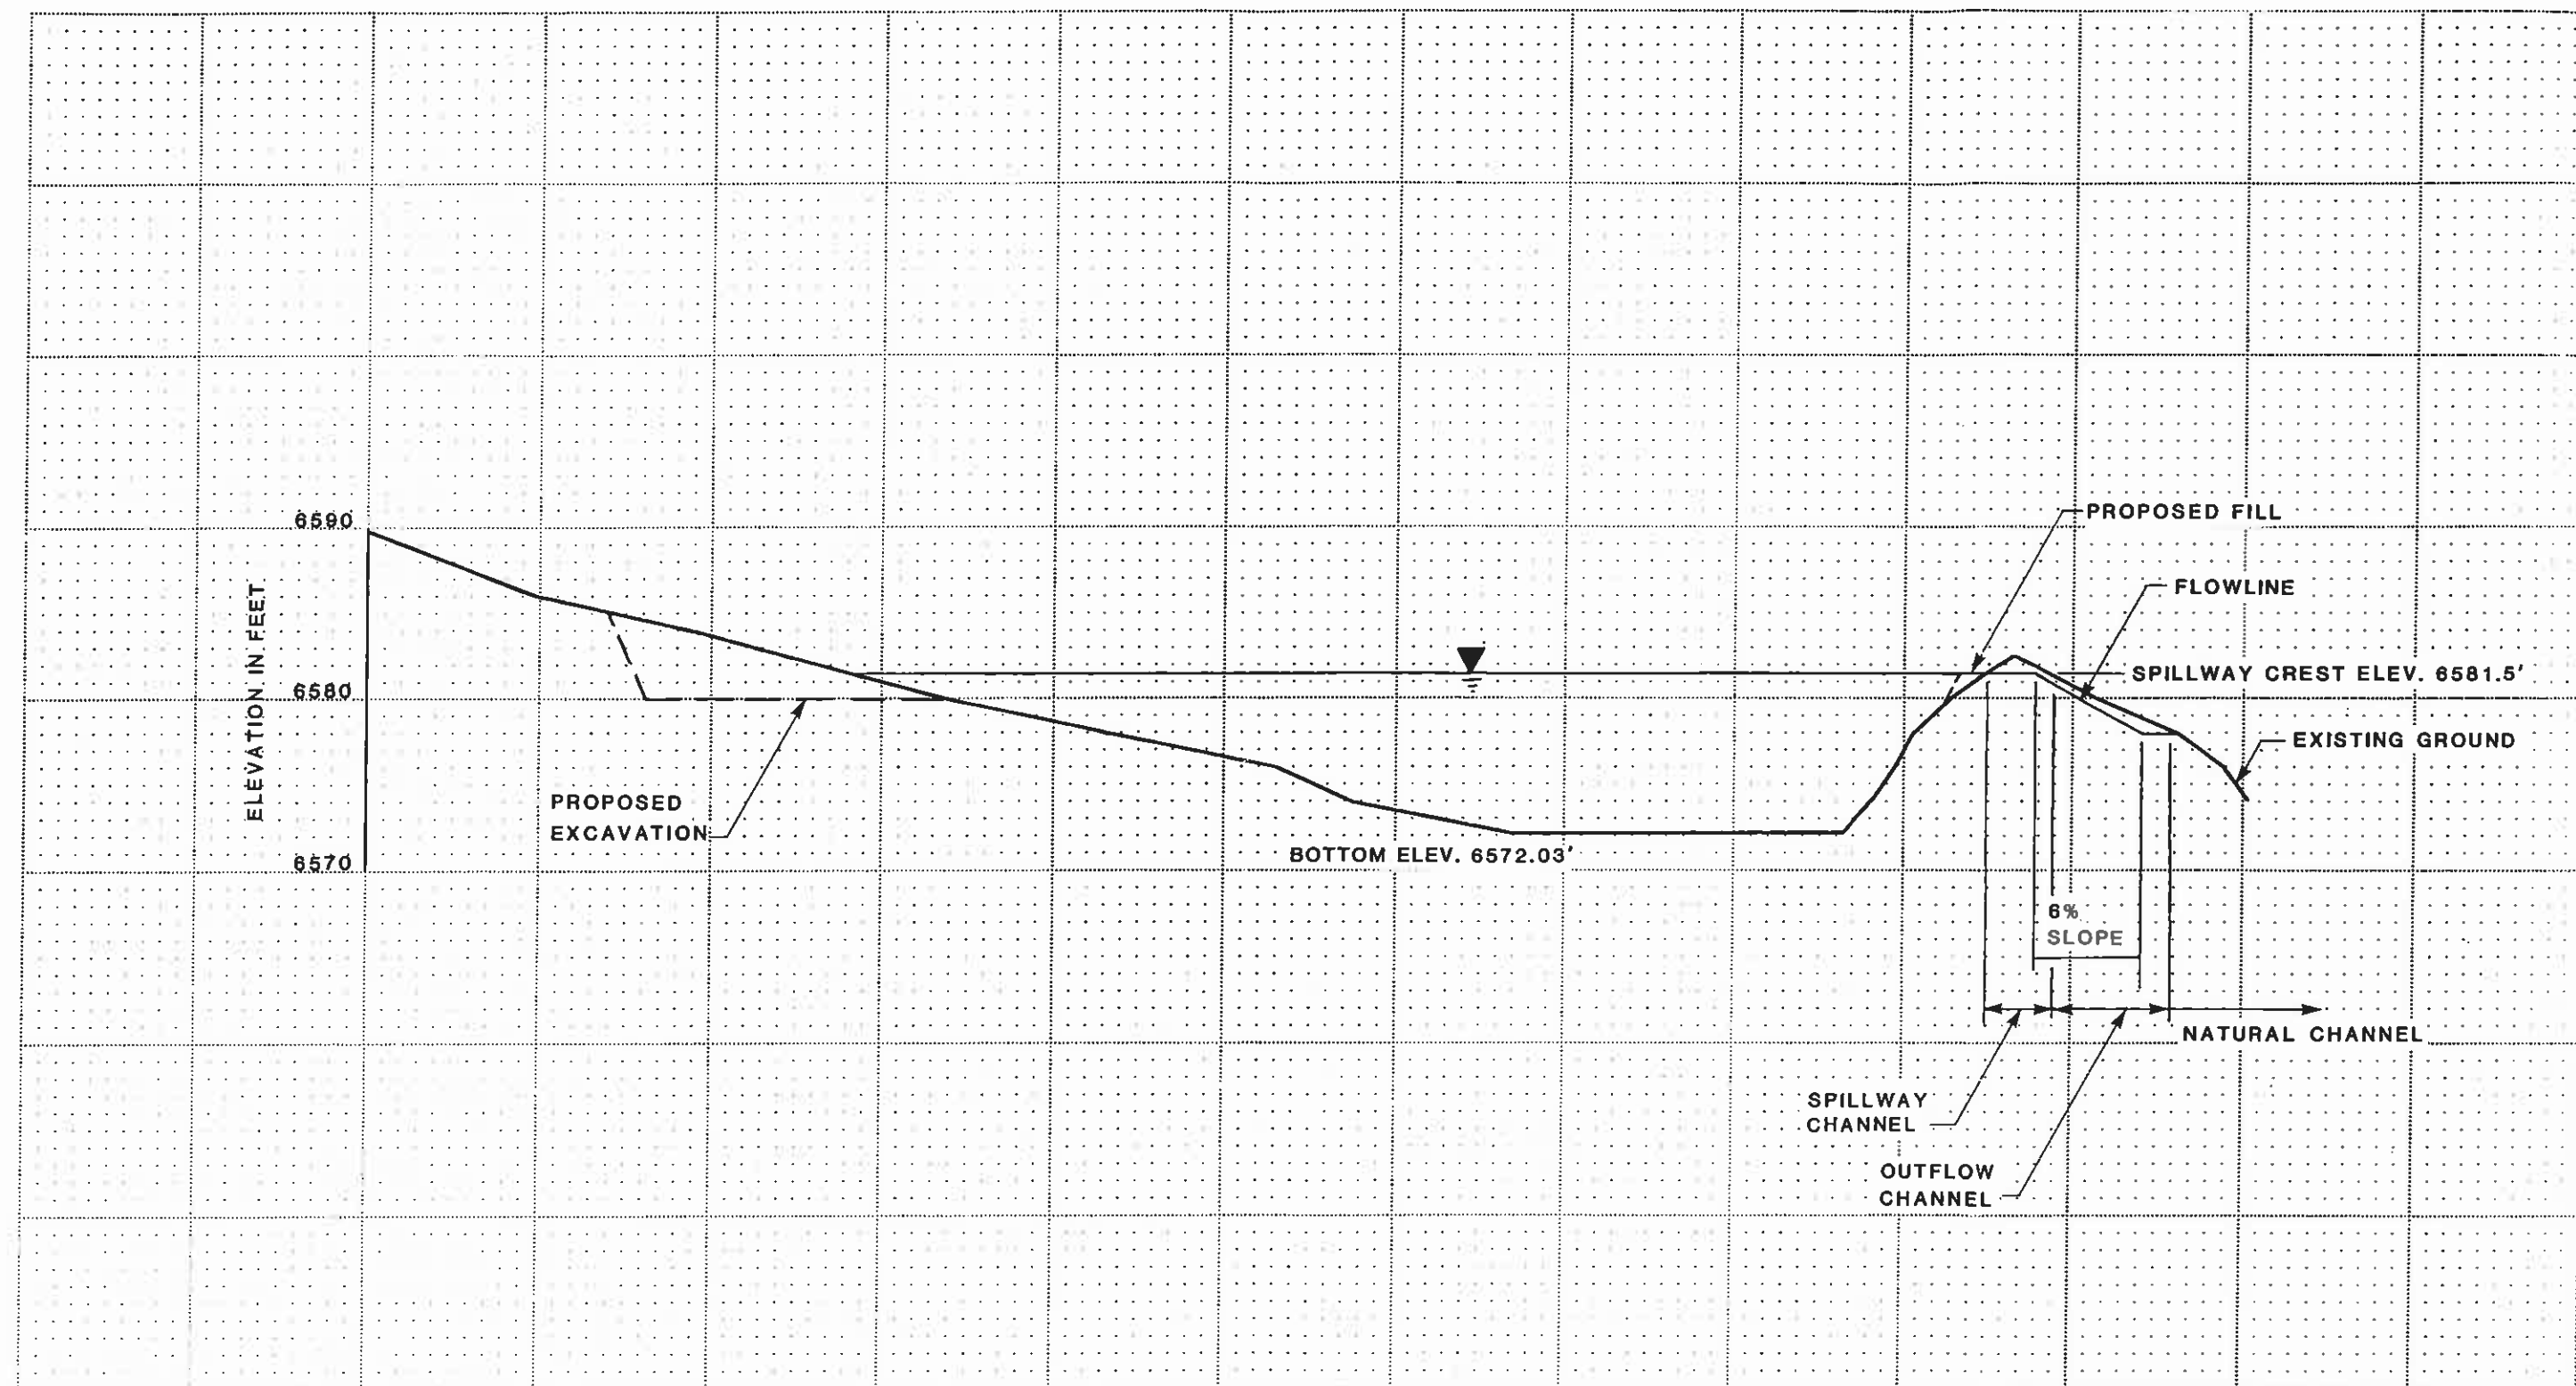
Plate 4

CHANNEL PROFILE B-B'
N10-D

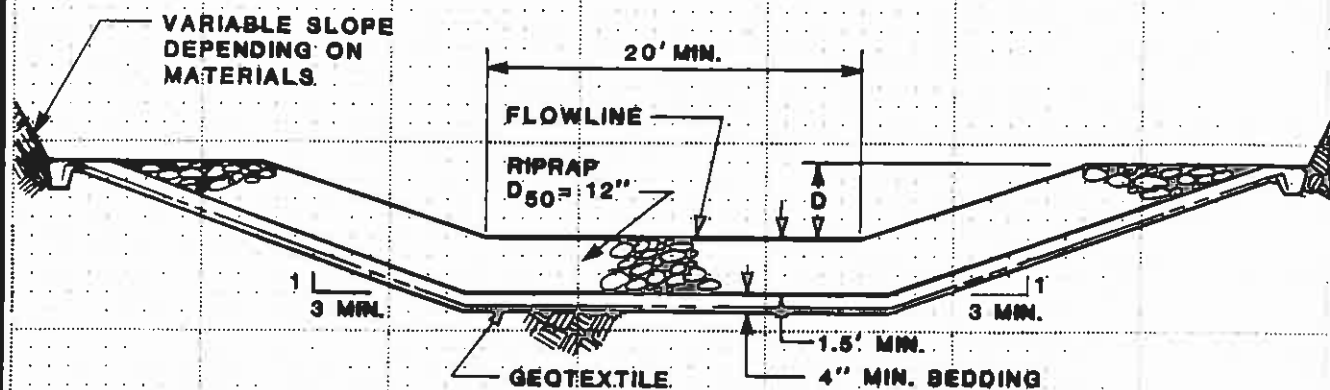
**SPILLWAY AND
 OUTFLOW CHANNEL
 CROSS SECTION
 N10-D**

The storage capacity of Structure N10-D is adequate but the spillway capacity is inadequate. The structure does not have an adequate outflow channel. The bottom elevation of the existing spillway channel should be lowered to elevation 6581.5 feet while maintaining the bottom width of 20 feet as shown on Plate 5. The pond should be excavated to maintain the storage capacity. The embankment crest should be raised to elevation 6586.00 feet. A trapezoidal outflow channel with the same bottom width as the spillway should be constructed along the alignment shown in Plate 1. The channel profile is shown in Plate 4 and required dimensions are shown in Plate 5. Both the spillway and outflow channel should be protected against erosion using geotextile and riprap as shown in Plate 5.

SPILLWAY CHANNEL

$D = 2.6'$
 LENGTH = 40'
 FLOWLINE ELEV. = 8581.50'

OUTFLOW CHANNEL

$D = 1.5'$
