INSPECTION REPORT  
Sedimentation Structure  
N12-M  
Kayenta Mine  
Navajo County, Arizona

for  
PEABODY COAL COMPANY

Dames & Moore  
10139-011-22

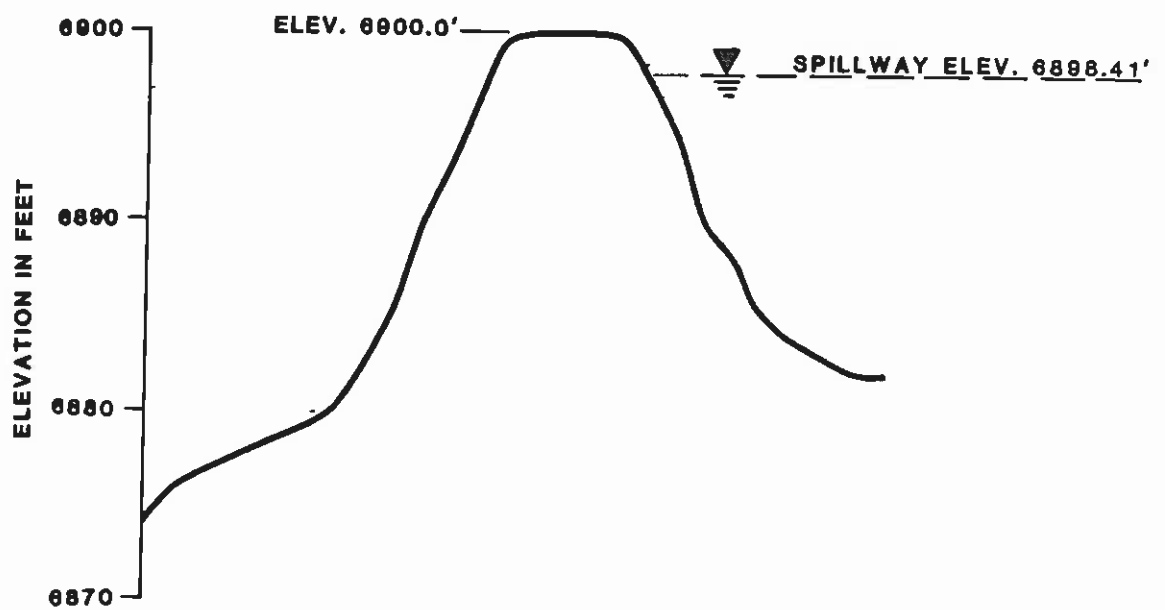
Plate 2

Embankment . . . . .	Residual Sandstone Soils
Foundation . . . . .	Residual Sandstone Soils
Right Abutment . . . . .	Residual Sandstone Soils
Left Abutment . . . . .	Residual Sandstone Soils
Height . . . . .	17.1 ft
Crest Width . . . . .	15 ft
Upstream Slope . . . . .	2.6 H : 1 V
Downstream Slope . . . . .	2.5 H : 1 V

The N12-M embankment is lower in height; however, the downstream slope is steeper than the category standard; therefore, the embankment has factors of safety less than the design minimum.

EXISTING  
MAXIMUM CROSS-SECTION  
A-A'  
N12-M

trimmed smooth and level to prevent masking of potential future problems. The downstream slope should be flattened to 4.0 horizontal to 1 vertical to meet stability requirements.

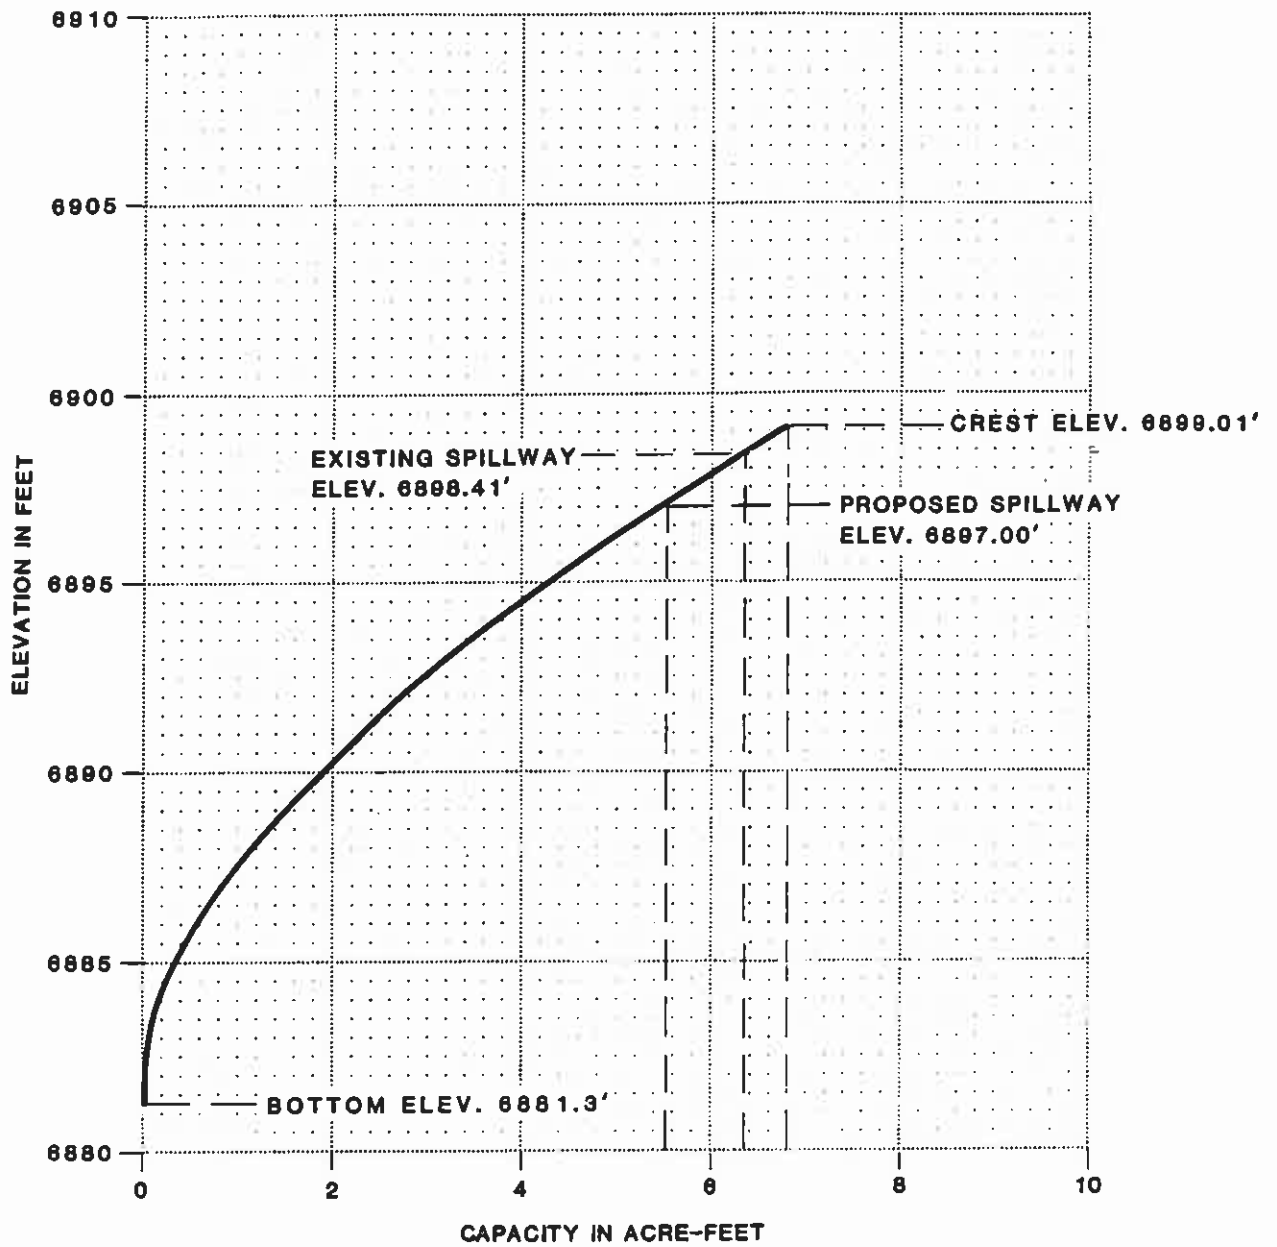
VOLUME-ELEVATION  
 CURVE  
 N12-M

The impoundment volume-elevation curve is based on site specific surveys conducted for Peabody Coal Company's August 1984 inspection, and 1985 resurveys, where available. Additionally, the most current topographic maps available were used in developing Plate 3, Volume-Elevation Curve, N12-M.

Total Storage Capacity . . . . .	6.33	acre-ft
10-year, 24-hour Storm Inflow . . . . .	0.507	acre-ft
Available Sediment Storage Capacity . . . . .	5.82	acre-ft
Sediment Inflow Rate . . . . .	0.035	acre-ft/yr
Sediment Storage Life . . . . .	166	yrs

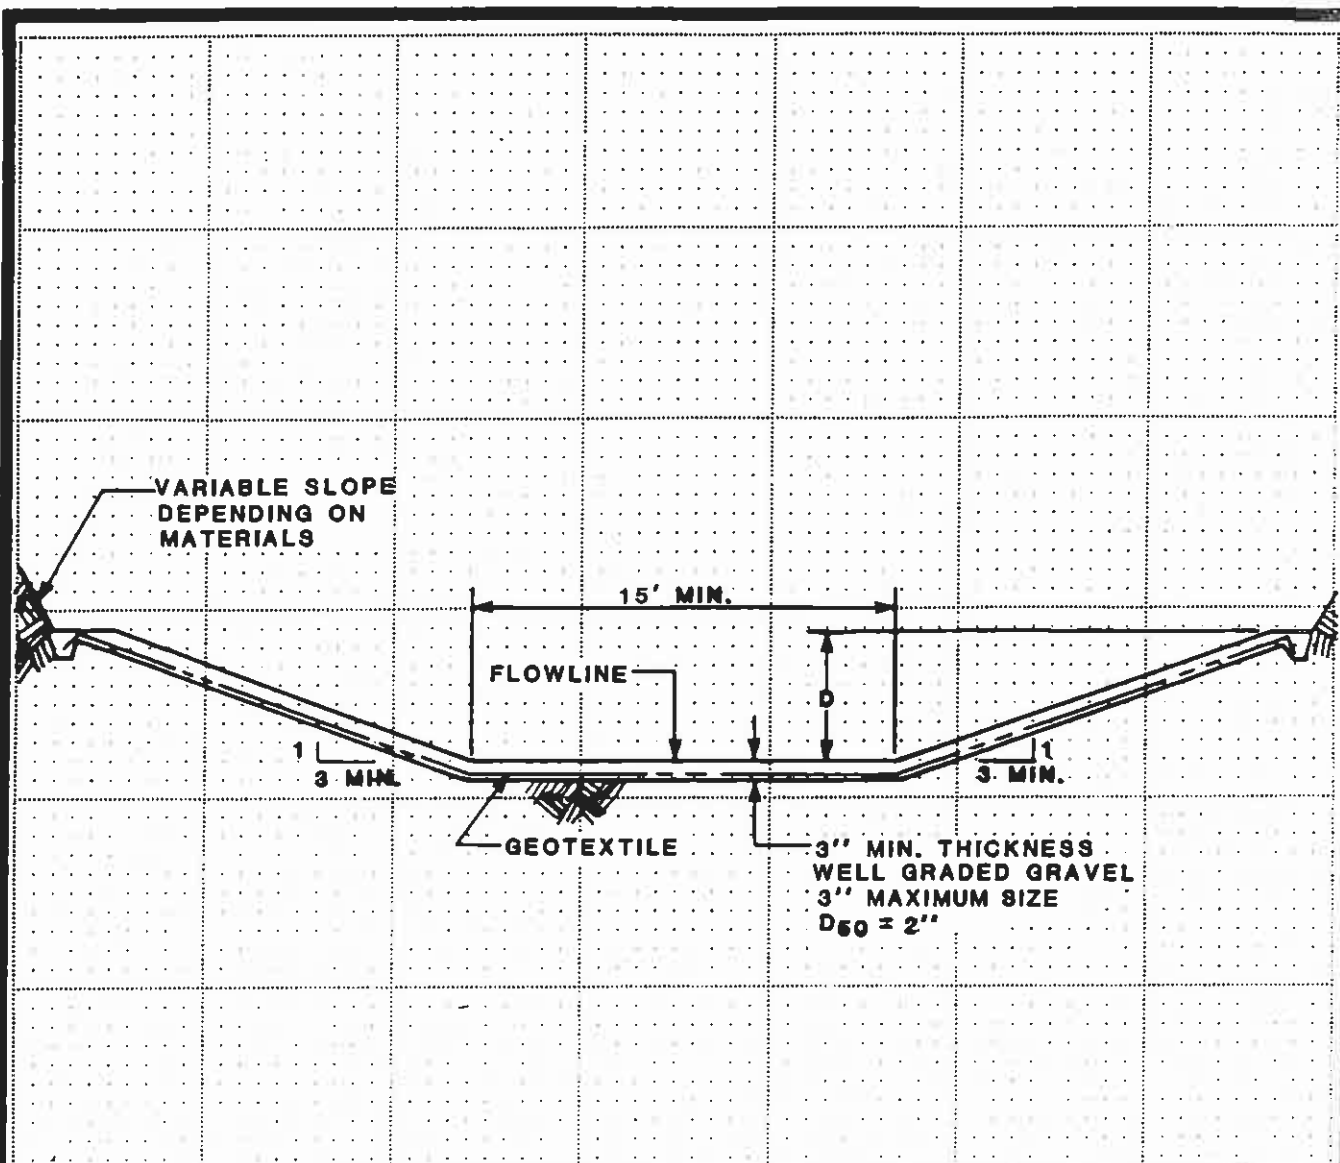
**SPILLWAY AND  
OUTFLOW CHANNEL  
CROSS SECTION  
N12-M**

The storage capacity of Structure N12-M is adequate but the spillway capacity is inadequate. The structure does not have an outflow channel. The bottom elevation of the existing spillway channel should be lowered to elevation 6897.00 feet while maintaining the bottom width of 15 feet as shown on Plate 5. A trapezoidal outflow channel with the same bottom width as the spillway should be constructed along the alignment shown in Plate 1. The channel profile is shown in Plate 4 and required dimensions are shown in Plate 5. Both the spillway and outflow channel should be protected against erosion using geotextile and gravel as shown in Plate 5.

**SPILLWAY CHANNEL**

D = 1.5'

LENGTH = 30'

FLOWLINE ELEV. = 8897.00'

**OUTFLOW CHANNEL**

D = 1'
