INSPECTION REPORT
Sedimentation Structure
N12-N
Kayenta Mine
Navajo County, Arizona
for
PEABODY COAL COMPANY

Dames & Moore
10139-011-22

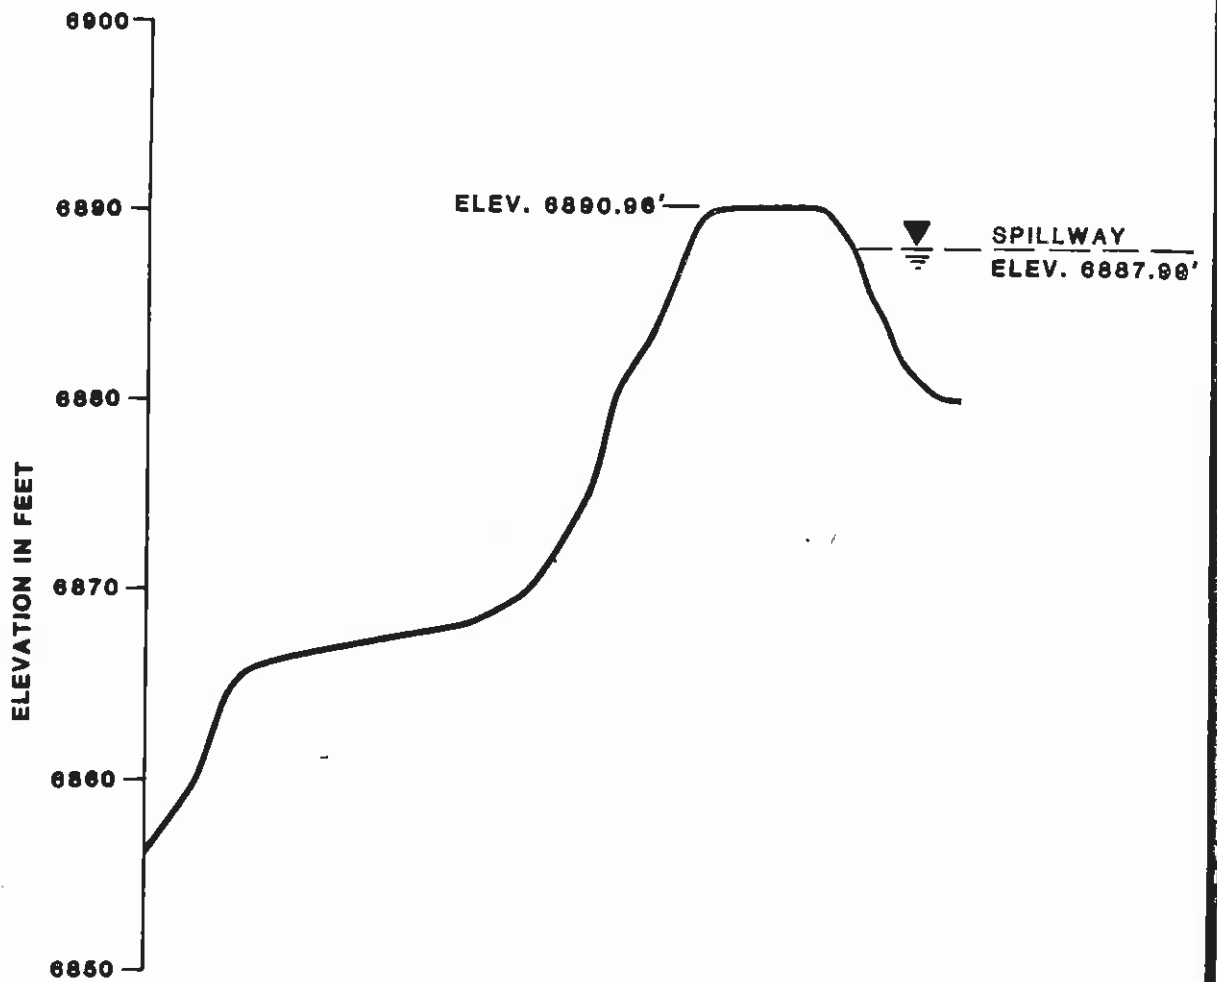
Plate 2

The inspection of Structure N12-N indicated that the geotechnical problems consist of rill and gully erosion on the upstream and downstream slopes, the side slopes of the approach, spillway, outlet channel, the bottom of the approach and outlet channel, and the right and left abutments; and an uneven upstream slope. Correction of erosion is considered a periodic maintenance task and does not require remedial action. The upstream slope of the embankment should be trimmed to prevent masking of potential future problems.

EXISTING
MAXIMUM CROSS-SECTION
A-A'
N12-N

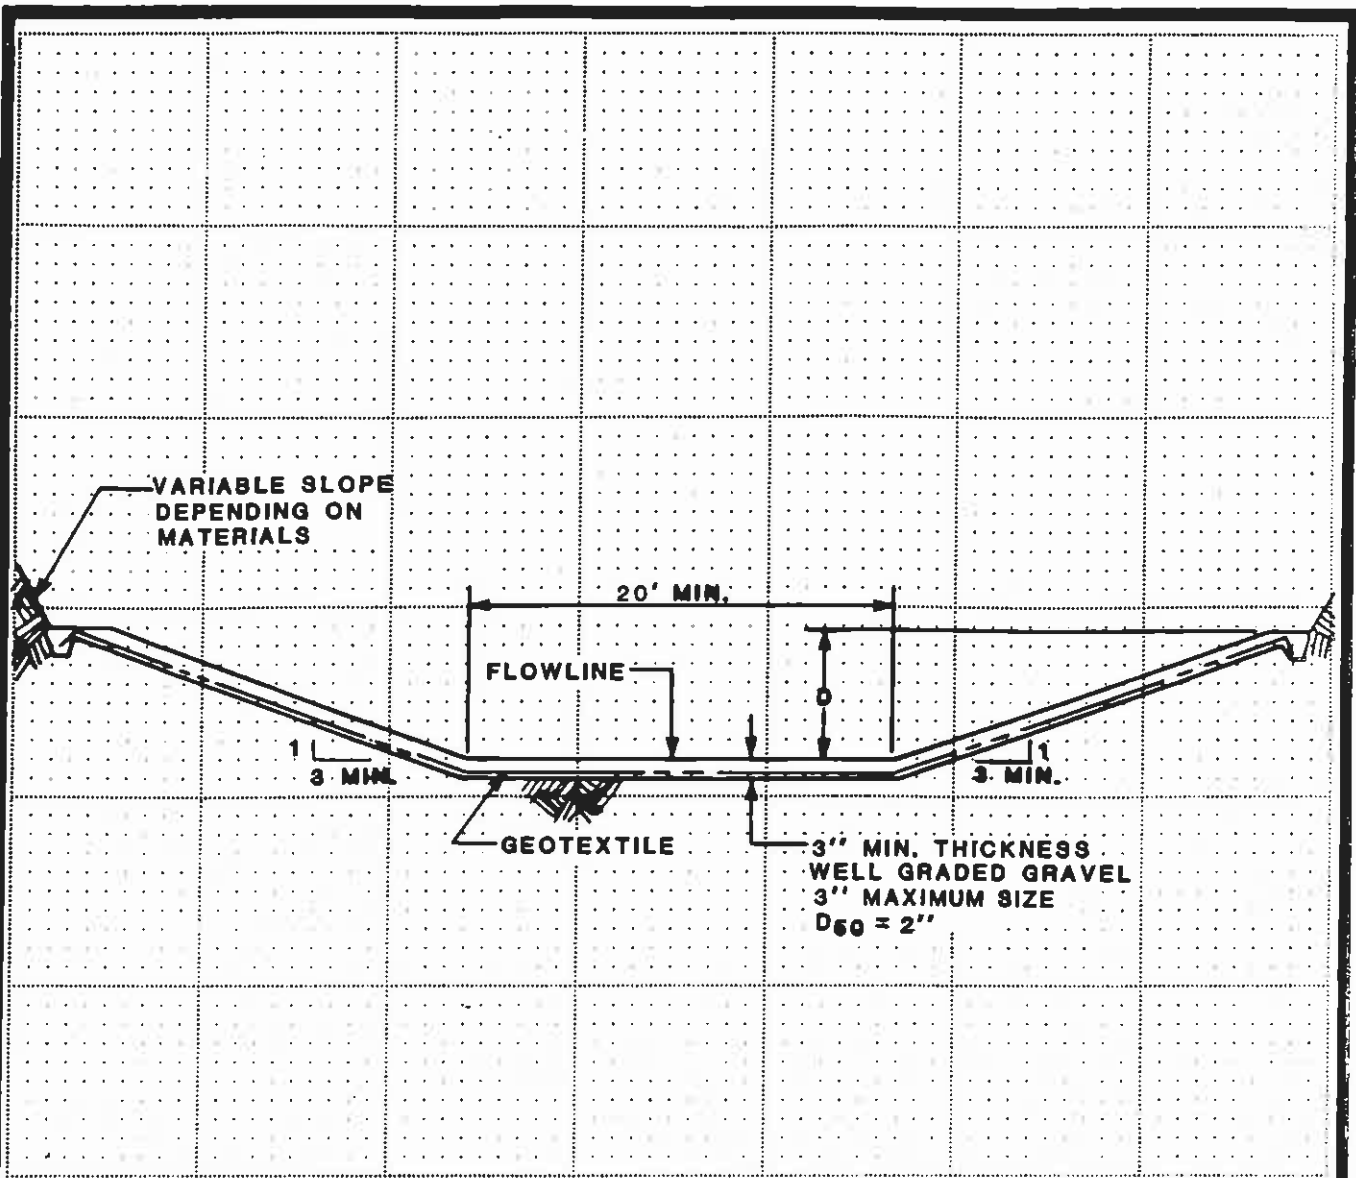
**SPILLWAY AND
 OUTFLOW CHANNEL
 CROSS SECTION
 N12-N**

The storage capacity and spillway capacity of Structure N12-N are adequate. The spillway and outflow channels are not protected with riprap. Both channels should be protected against erosion using geotextile and gravel as shown in Plate 5. Plate 4 shows the existing spillway and outflow channel profile and Plate 5 shows the channel dimensions.

SPILLWAY CHANNEL

D = 1.8'
 LENGTH = 40'
 FLOWLINE ELEV. = 6887.99'

OUTFLOW CHANNEL

D = 1'
