INSPECTION REPORT
Sedimentation Structure
N14-B
Kayenta Mine
Navajo County, Arizona
for
PEABODY COAL COMPANY

Dames & Moore
10139-011-22

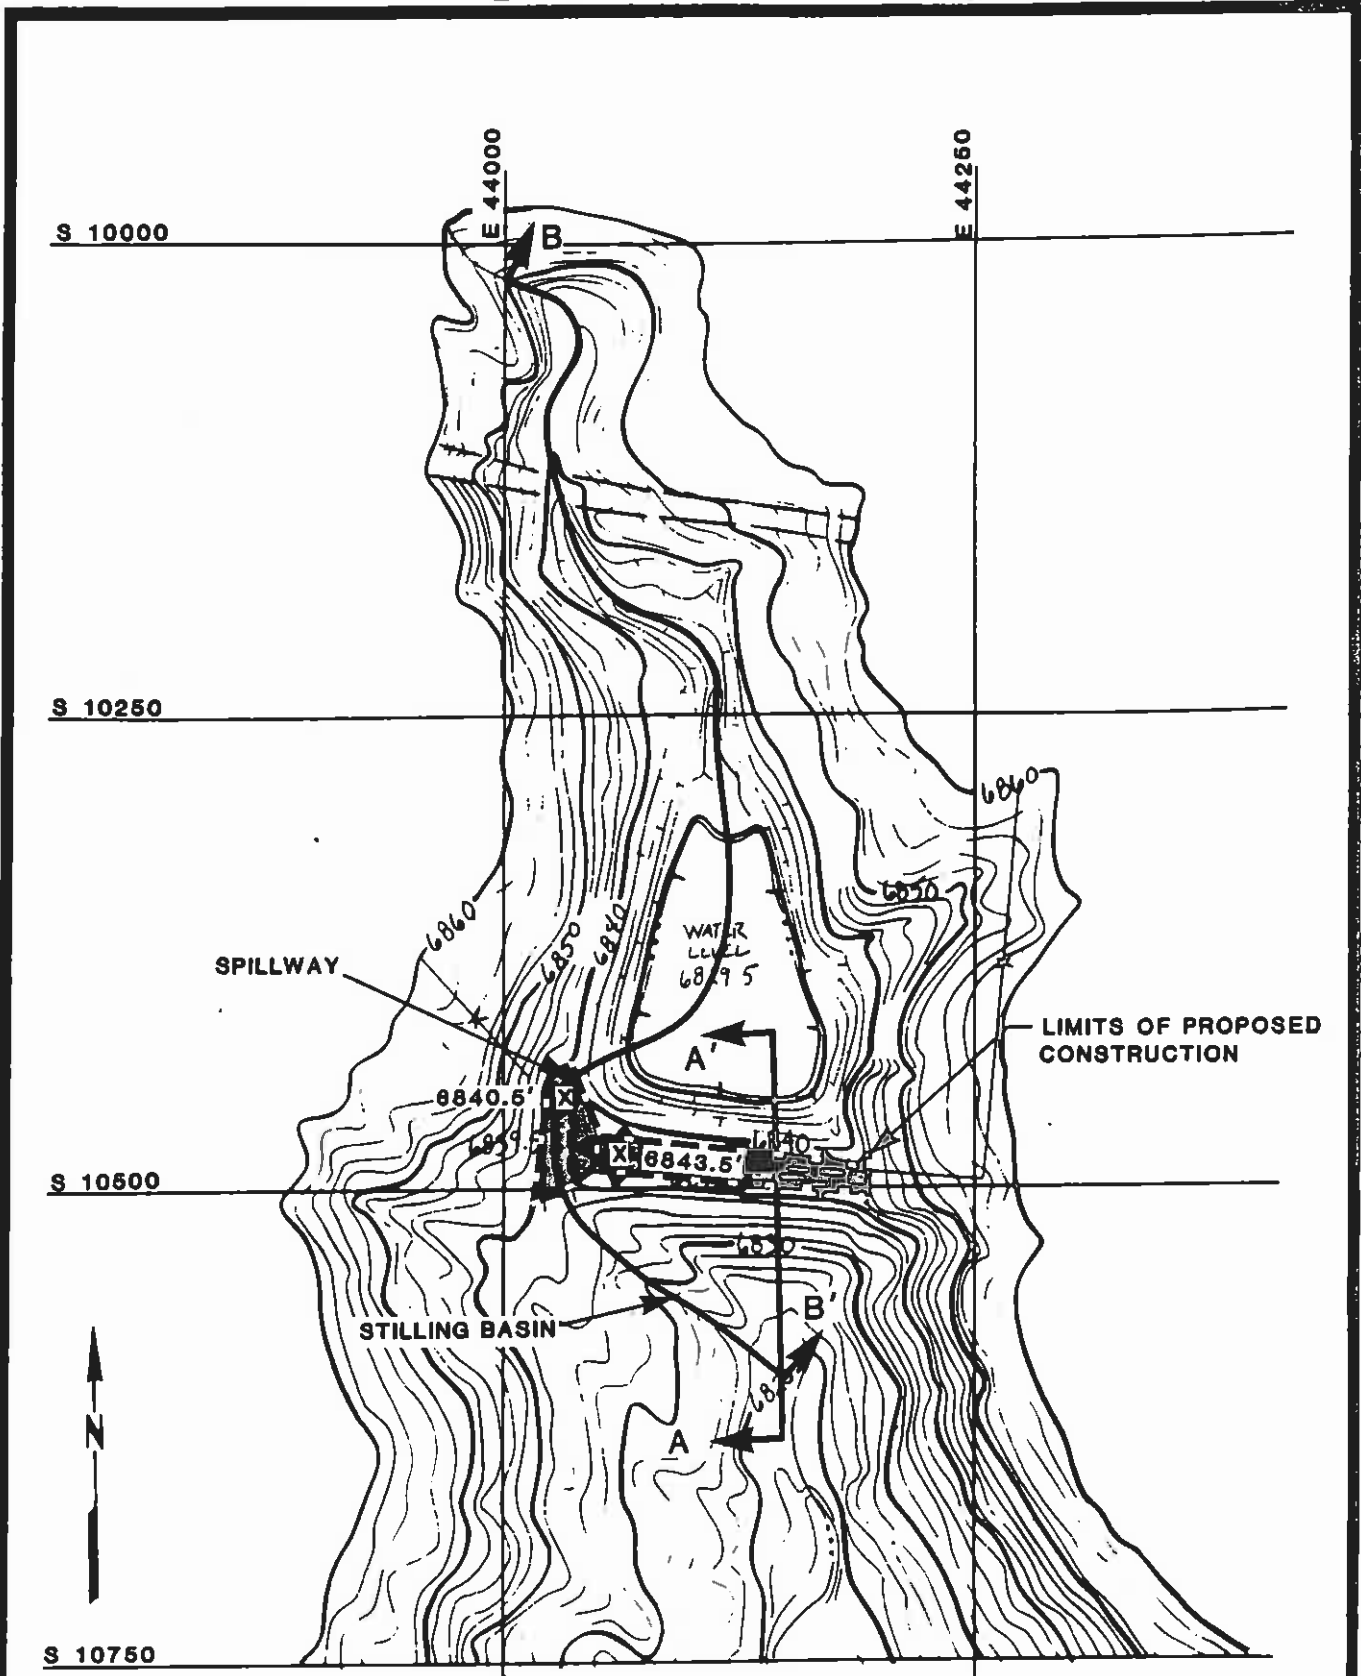
**SITE PLAN
N14-B.**

Sedimentation Structure N14-B is an earthen embankment, designed and constructed in 1981 by Peabody Coal Company as a temporary sedimentation structure to control runoff and sediment from the disturbed mining areas of the Kayenta Mine. The location of Structure N14-B is shown on Plate 1, Site Plan.

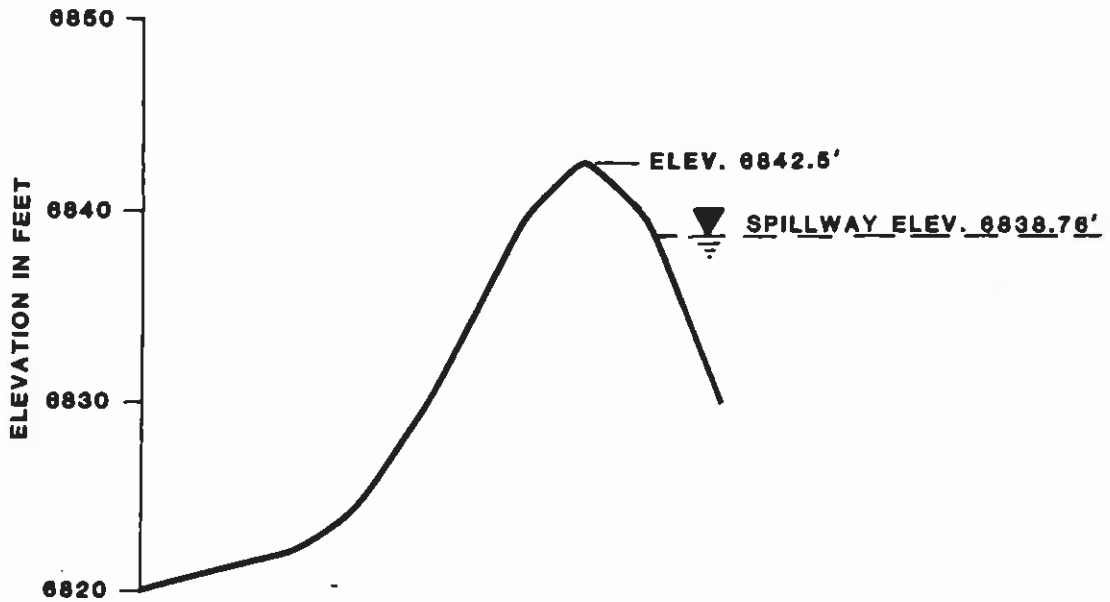
EXISTING
MAXIMUM CROSS-SECTION
A-A'
N14-B

Structure N14-B is a homogeneous earthen embankment classified as a cross-valley embankment. Physical characteristics of the embankment are listed in the following table:

A cross-section of the embankment is shown on Plate 2, Existing Maximum Cross Section N14-B, A-A'.

The N14-B embankment is lower in height and has flatter slopes than the category standard; therefore, the embankment has factors of safety greater than the design minimum.

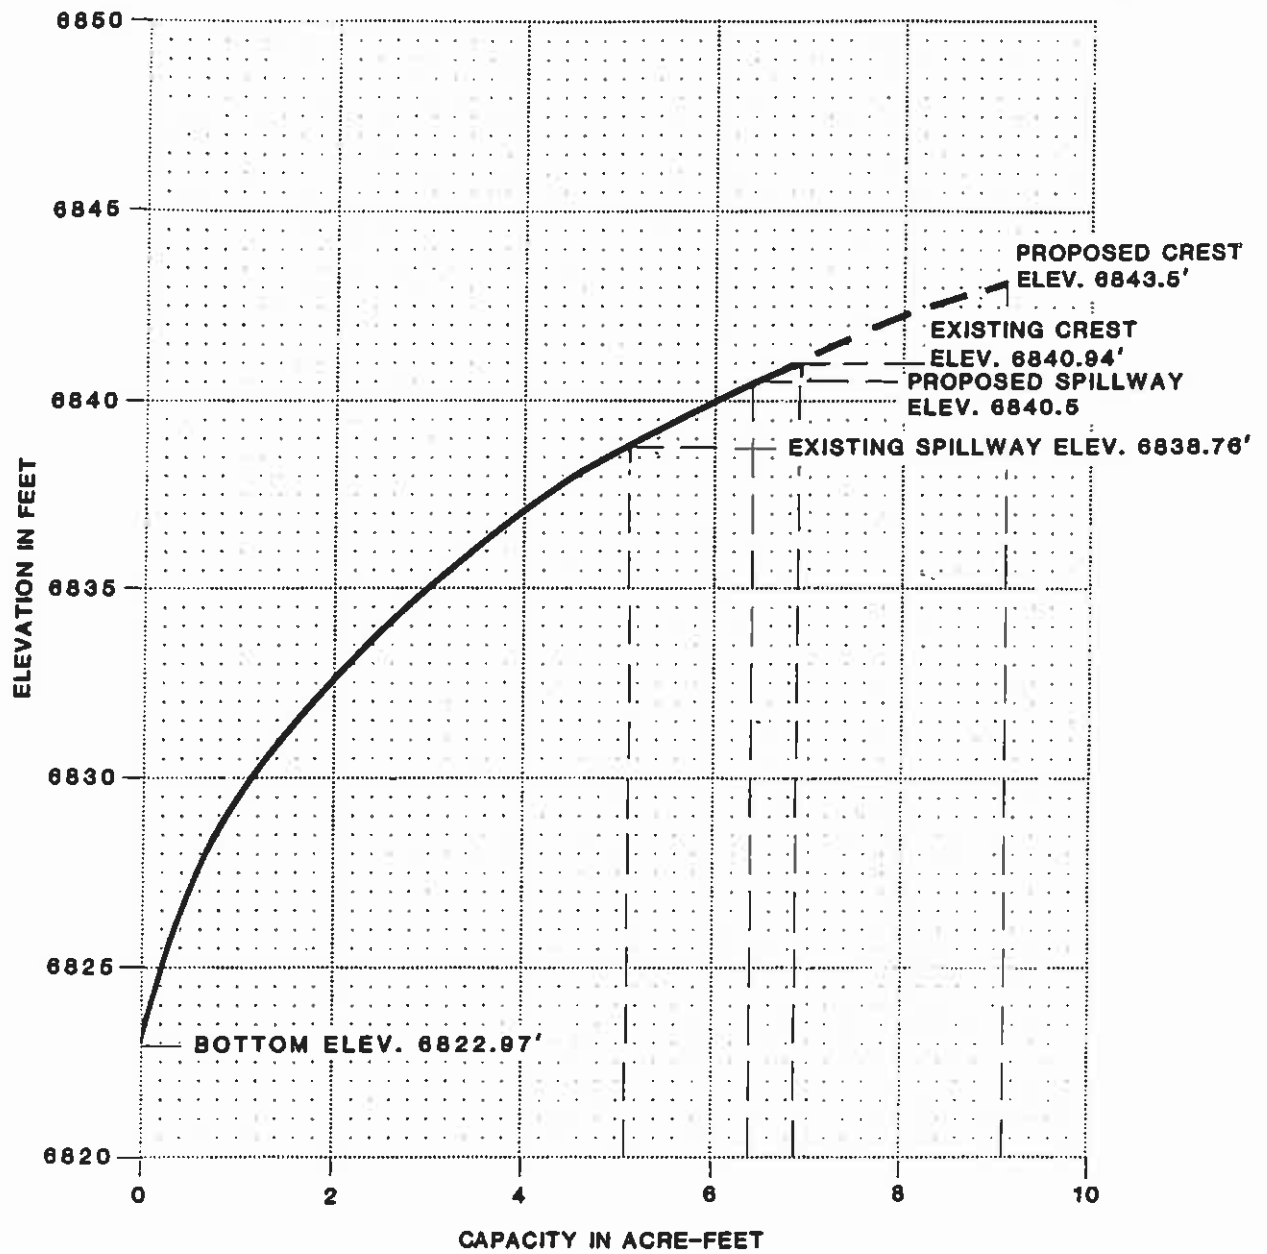
VOLUME-ELEVATION
CURVE
N14-B

The impoundment volume-elevation curve is based on site specific surveys conducted for Peabody Coal Company's August 1984 inspection, and 1985 resurveys, where available. Additionally, the most current topographic maps available were used in developing Plate 3, Volume-Elevation Curve, N14-B.

The hydrologic analysis gives the storage volume required to contain the 10-year, 24-hour storm, and the remaining storage volume available for storing sediment. The existing storage capacity of N14-B and the results of the sediment inflow analysis are summarized in the following table.
