INSPECTION REPORT
Sedimentation Structure
N14-C
Kayenta Mine
Navajo County, Arizona
for
PEABODY COAL COMPANY

Dames & Moore
10139-011-22

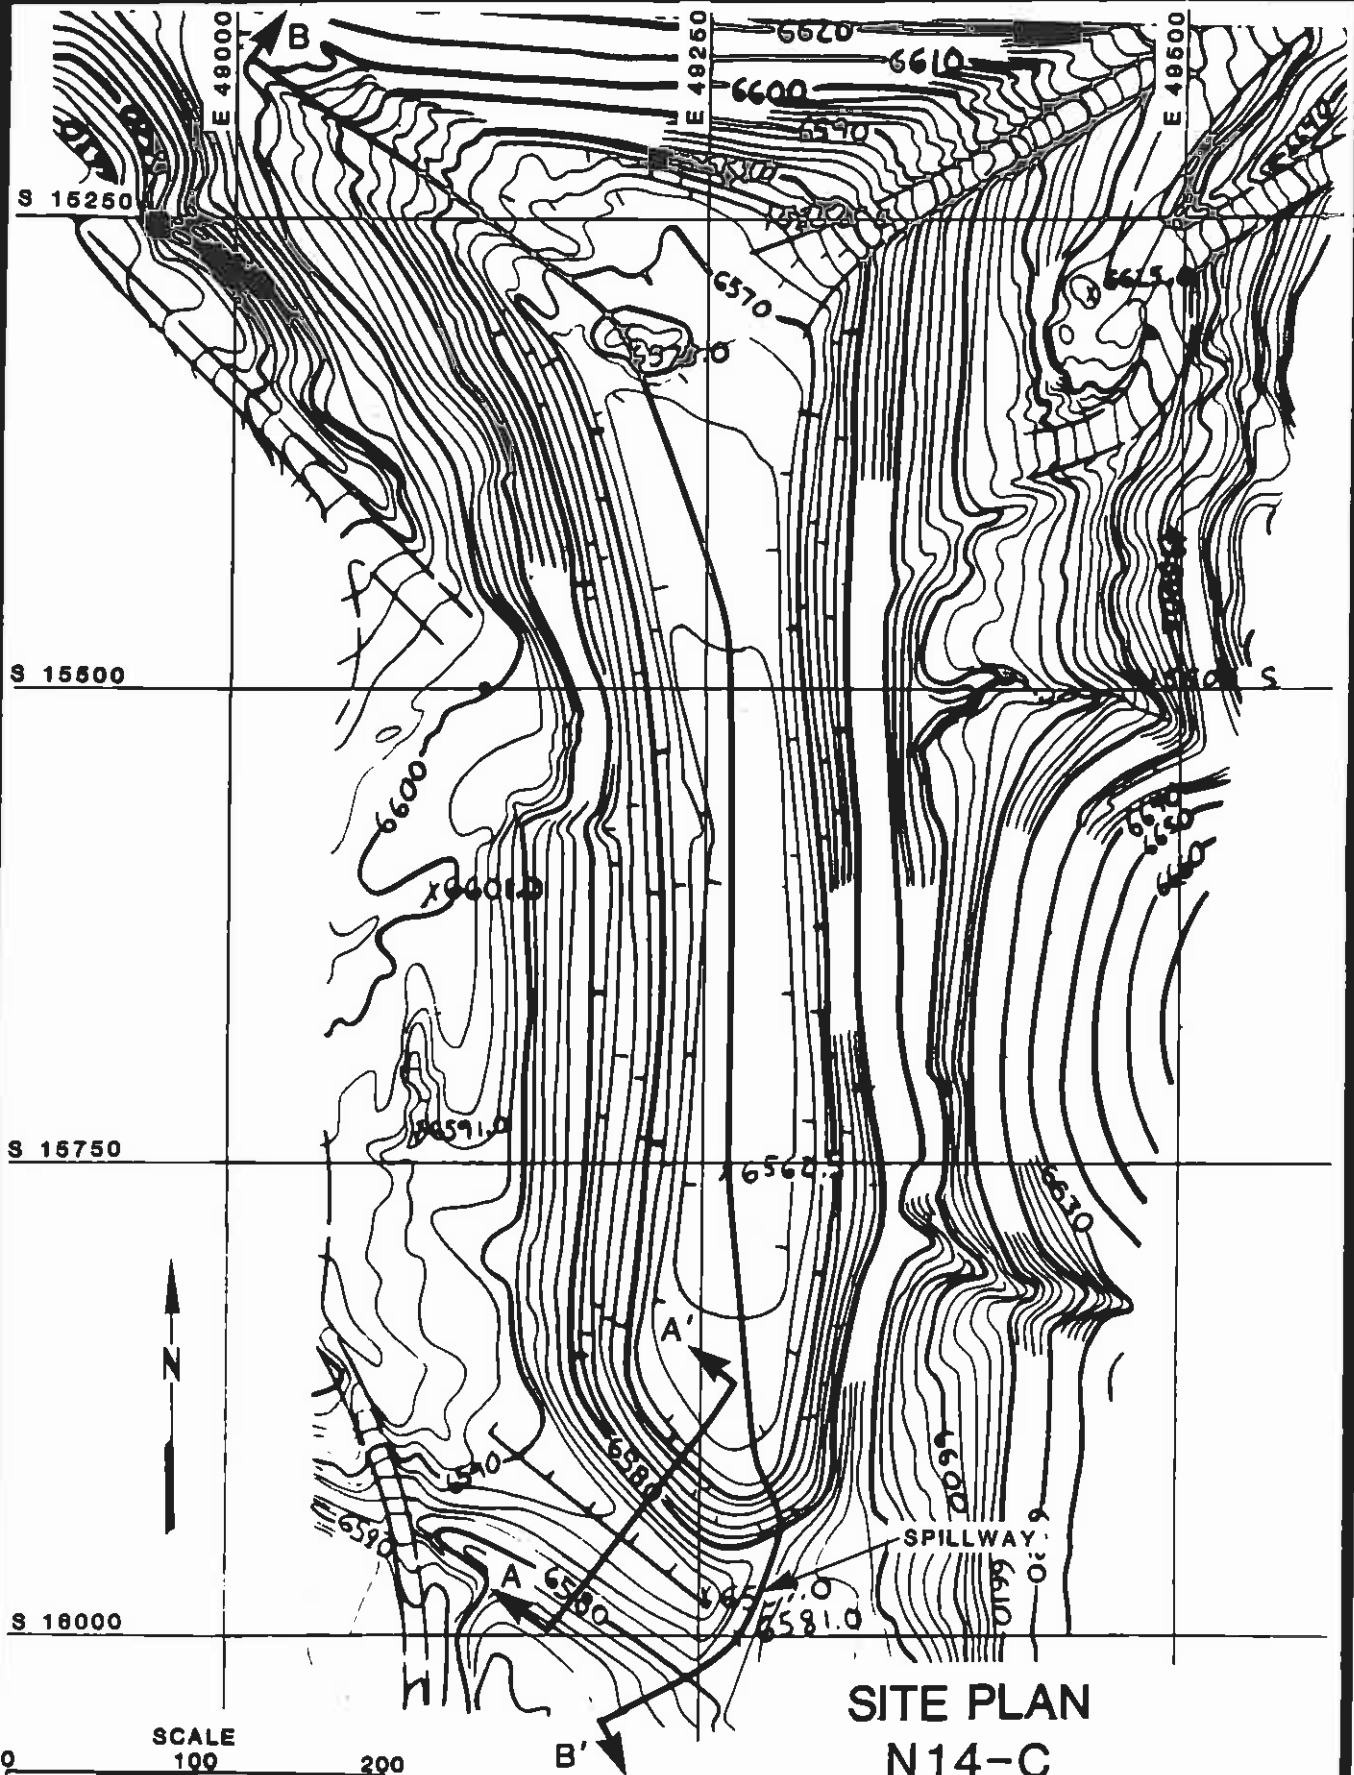
**SITE PLAN
N14-C**

Sedimentation Structure N14-C is an earthen embankment, designed and constructed in 1981 by Peabody Coal Company as a temporary sedimentation structure to control runoff and sediment from the disturbed mining areas of the Kayenta Mine. The location of Structure N14-C is shown on Plate 1, Site Plan.

The storage capacity and spillway capacity of Structure N14-C are adequate; however, the spillway does not have an adequate outflow channel or adequate erosion protection. A trapezoidal outflow channel should be constructed along the alignment B-B' shown in Plate 1. The channel profile is shown in Plate 4 and the required dimensions are shown in Plate 5. Both the spillway and outflow channel should be protected against erosion using geotextile and riprap as shown in Plate 5.

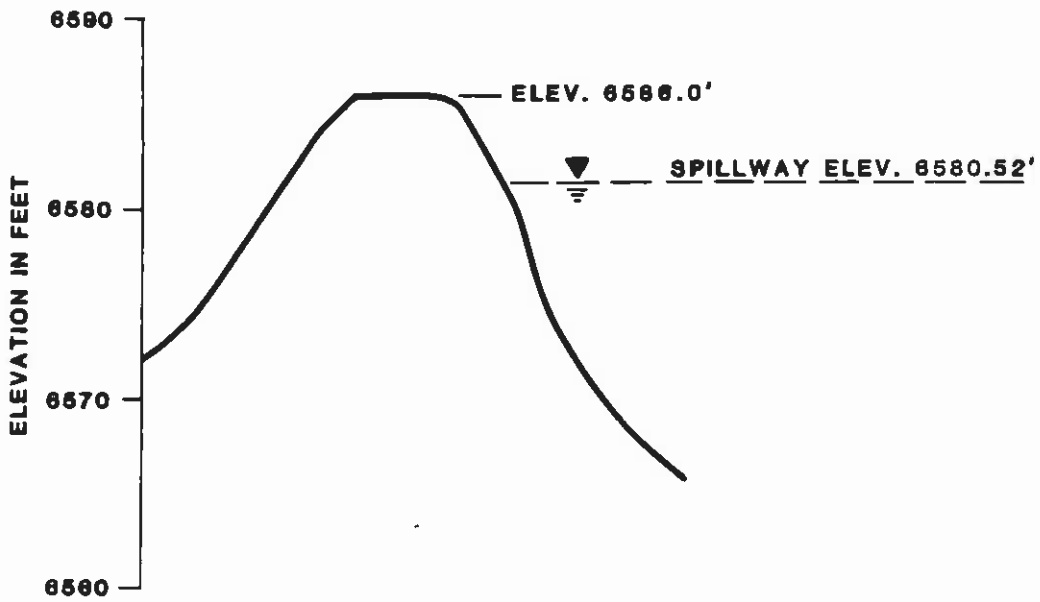
EXISTING
 MAXIMUM CROSS-SECTION
 A-A'
 N14-C

A cross-section of the embankment is shown on Plate 2, Existing Maximum Cross Section N14-C, A-A'. Grass provides erosion protection on the upstream slope of the embankment.

The N14-C embankment is lower in height and has flatter slopes than the category standard; therefore, the embankment has factors of safety greater than the design minimum.

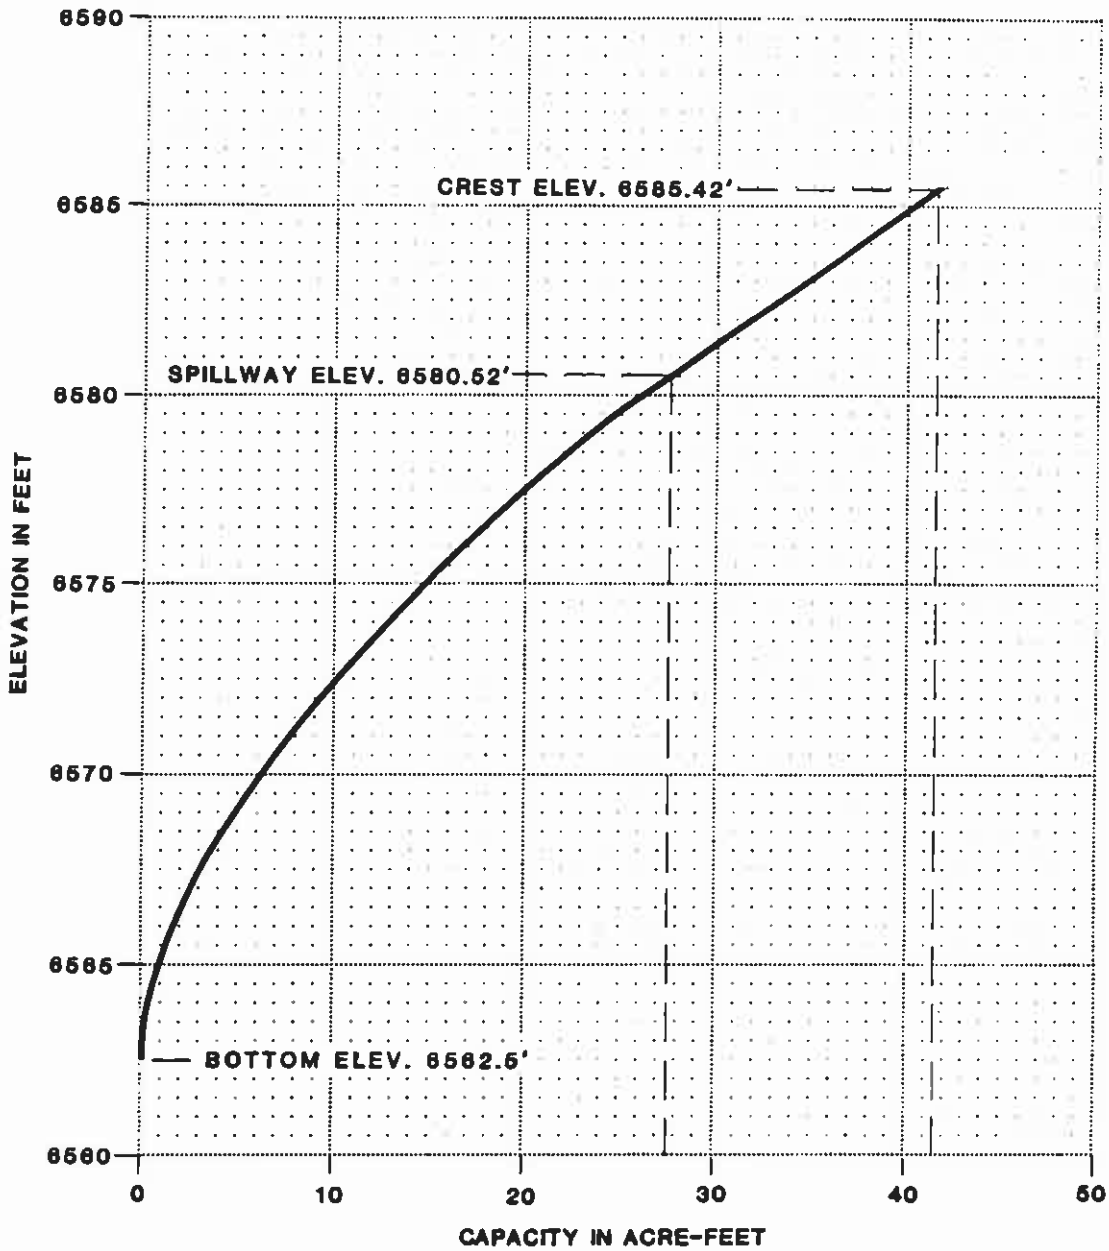
VOLUME-ELEVATION
 CURVE
 N14-C

The impoundment volume-elevation curve is based on site specific surveys conducted for Peabody Coal Company's August 1984 inspection, and 1985 resurveys, where available. Additionally, the most current topographic maps available were used in developing Plate 3, Volume-Elevation Curve, N14-C.

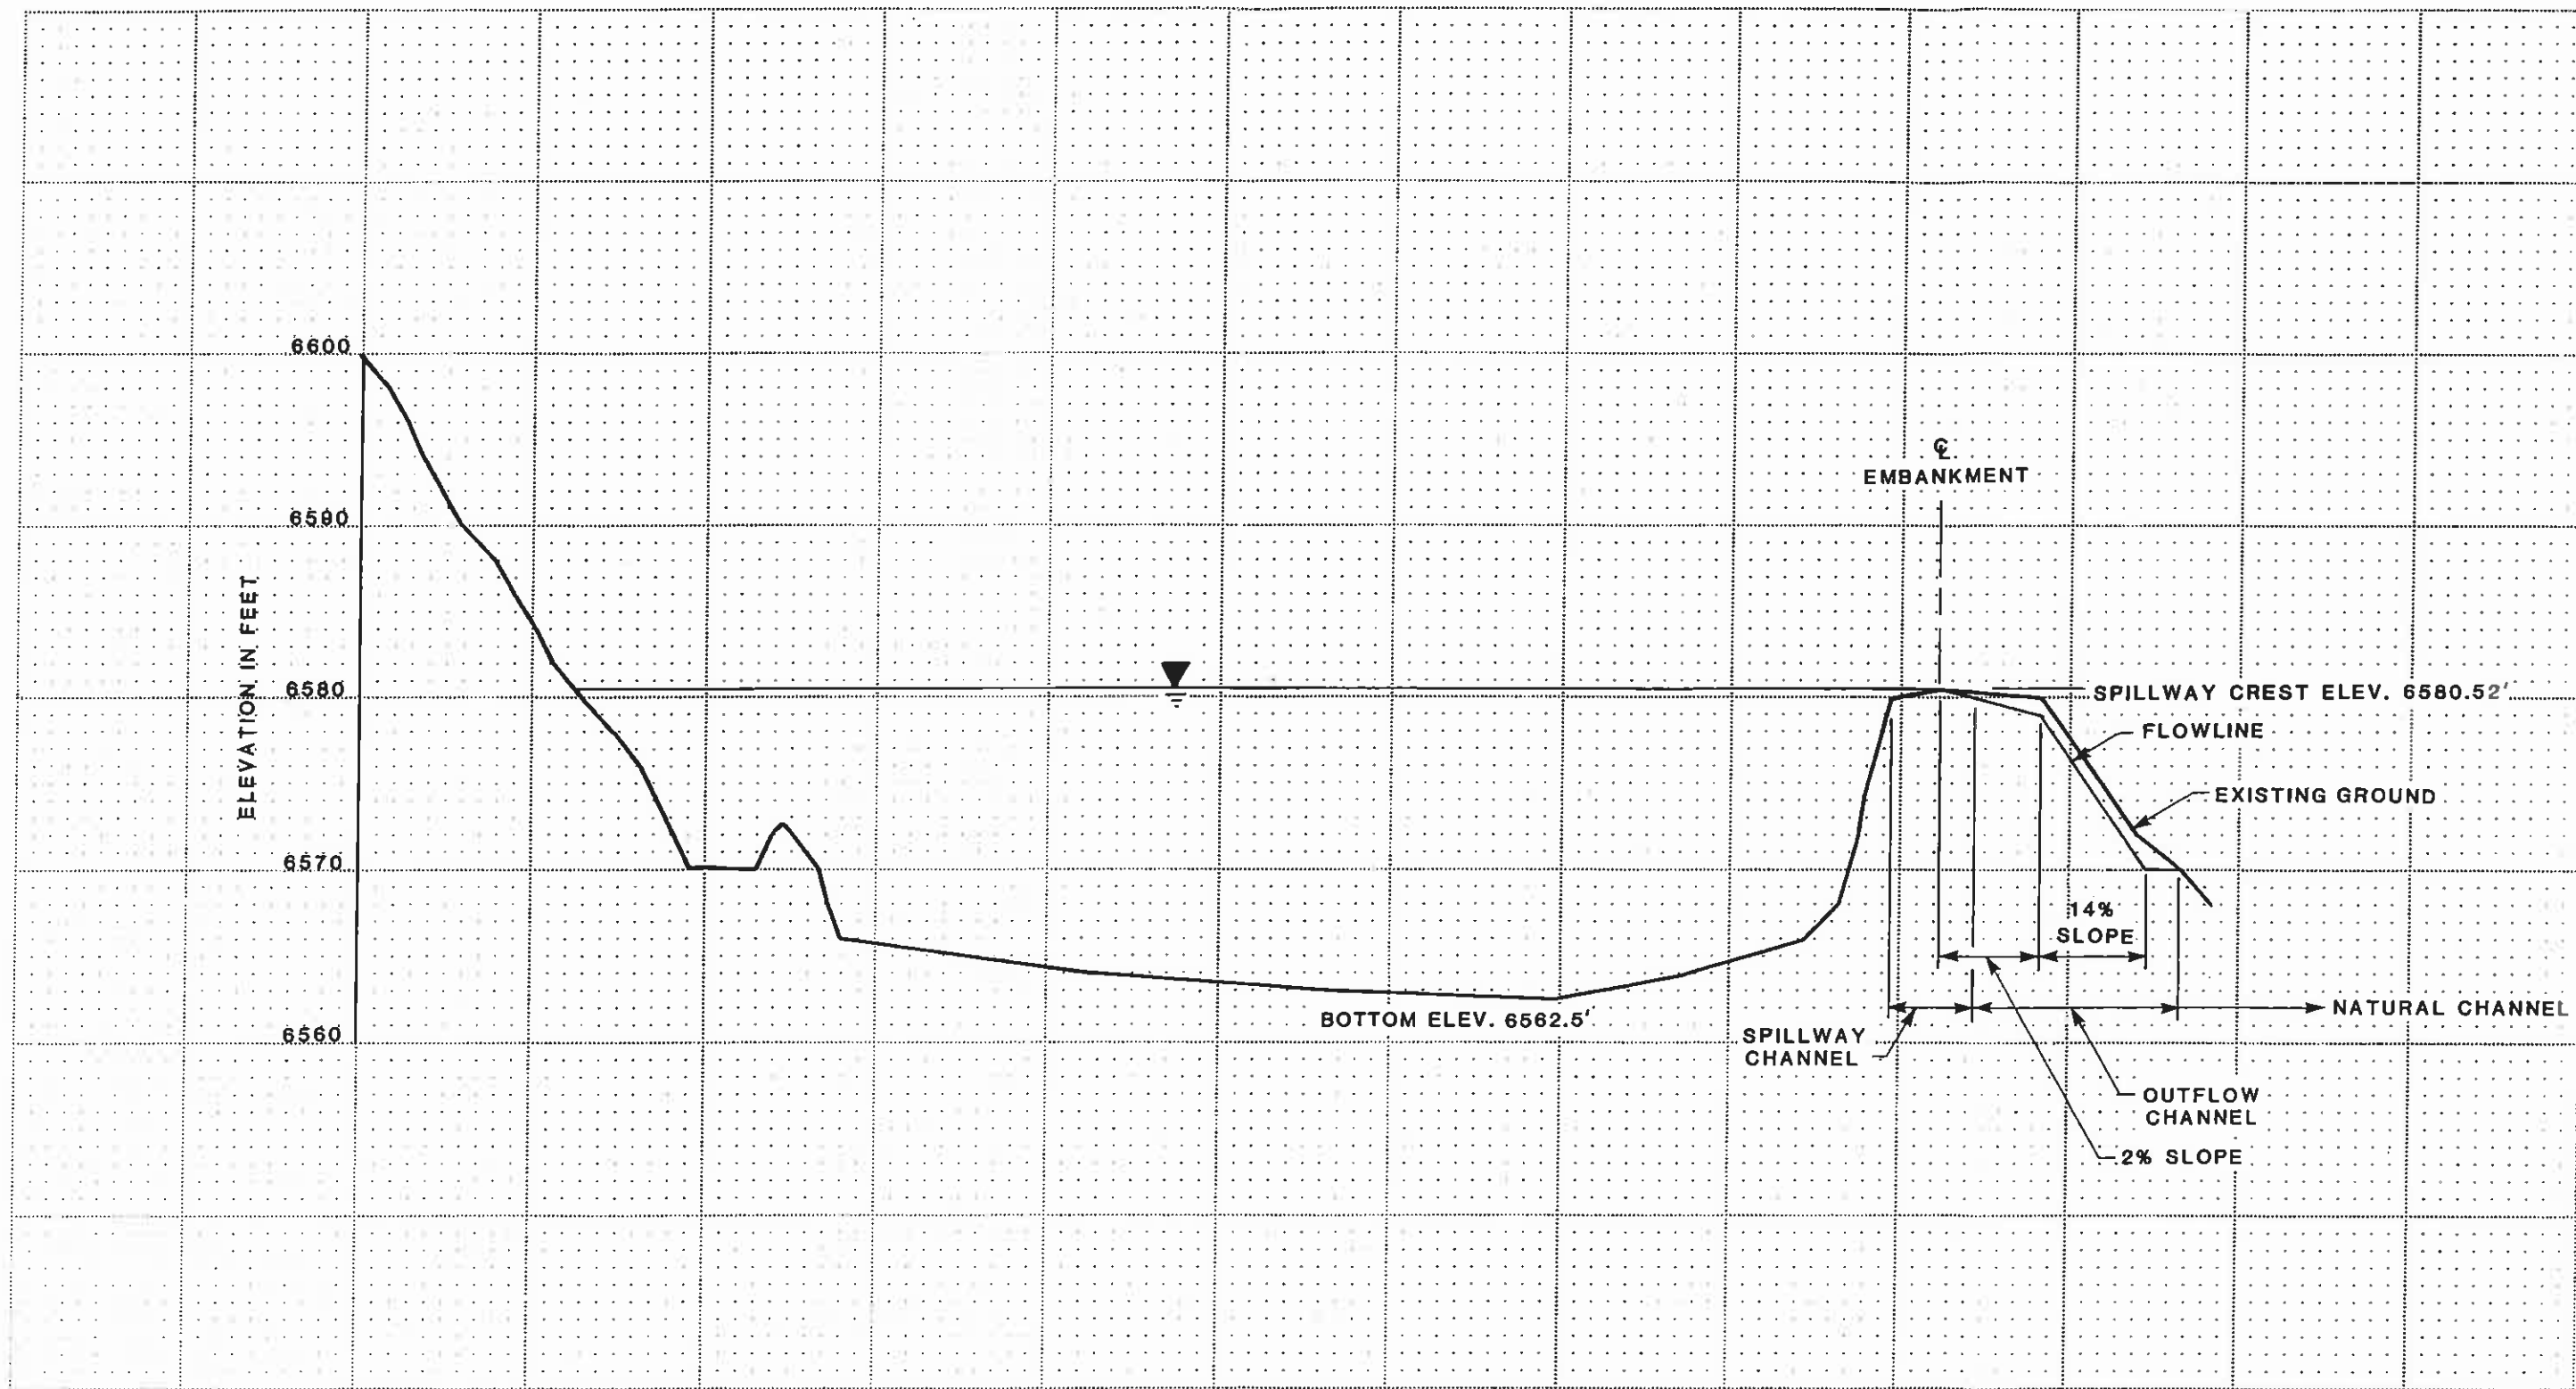
CHANNEL PROFILE B-B'
N14-C

The structure presently has no outflow channel.

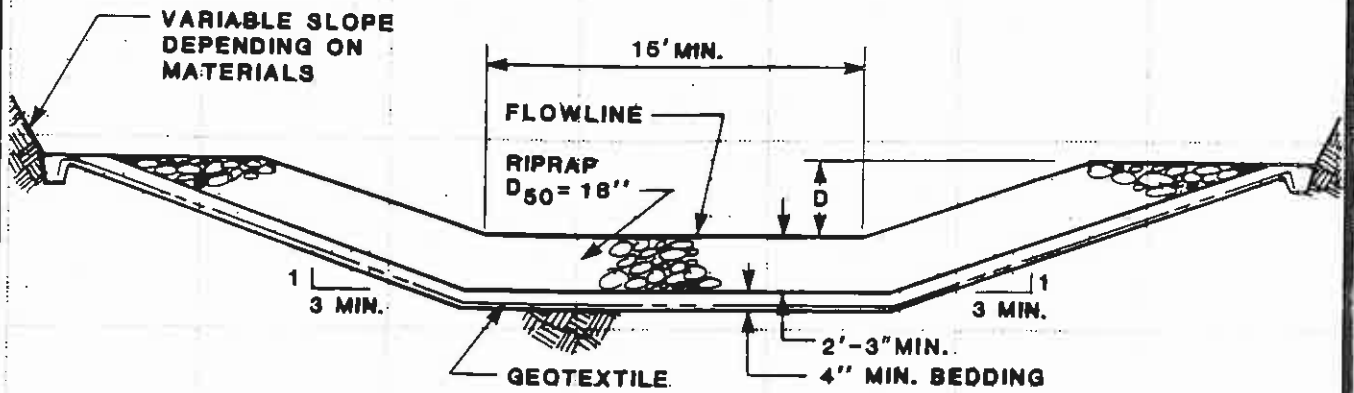
SPILLWAY AND
OUTFLOW CHANNEL
CROSS SECTION
N14-C

There is presently no erosion protection within the channel.

The inspection of Structure N14-C indicated that the only geotechnical problem is rill erosion on the upstream and downstream slopes and the side slopes of the spillway channel. Correction of erosion is considered a periodic maintenance task and does not require remedial action.
