INSPECTION REPORT
Sedimentation Structure
N14-M
Kayenta Mine
Navajo County, Arizona
for
PEABODY COAL COMPANY

Dames & Moore
10139-011-22

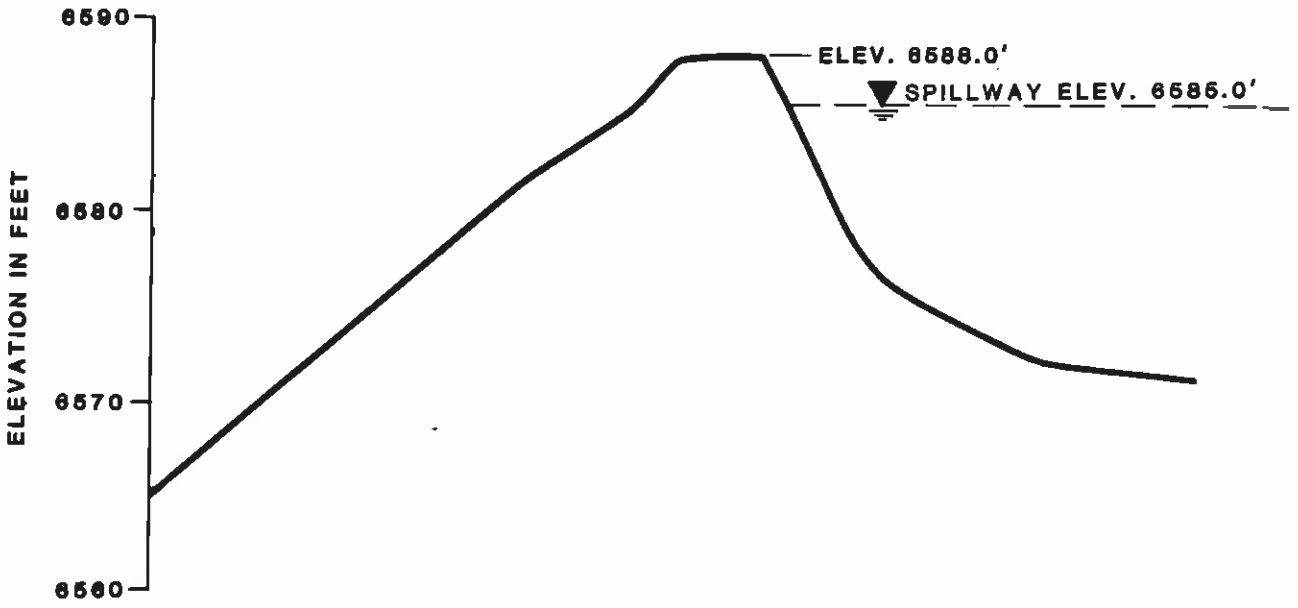
EXISTING
MAXIMUM CROSS-SECTION
A-A'
N14-M

A cross-section of the embankment is shown on Plate 2, Existing Maximum Cross Section N14-M, A-A'. Grass provides erosion protection on the upstream and downstream slopes of the embankment.

The downstream slope is lower in height and has a flatter slope than the category standard. The upstream slope is steeper than the category standard; therefore, the embankment has factors of safety less than the design minimum.

The inspection of Structure N14-M indicated that the only geotechnical problem is rill and gully erosion on the upstream slope, the side slopes of the outlet channel and the left abutment. Correction of erosion is considered a periodic maintenance task and does not require remedial action. The upstream slope should be flattened to 1.75 horizontal to 1 vertical to meet stability requirements.

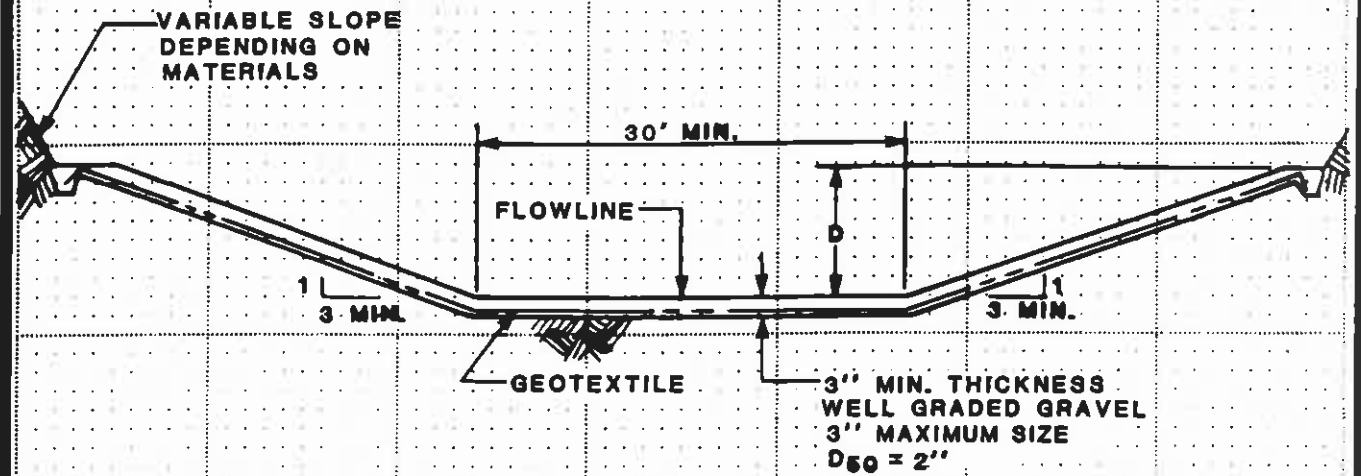
**SPILLWAY AND
OUTFLOW CHANNEL
CROSS SECTION
N14-M**

The storage capacity of Structure N14-M is adequate but the spillway capacity is inadequate. The structure does not have an adequate outflow channel. The bottom elevation of the existing spillway channel should be lowered to elevation 6583.5 feet and the bottom width increased to 30 feet as shown on Plate 5. A trapezoidal outflow channel with the same bottom width as the spillway should be constructed along the alignment shown in Plate 1. The channel profile is shown in Plate 4 and required dimensions are shown in Plate 5. Both the spillway and outflow channel should be protected against erosion using geotextile and gravel as shown in Plate 5.

Lowering the spillway elevation to 6583.5 feet decreases the storage capacity and increases the freeboard. The analysis of these conditions is summarized in the following table.
