INSPECTION REPORT  
Sedimentation Structure  
N14-P  
Kayenta Mine  
Navajo County, Arizona  
for  
PEABODY COAL COMPANY

Dames & Moore  
10139-011-22

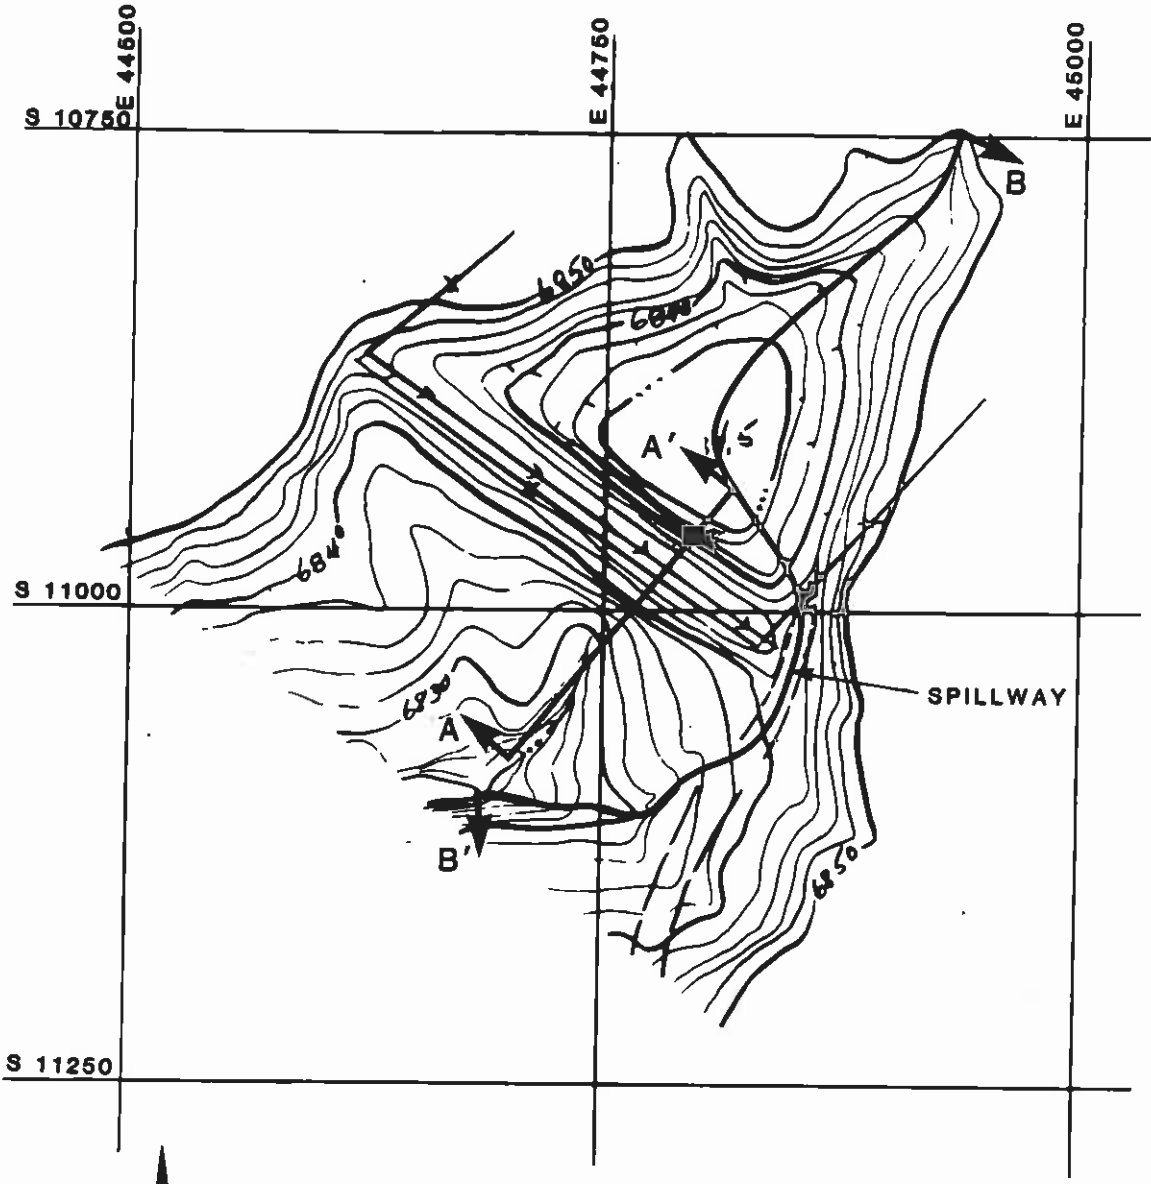
SITE PLAN  
N14-P

Sedimentation Structure N14-P is an earthen embankment, designed and constructed in 1982 by Peabody Coal Company as a temporary sedimentation structure to control runoff and sediment from the disturbed mining areas of the Kayenta Mine. The location of Structure N14-P is shown on Plate 1, Site Plan.

The storage capacity and spillway capacity of Structure N14-P are adequate; however, the spillway does not have an adequate outflow channel or adequate erosion protection. A trapezoidal outflow channel should be constructed along the alignment B-B' shown in Plate 1. The channel profile is shown in Plate 4 and the required dimensions are shown in Plate 5. Both the spillway and outflow channel should be protected against erosion using geotextile and gravel as shown in Plate 5.

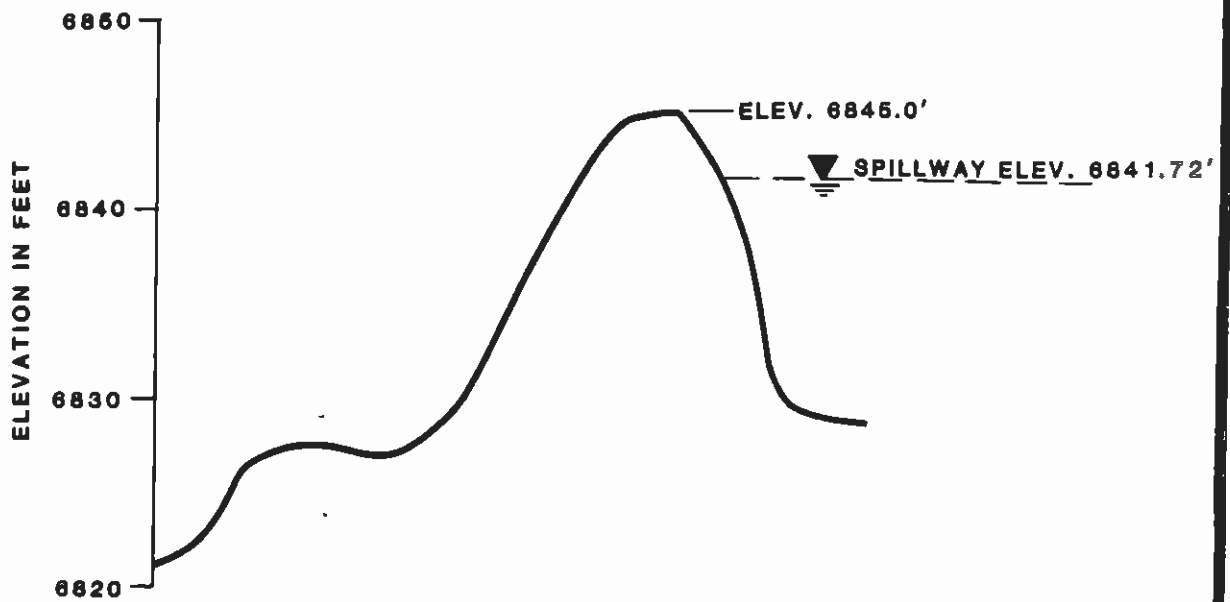
EXISTING  
 MAXIMUM CROSS-SECTION  
 A-A'  
 N14-P

A cross-section of the embankment is shown on Plate 2, Existing Maximum Cross Section N14-P, A-A'.

The N14-P embankment is lower in height and has flatter slopes than the category standard; therefore, the embankment has factors of safety greater than the design minimum.

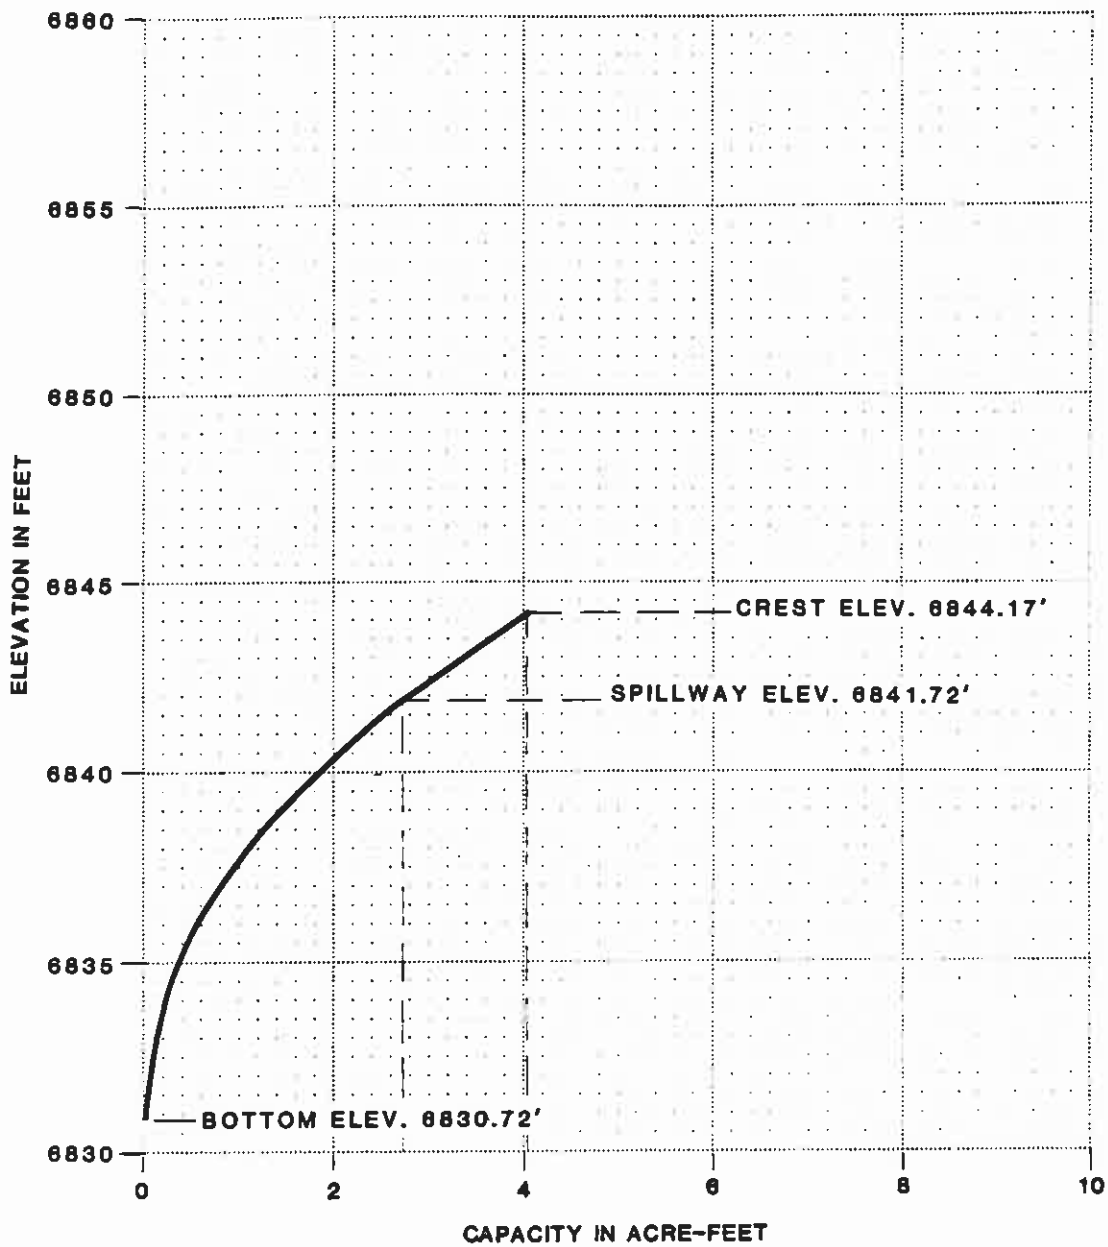
VOLUME-ELEVATION  
 CURVE  
 N14-P

The impoundment volume-elevation curve is based on site specific surveys conducted for Peabody Coal Company's August 1984 inspection, and 1985 resurveys, where available. Additionally, the most current topographic maps available were used in developing Plate 3, Volume-Elevation Curve, N14-P.

The hydrologic analysis gives the storage volume required to contain the 10-year, 24-hour storm, and the remaining storage volume available for storing sediment. The existing storage capacity of N14-P and the results of the sediment inflow analysis are summarized in the following table.

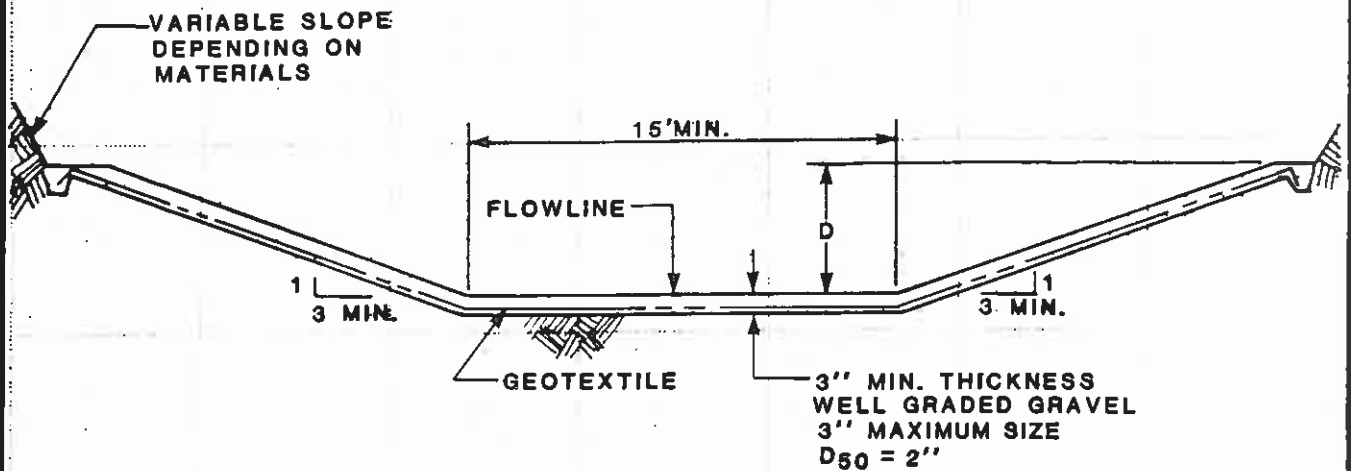
**SPILLWAY AND  
 OUTFLOW CHANNEL  
 CROSS SECTION  
 N14-P**

There is presently no erosion protection within the channel.

The structure presently has no outflow channel.
