INSPECTION REPORT
Sedimentation Structure
N14-Q
Kayenta Mine
Navajo County, Arizona

for
PEABODY COAL COMPANY

Dames & Moore
10139-011-22

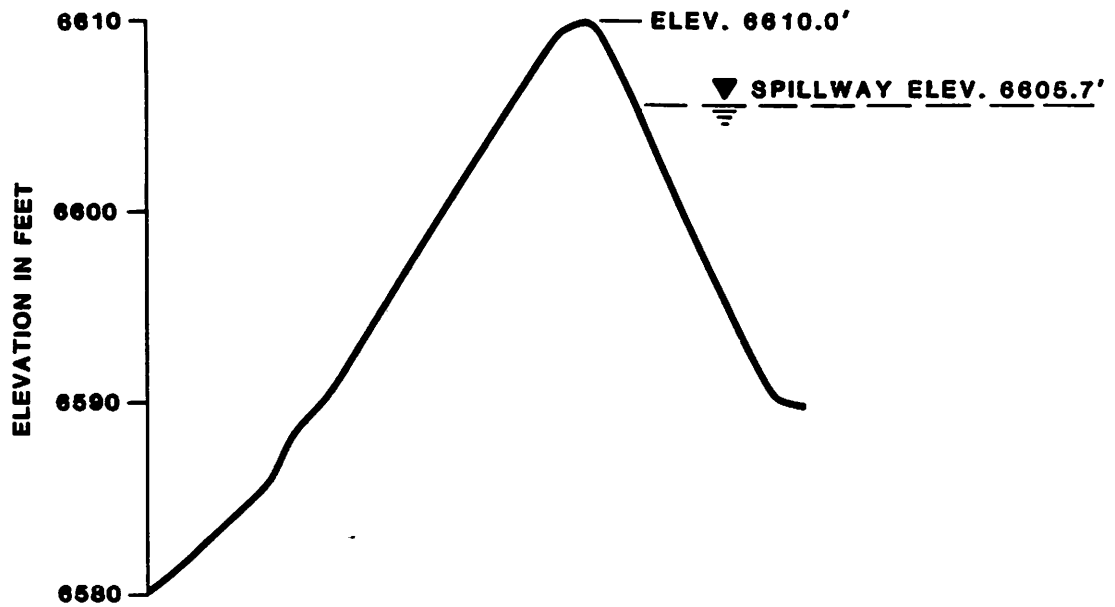
Plate 2

The N14-Q embankment is lower in height; however, the downstream slope is steeper than the category standard; therefore, the embankment has factors of safety less than the design minimum.

EXISTING
MAXIMUM CROSS-SECTION
A-A'
N14-Q

small sinkhole (3-foot in diameter and 18 inches deep) upstream of the embankment adjacent to the left abutment. Correction of erosion is considered a periodic maintenance task and does not require remedial action. The downstream slope should be flattened to 4.0 horizontal to 1 vertical to meet stability requirements. The sinkhole should be excavated to determine the extent of the cavity and then backfilled with a cohesive material. Future inspections should note any changes in the condition of the bottom in the vicinity of the repaired section.

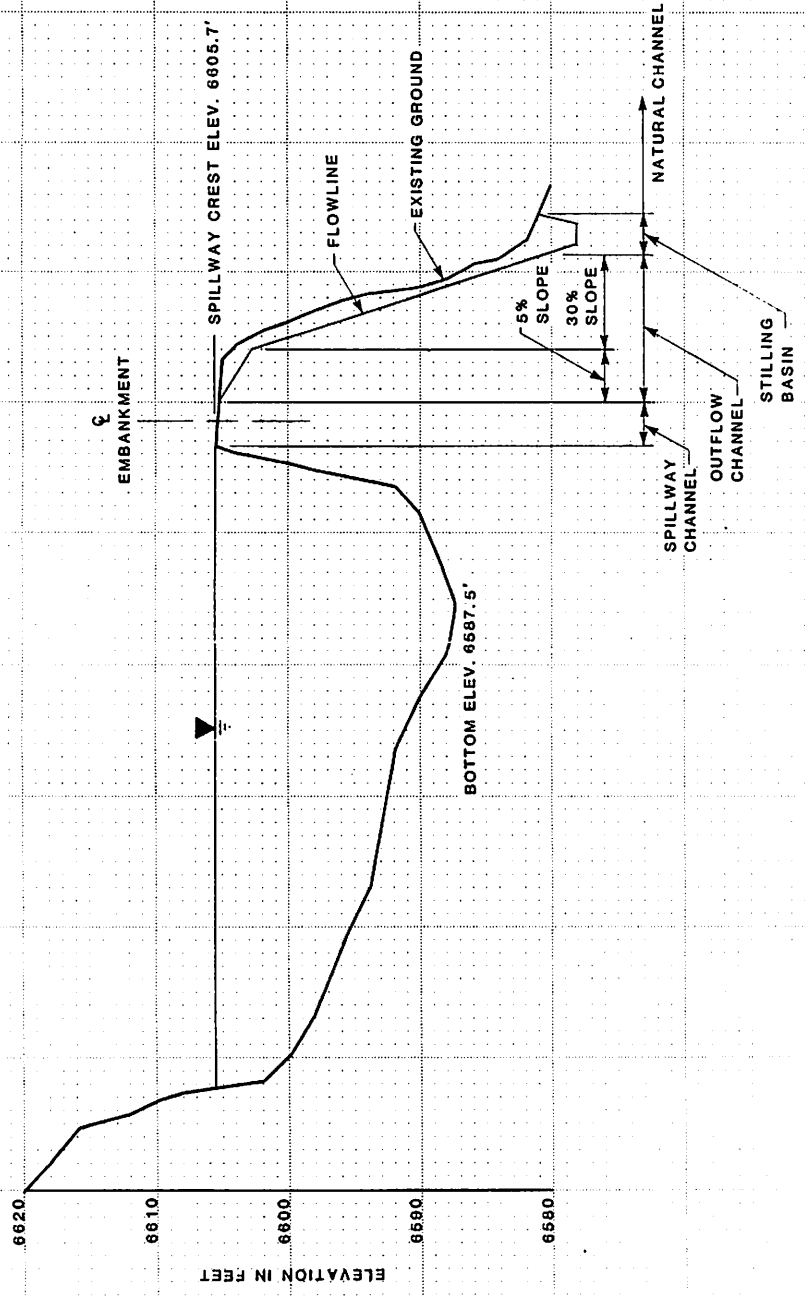
BY **Dames & Moore** Plate 4

CHANNEL PROFILE B-B'
N14-Q

The storage capacity and spillway capacity of Structure N14-0 are adequate; however, the spillway outflow channel does not have adequate erosion protection. A trapezoidal outflow channel and a stilling basin should be constructed along the alignment B-B' shown in Plate 1. The channel and stilling basin profile is shown in Plate 4 and the required dimensions are shown in Plate 5 and Plate 6. The outflow channel and stilling basin should be protected against erosion using geotextile and riprap as shown in Plate 5.

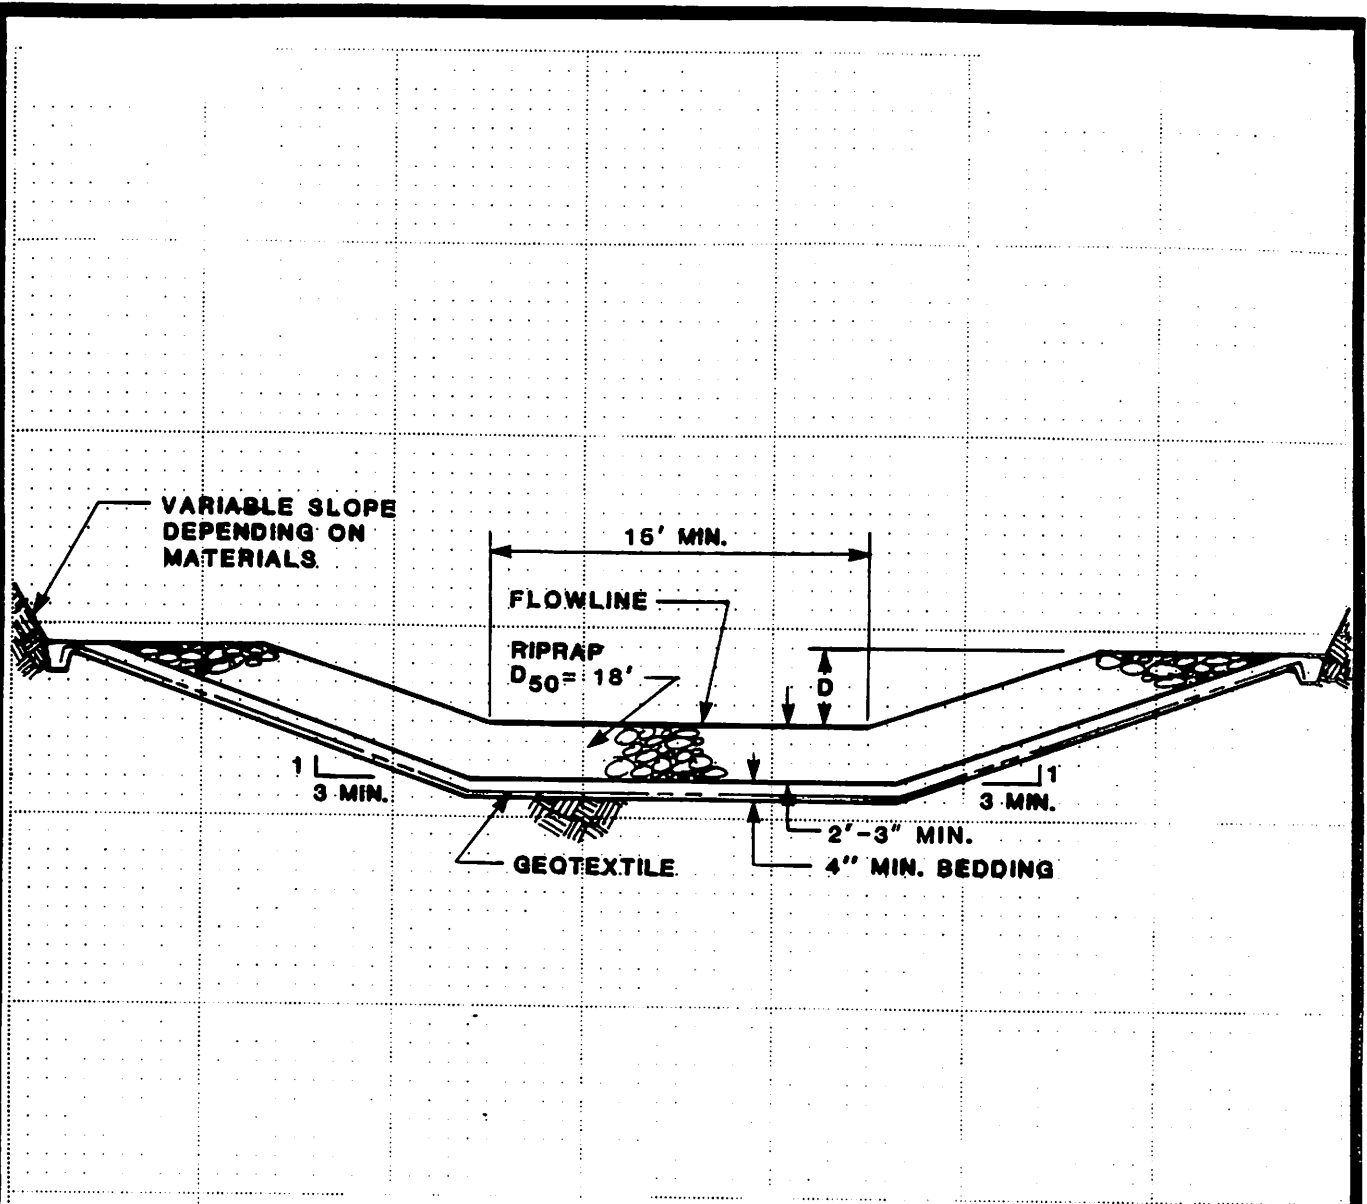
**SPILLWAY AND
 OUTFLOW CHANNEL
 CROSS SECTION
 N14-Q**

The present rock size of D50 of 10 inches is not adequate for the calculated outflow velocity and therefore does not provide adequate erosion protection within the channel.

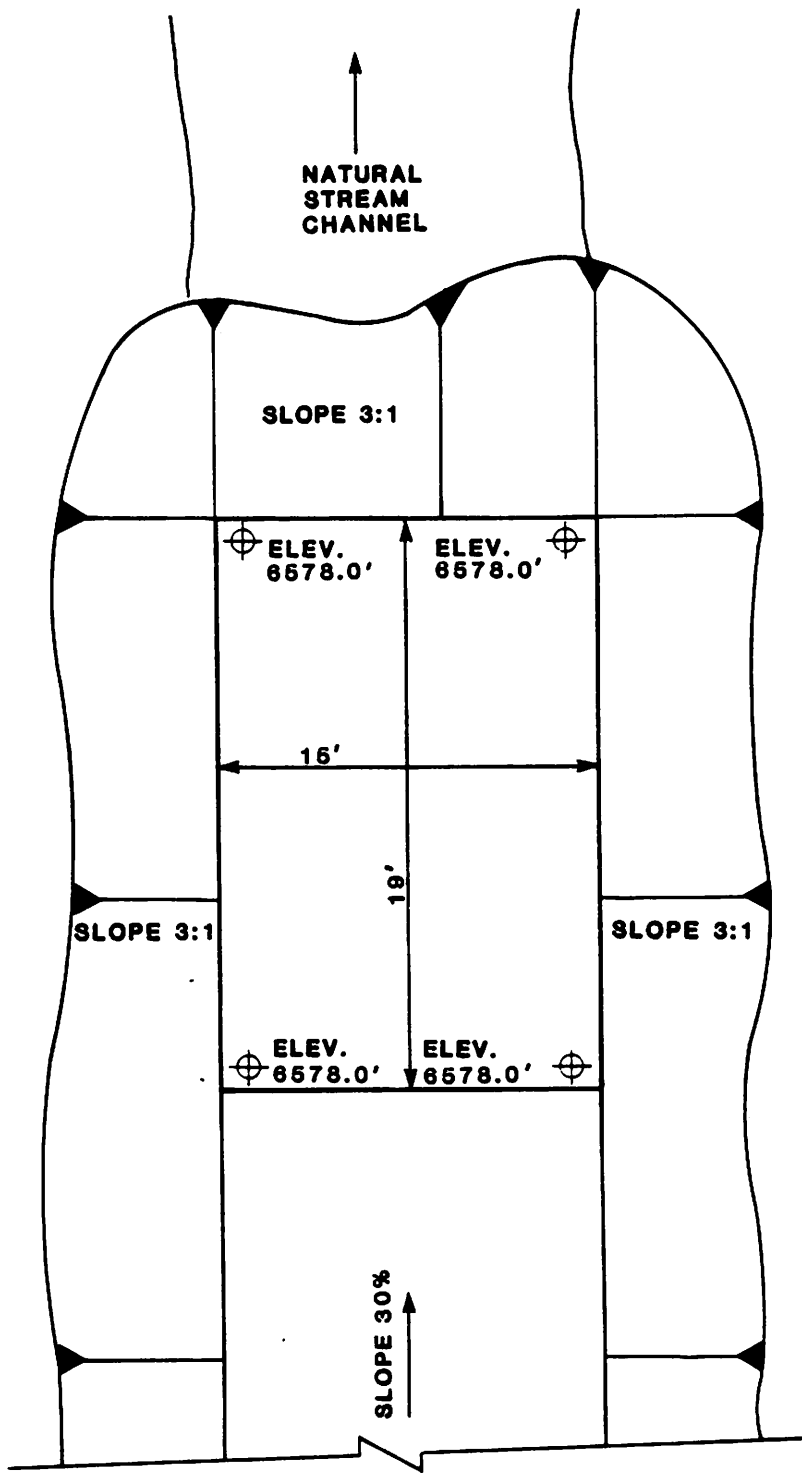
SPILLWAY STILLING BASIN PLAN N14-Q

MINIMUM HEIGHT OF RIPRAP
ALONG SIDEWALLS ABOVE
THE BASIN FLOOR = 5.3'

MINIMUM DEPTH OF BASIN FLOOR
BELOW NATURAL STREAMBED = 2.9'
