INSPECTION REPORT
Sedimentation Structure
TPF-C
Kayenta Mine
Navajo County, Arizona
for
PEABODY COAL COMPANY

Dames & Moore
10139-011-22

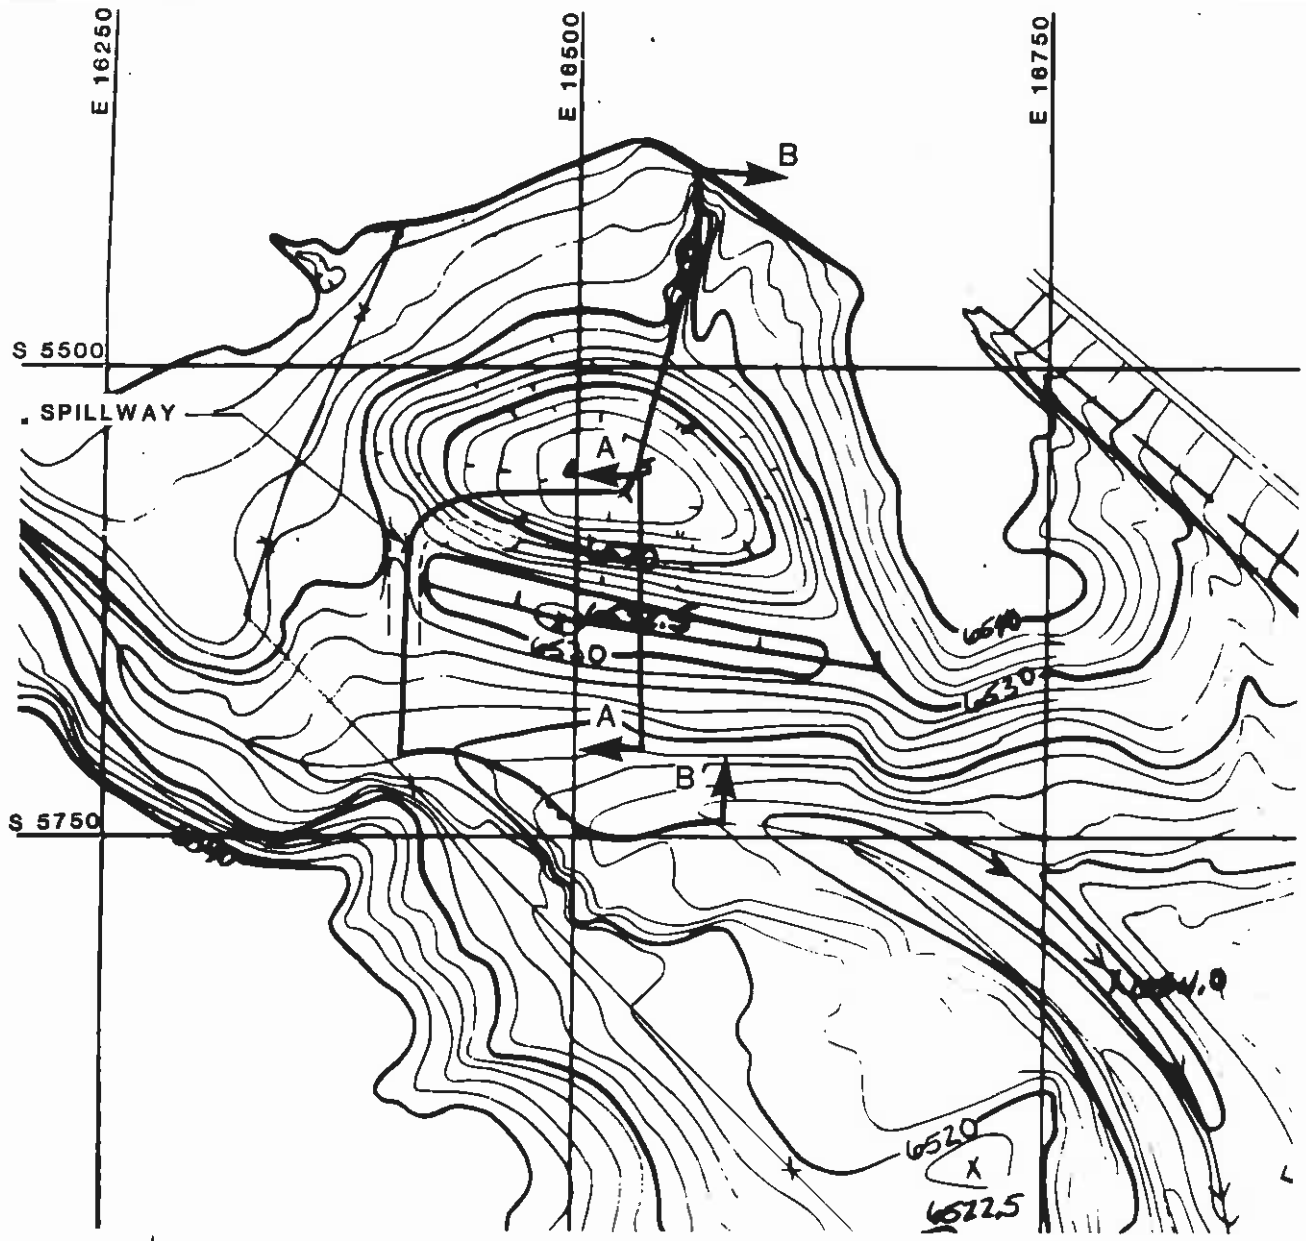
SITE PLAN
TPF-C

Sedimentation Structure TPF-C is an earthen embankment, designed and constructed in 1982 by Peabody Coal Company as a temporary sedimentation structure to control runoff and sediment from the disturbed mining areas of the Kayenta Mine. The location of Structure TPF-C is shown on Plate 1, Site Plan.

The storage capacity and spillway capacity of Structure TPF-C are adequate; however, the spillway does not have an outflow channel or adequate erosion protection. A trapezoidal outflow channel should be constructed along the alignment B-B' shown in Plate 1. The channel profile is shown in Plate 4 and the required dimensions are shown in Plate 5. Both the spillway and outflow channel should be protected against erosion using geotextile and gravel as shown in Plate 5.

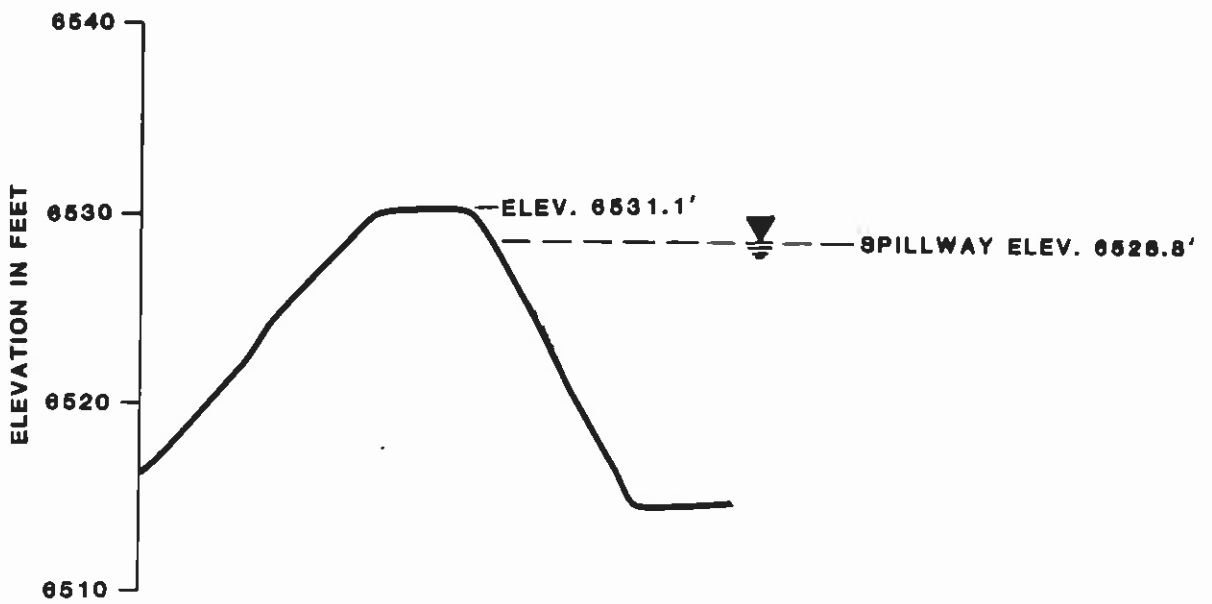
EXISTING
MAXIMUM CROSS-SECTION
A-A'
TPF-C

A cross-section of the embankment is shown on Plate 2, Existing Maximum Cross Section TPF-C, A-A'. Grass provides erosion protection on the upstream and downstream slopes of the embankment.

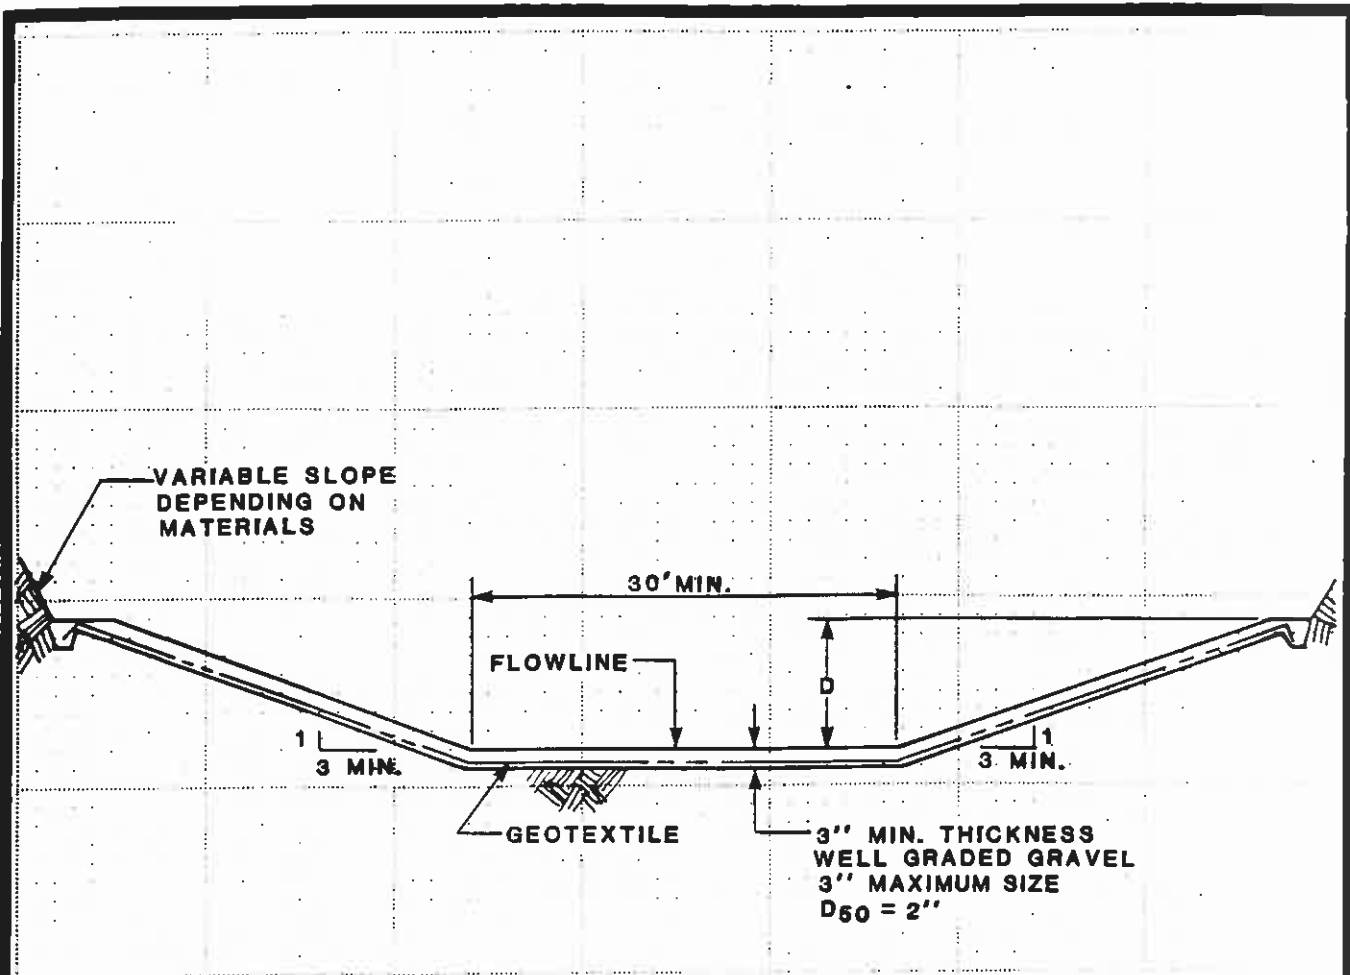
**SPILLWAY AND
OUTFLOW CHANNEL
CROSS SECTION
TPF-C**

There is presently no erosion protection within the channel.

The structure presently has no outflow channel.
