INSPECTION REPORT
Sedimentation Structure
TFP-D
Kayenta Mine
Navajo County, Arizona
for
PEABODY COAL COMPANY

Dames & Moore
10139-011-22

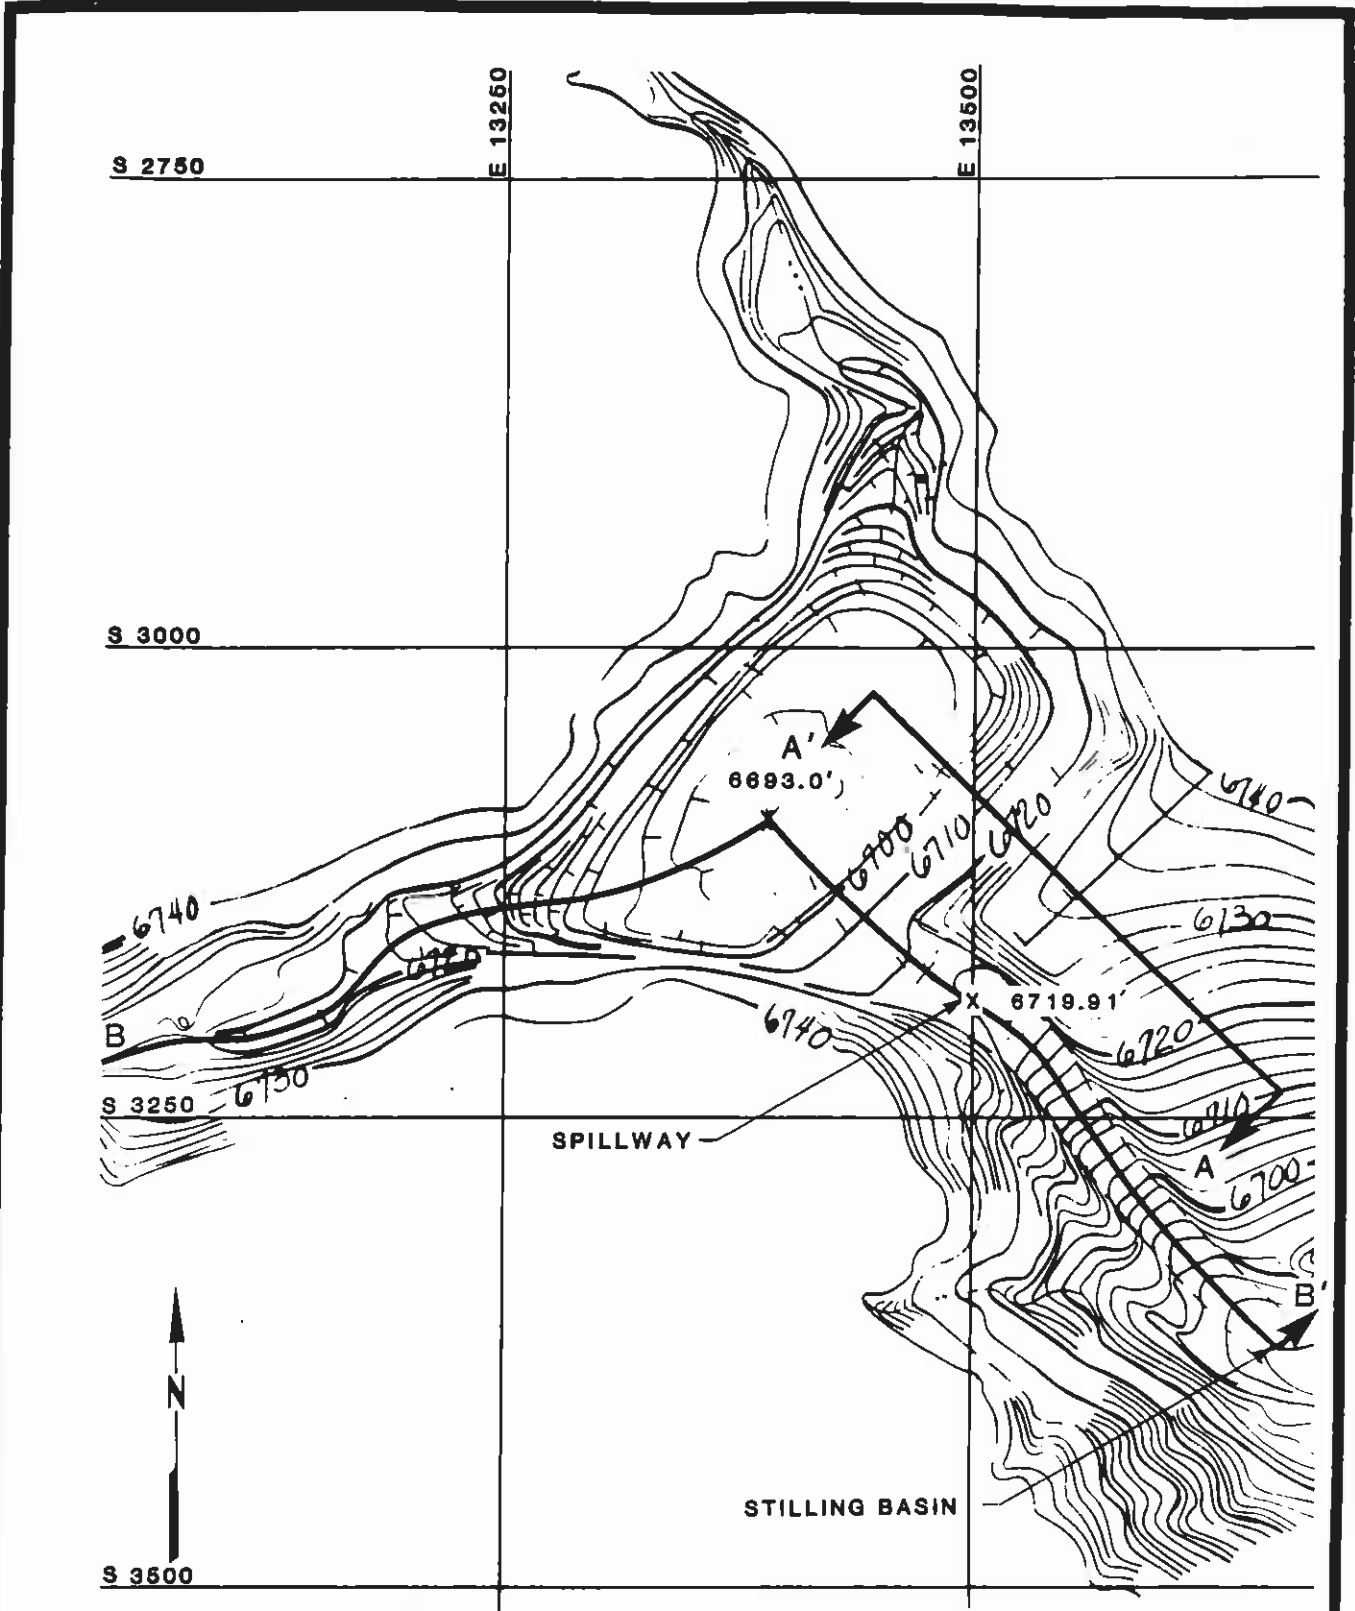
**SITE PLAN
TPF-D**

Sedimentation Structure TPF-D is a partially incised structure with an earthen embankment, designed and constructed in 1984 by Peabody Coal Company as a temporary sedimentation structure to control runoff and sediment from the disturbed mining areas of the Kayenta Mine. The location of Structure TPF-D is shown on Plate 1, Site Plan.

The storage capacity and spillway capacity of Structure TPF-D are adequate; however, the spillway does not have an adequate outflow channel or adequate erosion protection. A trapezoidal outflow channel and a stilling basin should be constructed along the alignment B-B' shown in Plate 1. The channel and stilling basin profile is shown in Plate 4 and the required dimensions are shown in Plate 5 and Plate 6. The spillway, outflow channel and stilling basin should be protected against erosion using geotextile and riprap as shown in Plate 5.

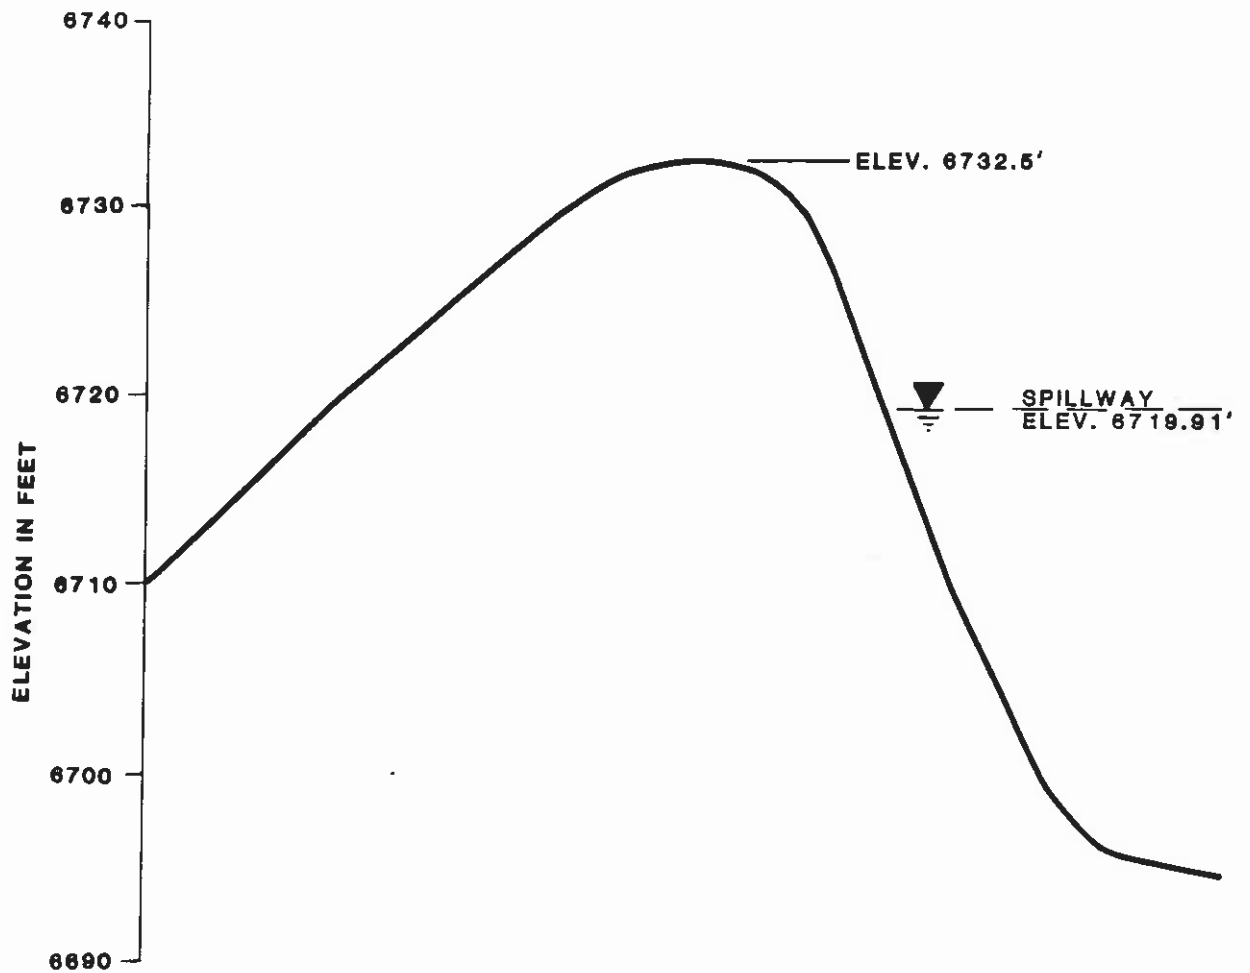
Plate 2

A cross-section of the embankment is shown on Plate 2, Existing Maximum Cross Section TPF-D, A-A'.

EXISTING
MAXIMUM CROSS-SECTION
A-A'
TPF-D

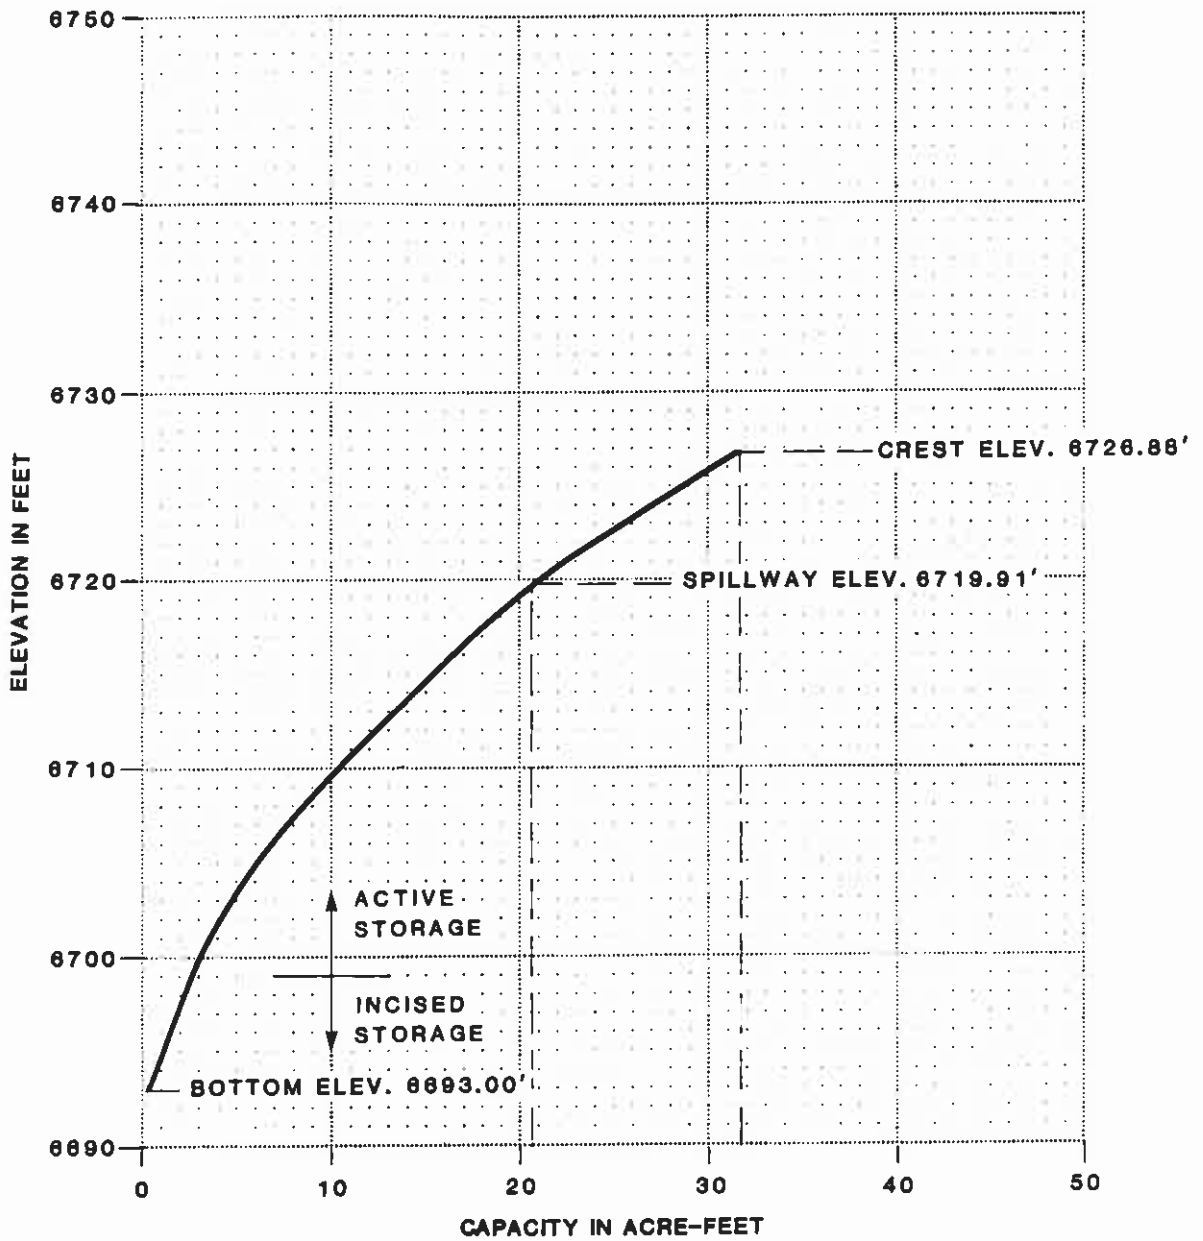
VOLUME-ELEVATION
CURVE
TPF-D

1985 resurveys, where available. Additionally, the most current topographic maps available were used in developing Plate 3, Volume-Elevation Curve, TPF-D.

Total Storage Capacity	20.60 acre-ft
10-year, 24-hour Storm Inflow	16.69 acre-ft
Available Sediment Storage Capacity	3.91 acre-ft
Sediment Inflow Rate	2.14 acre-ft/yr
Sediment Storage Life	2 yrs

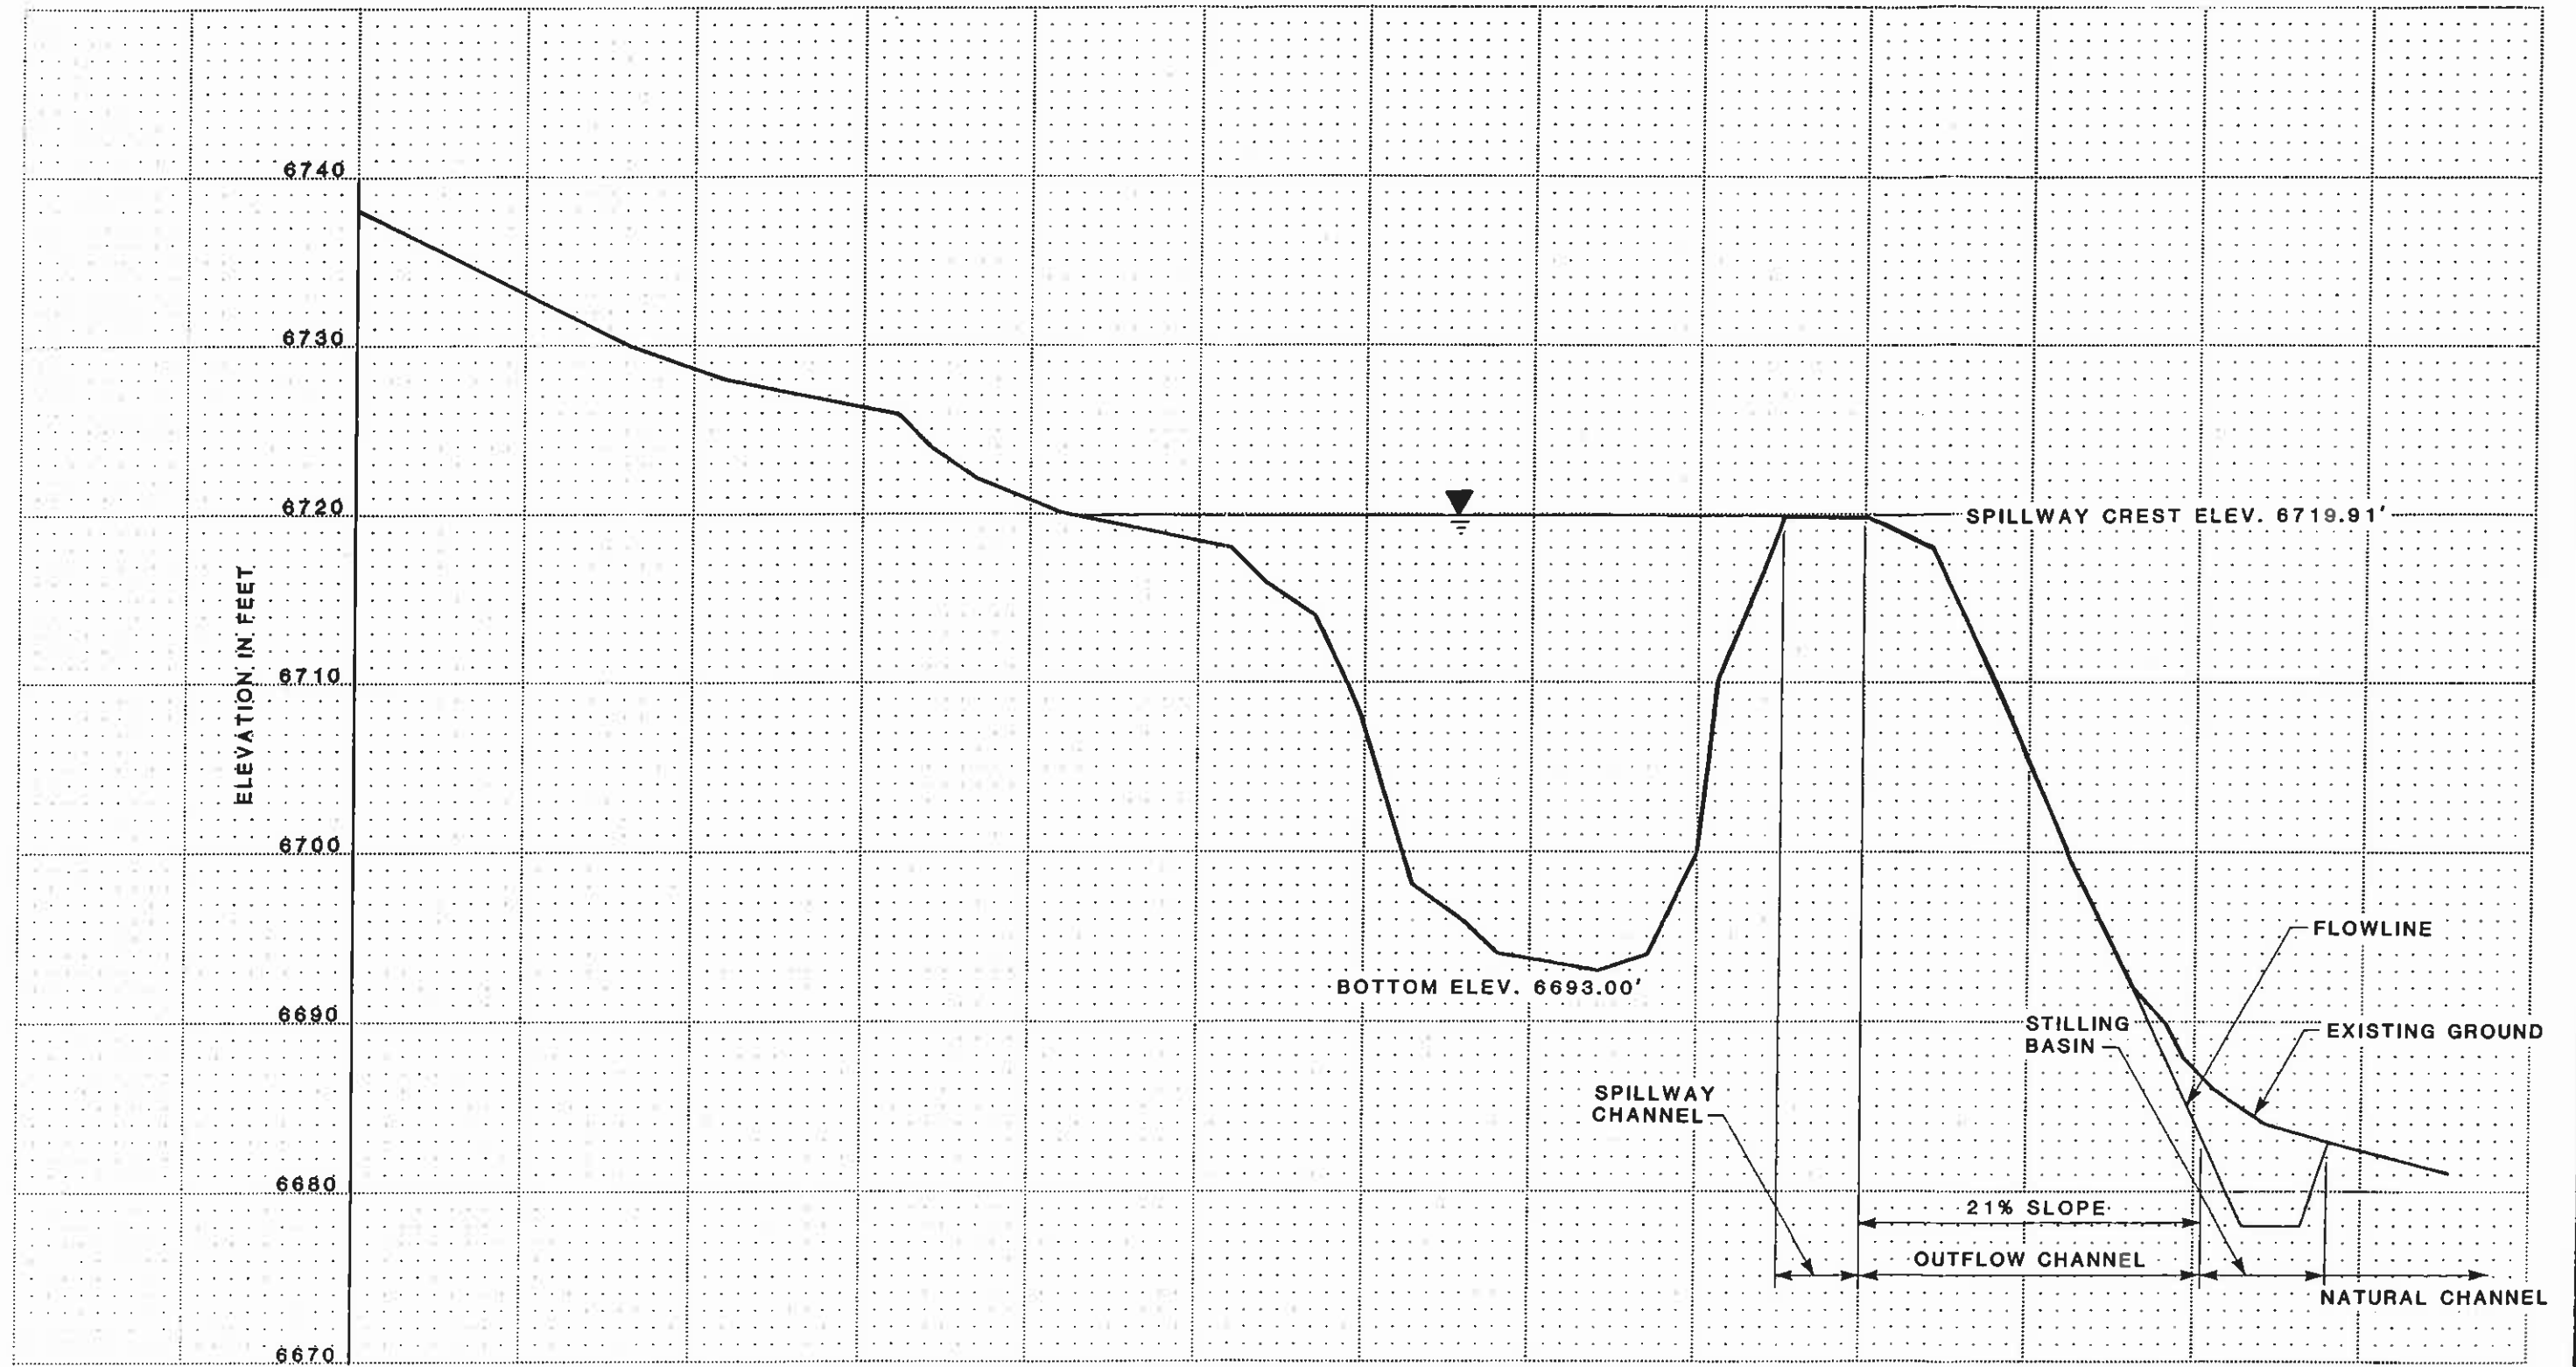
Plate 4

CHANNEL PROFILE B-B'
TPF-D

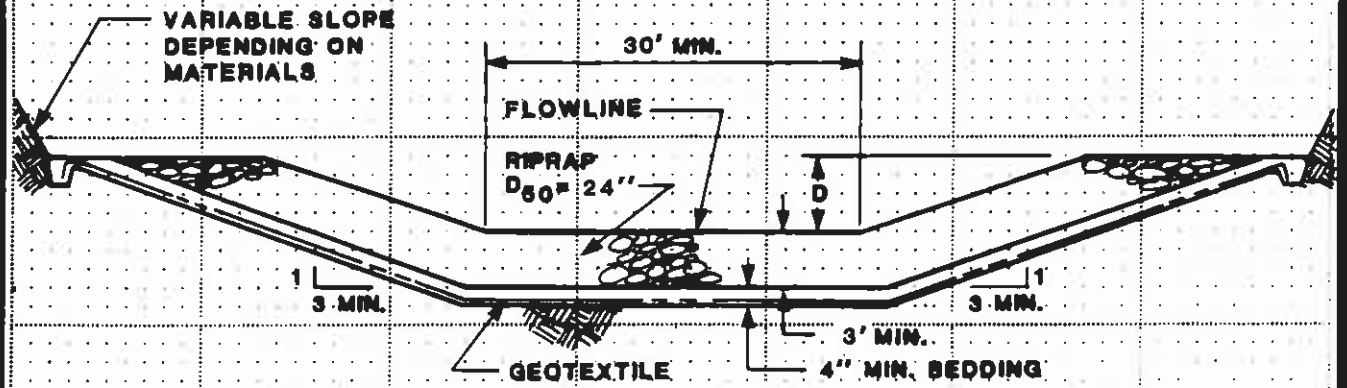
**SPILLWAY AND
 OUTFLOW CHANNEL
 CROSS SECTION
 TPF-D**

There is presently no erosion protection within the channel.

Rock provides some, however inadequate erosion protection within the channel. The outflow channel also has a stilling basin which needs to be enlarged.

SPILLWAY CHANNEL

D = 6.0'
 LENGTH = 50'
 FLOWLINE ELEV. = 6719.91'

OUTFLOW CHANNEL

D = 2.5'
