INSPECTION REPORT

Sedimentation Structure

WW-2

Kayenta Mine

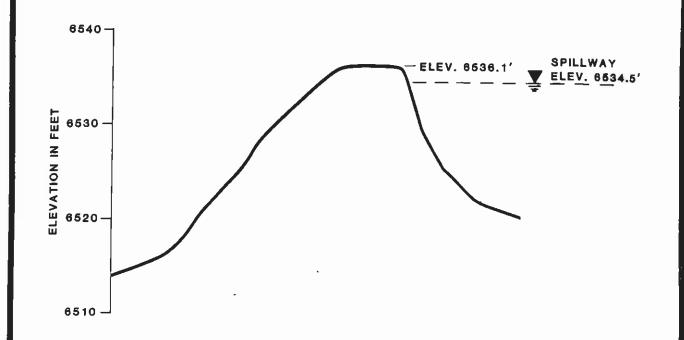
EXISTING
MAXIMUM CROSS-SECTION
A-A'
WW-2

The WW-2 embankment is lower in height; however, the downstream slope is steeper than the category standard; therefore, the embankment has factors of safety less than the design minimum.

require remedial action. The downstream slope should be flattened to 4.0 horizontal to 1 vertical to meet stability requirements.

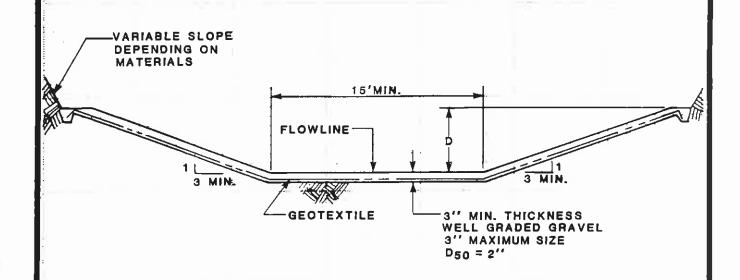
SPILLWAY AND OUTFLOW CHANNEL CROSS SECTION WW-2

There is presently no erosion protection within the channel.

The storage capacity and spillway capacity of Structure WW-2 are adequate; however, the spillway does not have an adequate outflow channel or adequate erosion protection. A trapezoidal outflow channel should be constructed along the alignment B-B' shown in Plate 1. The channel profile is shown in Plate 4 and the required dimensions are shown in Plate 5. Both the spillway and outflow channel should be protected against erosion using geotextile and gravel as shown in Plate 5.
