INSPECTION REPORT
Sedimentation Structure
WW-3
Black Mesa Mine
Navajo County, Arizona
for
PEABODY COAL COMPANY

Dames & Moore
10139-011-22

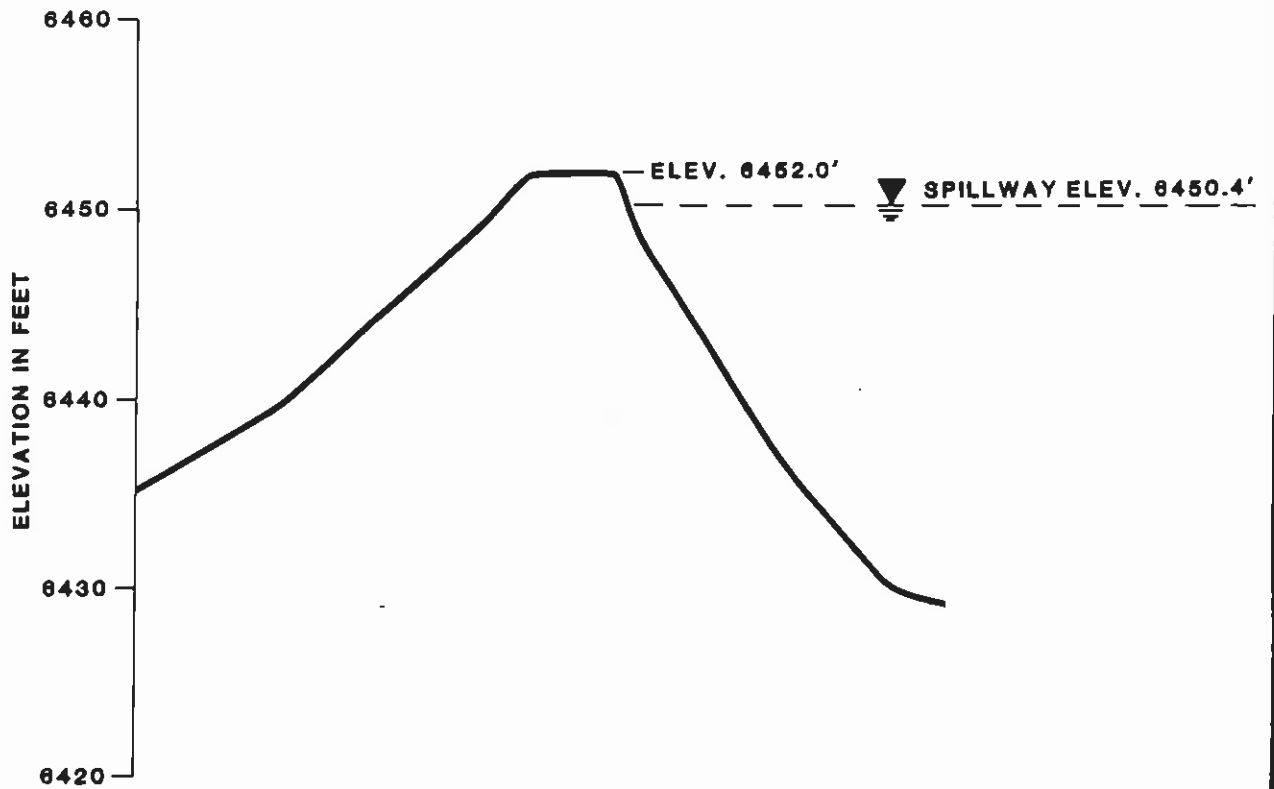
EXISTING
 MAXIMUM CROSS-SECTION
 A-A'
 WW-3

A cross-section of the embankment is shown on Plate 2, Existing Maximum Cross Section WW-3, A-A'. Grass provides erosion protection on the upstream slope of the embankment.

The inspection of Structure WW-3 indicated that the geotechnical problems consist of rill and gully erosion on the upstream slope and the right abutment and major undercutting of the upstream slope near the right

abutment. Correction of erosion is considered a periodic maintenance task and does not require remedial action. The undercut section of the embankment, due to past discharges from the well pump, should be repaired by placement of compacted fill.

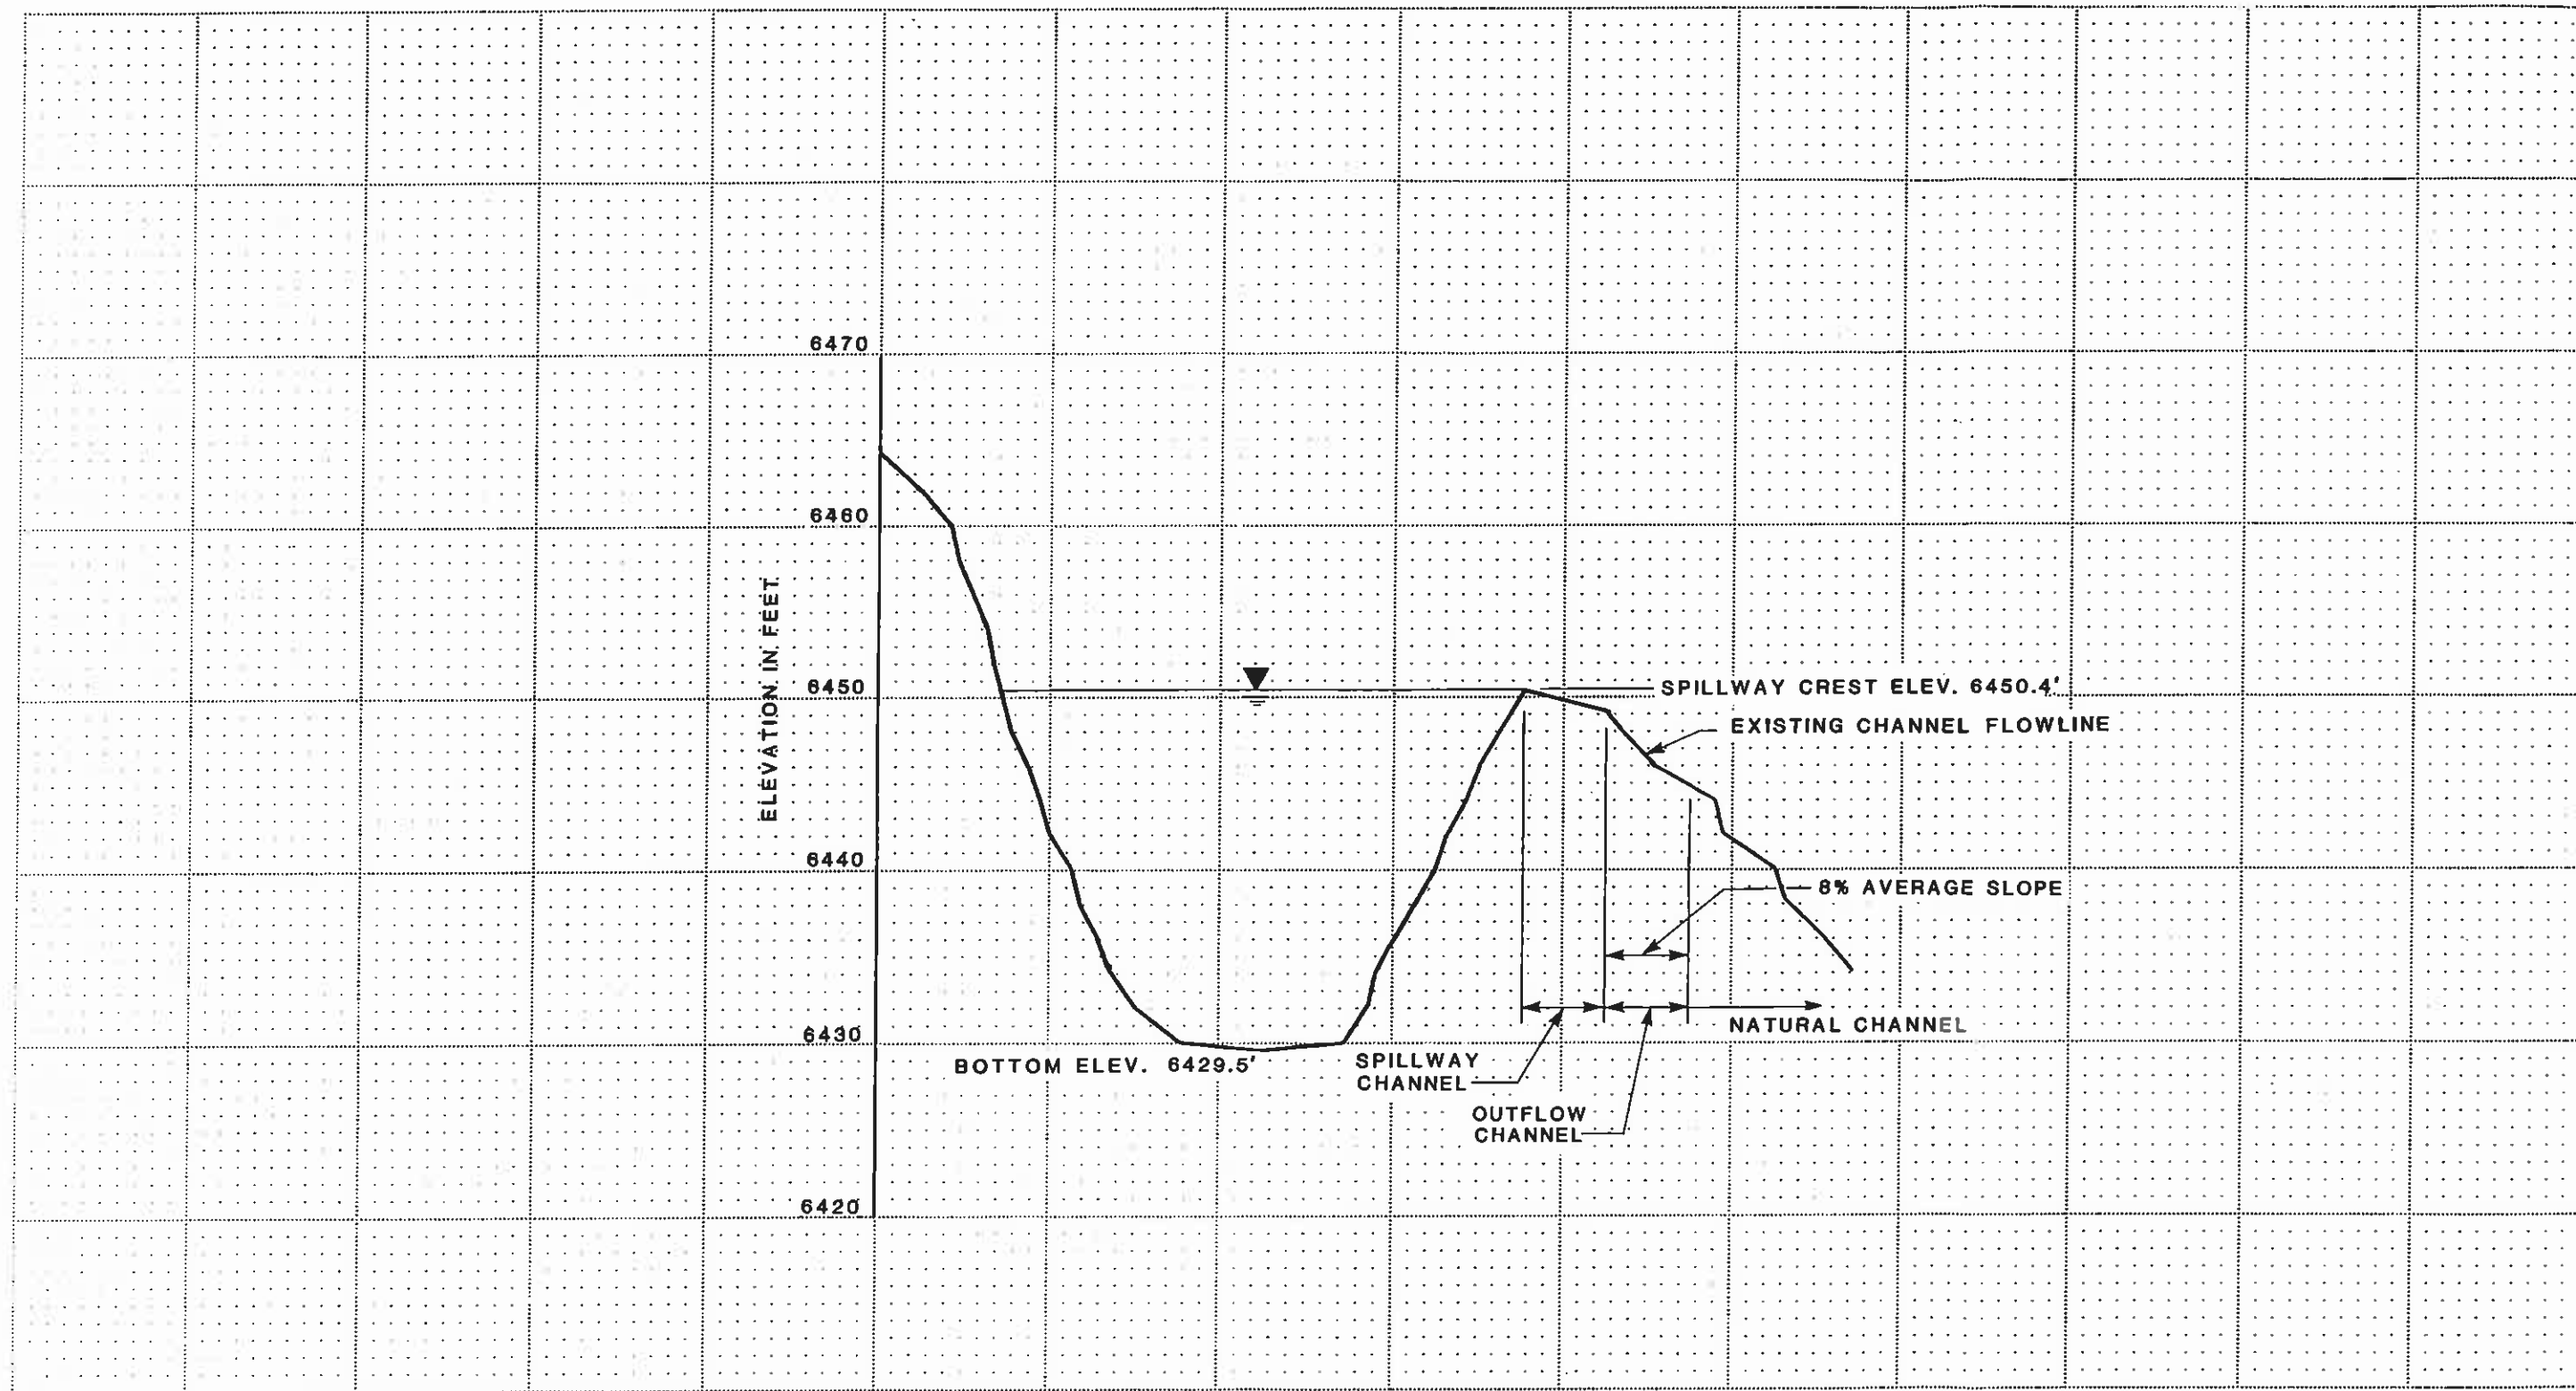
CHANNEL PROFILE B-B'
WW-3

The storage capacity and spillway capacity of Structure WW-3 are adequate. The spillway channel and outflow channel are protected with riprap. Therefore, no construction is required to bring the structure into compliance with the regulations. Plate 4 shows the existing spillway and outflow channel profile and Plate 5 shows the channel dimensions.
