INSPECTION REPORT
SEDIMENTATION STRUCTURE

WW-4

Black Mesa Mine

PEABODY COAL COMPANY

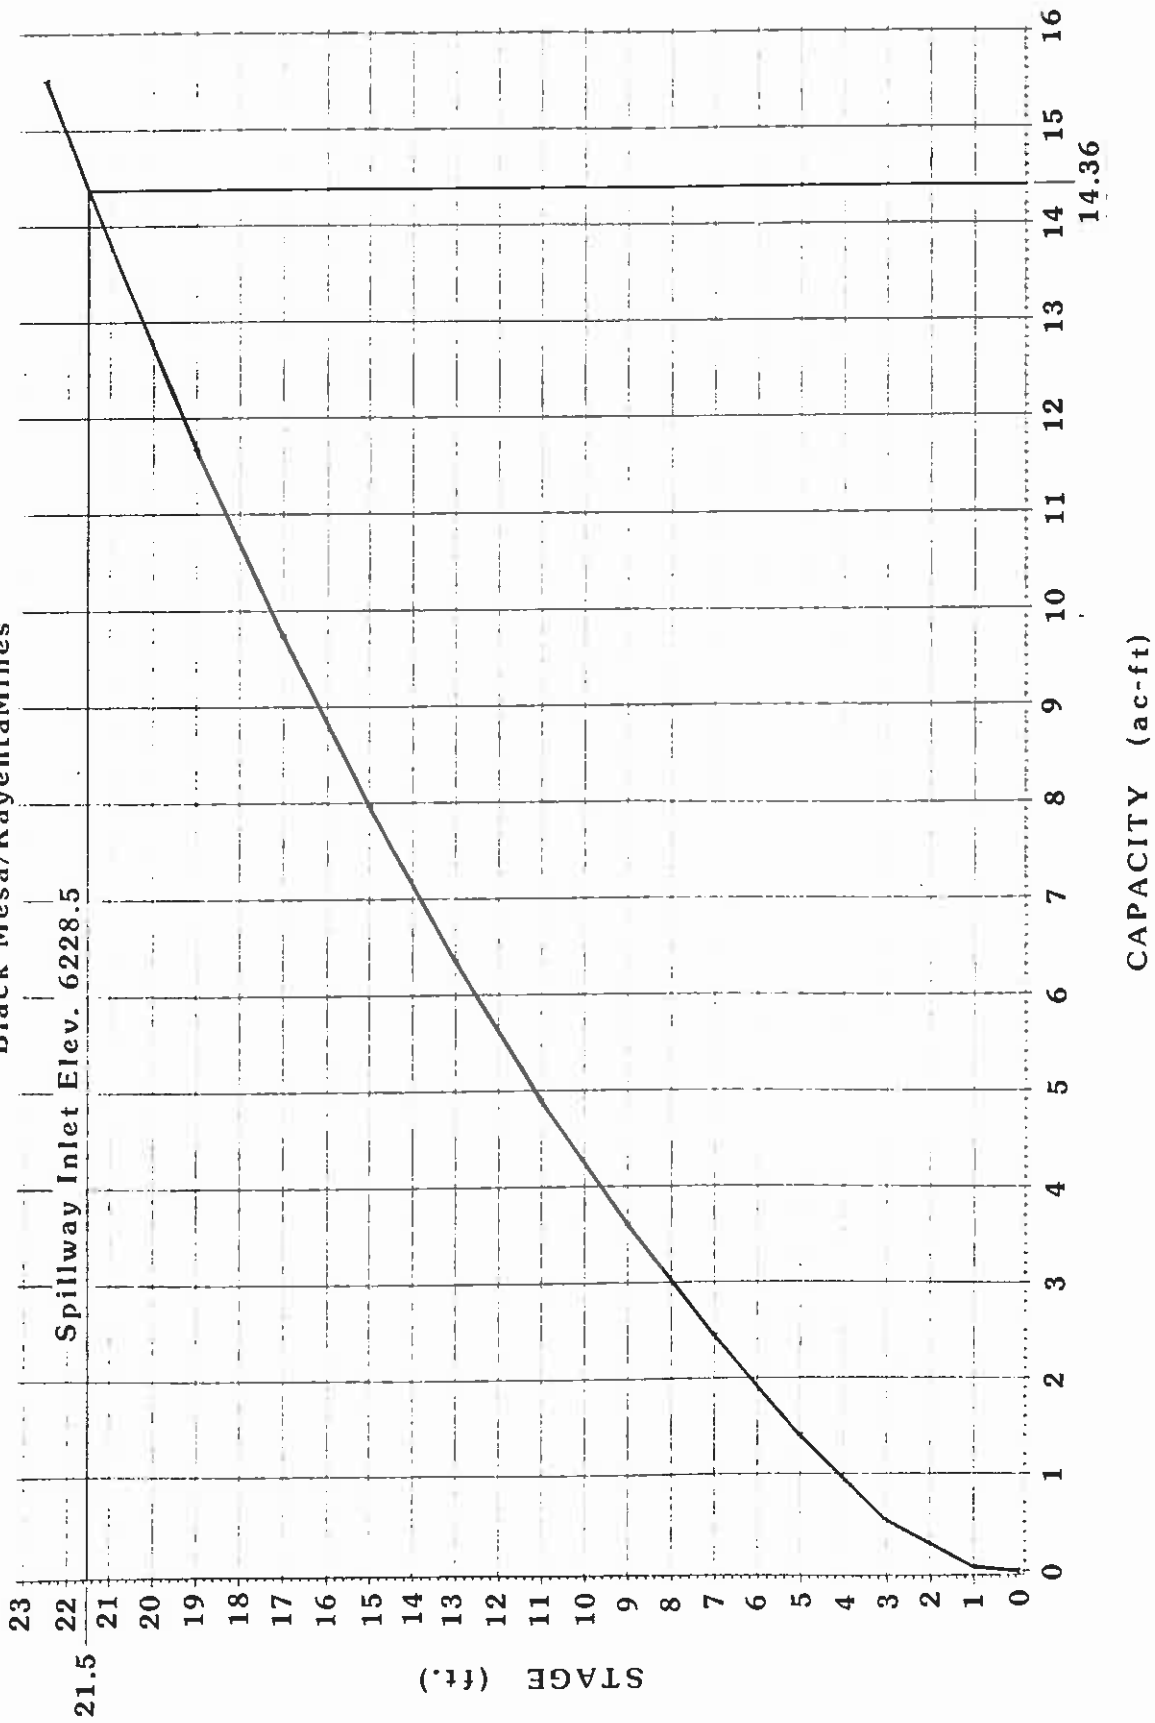
STAGE-CAPACITY CURVE WW-4
 Black Mesa/Kayenta Mines

Storage Capacity. The impoundment Stage-Capacity Curve is based on site specific survey conducted for Peabody Coal Company's as-built inspection. Additionally, the most recent topographic maps available were used in developing Plate 2, Stage-Capacity Curve, WW-4.

The hydrologic analysis give the storage volume required to contain the 10-year, 24-hour storm, and the remaining storage volume available for storing sediment. The storage capacity of WW-4 is shown on Plate 2. Stage-Capacity Curve, WW-4, and the results of the analysis are summarized in the following table.

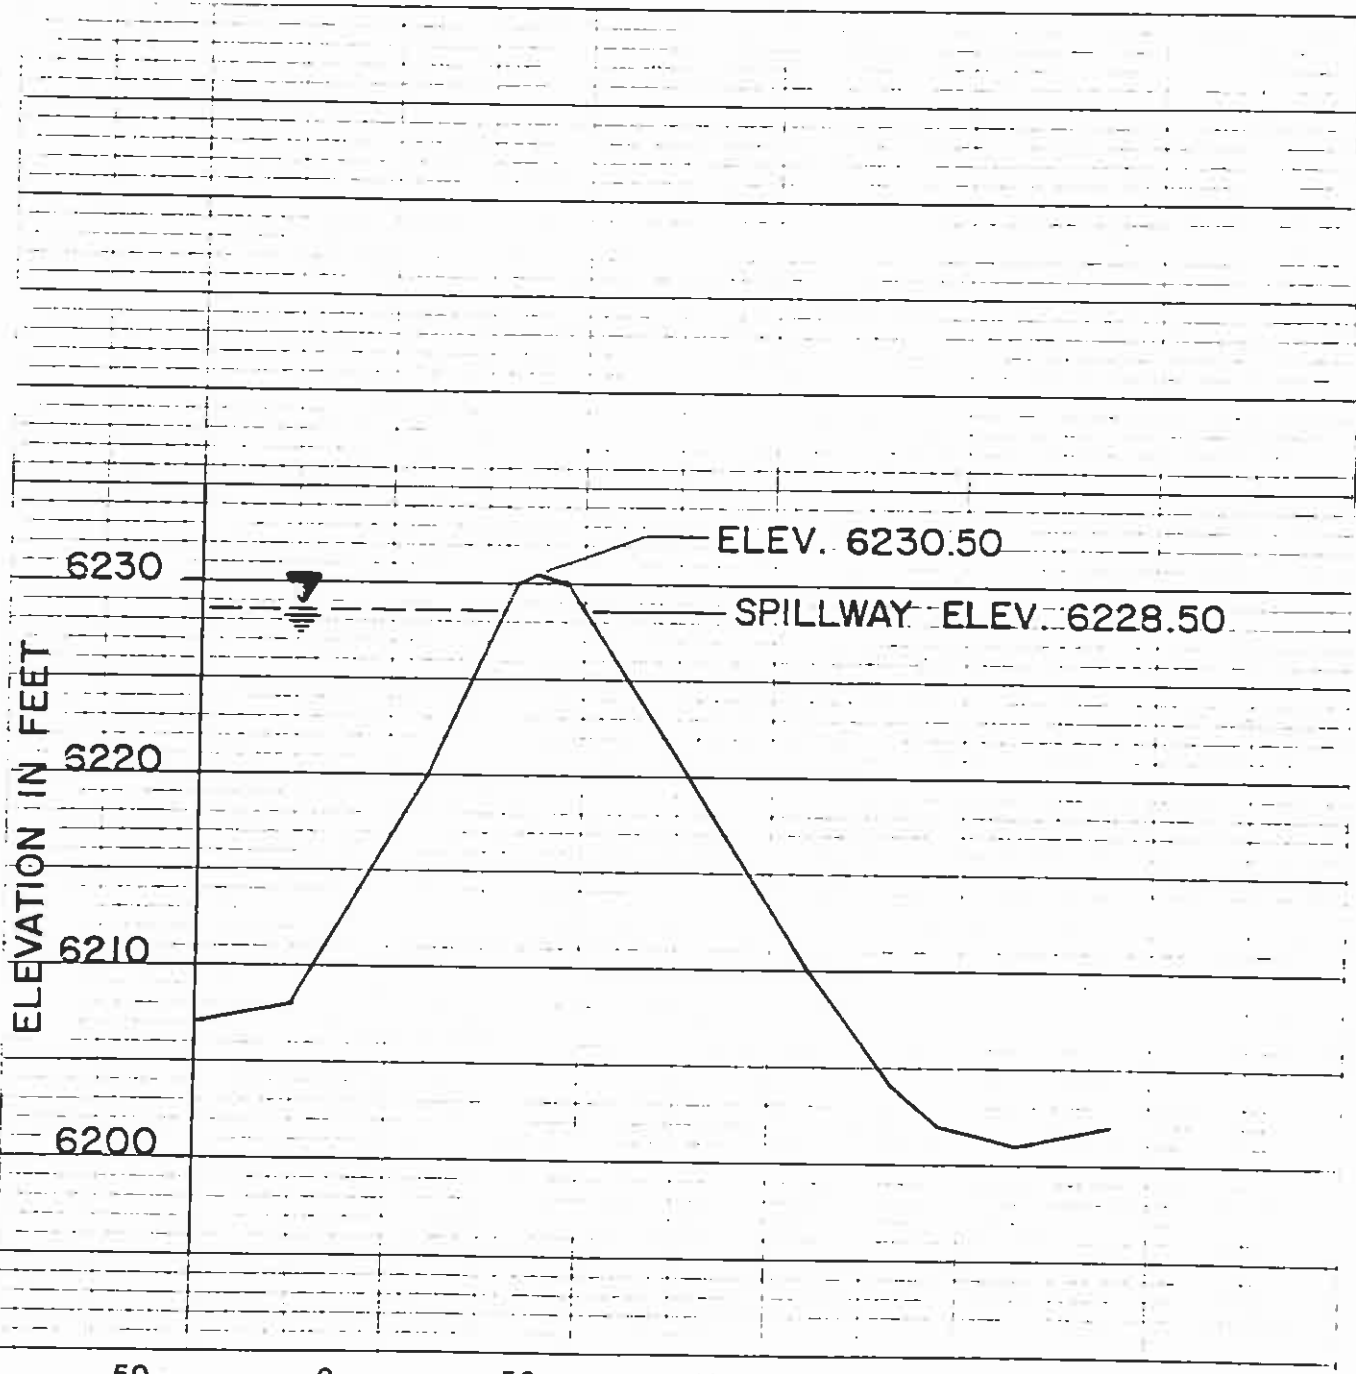
**MAXIMUM CROSS-SECTION
A-A'
WW-4**

Embankment. Structure WW-4 is a homogeneous earthen embankment classified as an in-wash embankment. Physical characteristics of the embankment are listed in the following table:

Embankment	Alluvium Soils
Foundation	Alluvium Soils
Right Abutment	Alluvium Soils
Left Abutment	Alluvium Soils
Height	12.0 ft
Crest Width	15.0 ft
Upstream Slope	2.0 H : 1.0 V
Downstream Slope	3.0 H : 1.0 V

The WW-4 embankment is lower in height and has flatter slopes than the category standard; therefore, the embankment has factors of safety greater than the design minimum.

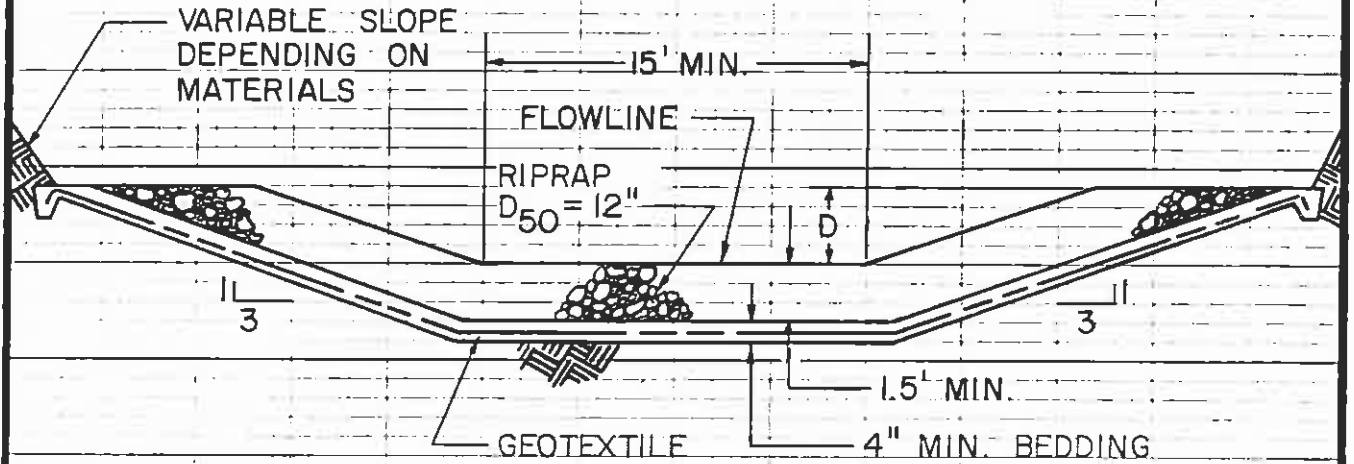
WW-4
SPILLWAY AND
OUTFLOW CHANNEL
CROSS SECTION

Spillway Channel. The existing spillway for WW-4 has a trapezoidal channel with the following dimensions:

- Channel depth 1.7 ft
- Channel width 15.0 ft
- Channel length 30.0 ft
- Side Slope (horizontal to vertical) 3 : 1
- Average Exit Slope 0 percent

The spillway channel is riprapped as per the approved design.

Outflow Channel. The existing outflow channel for WW-4 is a trapezoidal channel of the following dimensions:

- Channel depth 1.7 ft
- Channel width 15.0 ft
- Channel length 150.0 ft
- Side Slopes (horizontal to vertical) 3 : 1
- Average Exit Slope 12 percent
