INSPECTION REPORT
Sedimentation Structure
WW-5
Black Mesa Mine
Navajo County, Arizona
for
PEABODY COAL COMPANY

Dames & Moore
10139-011-22

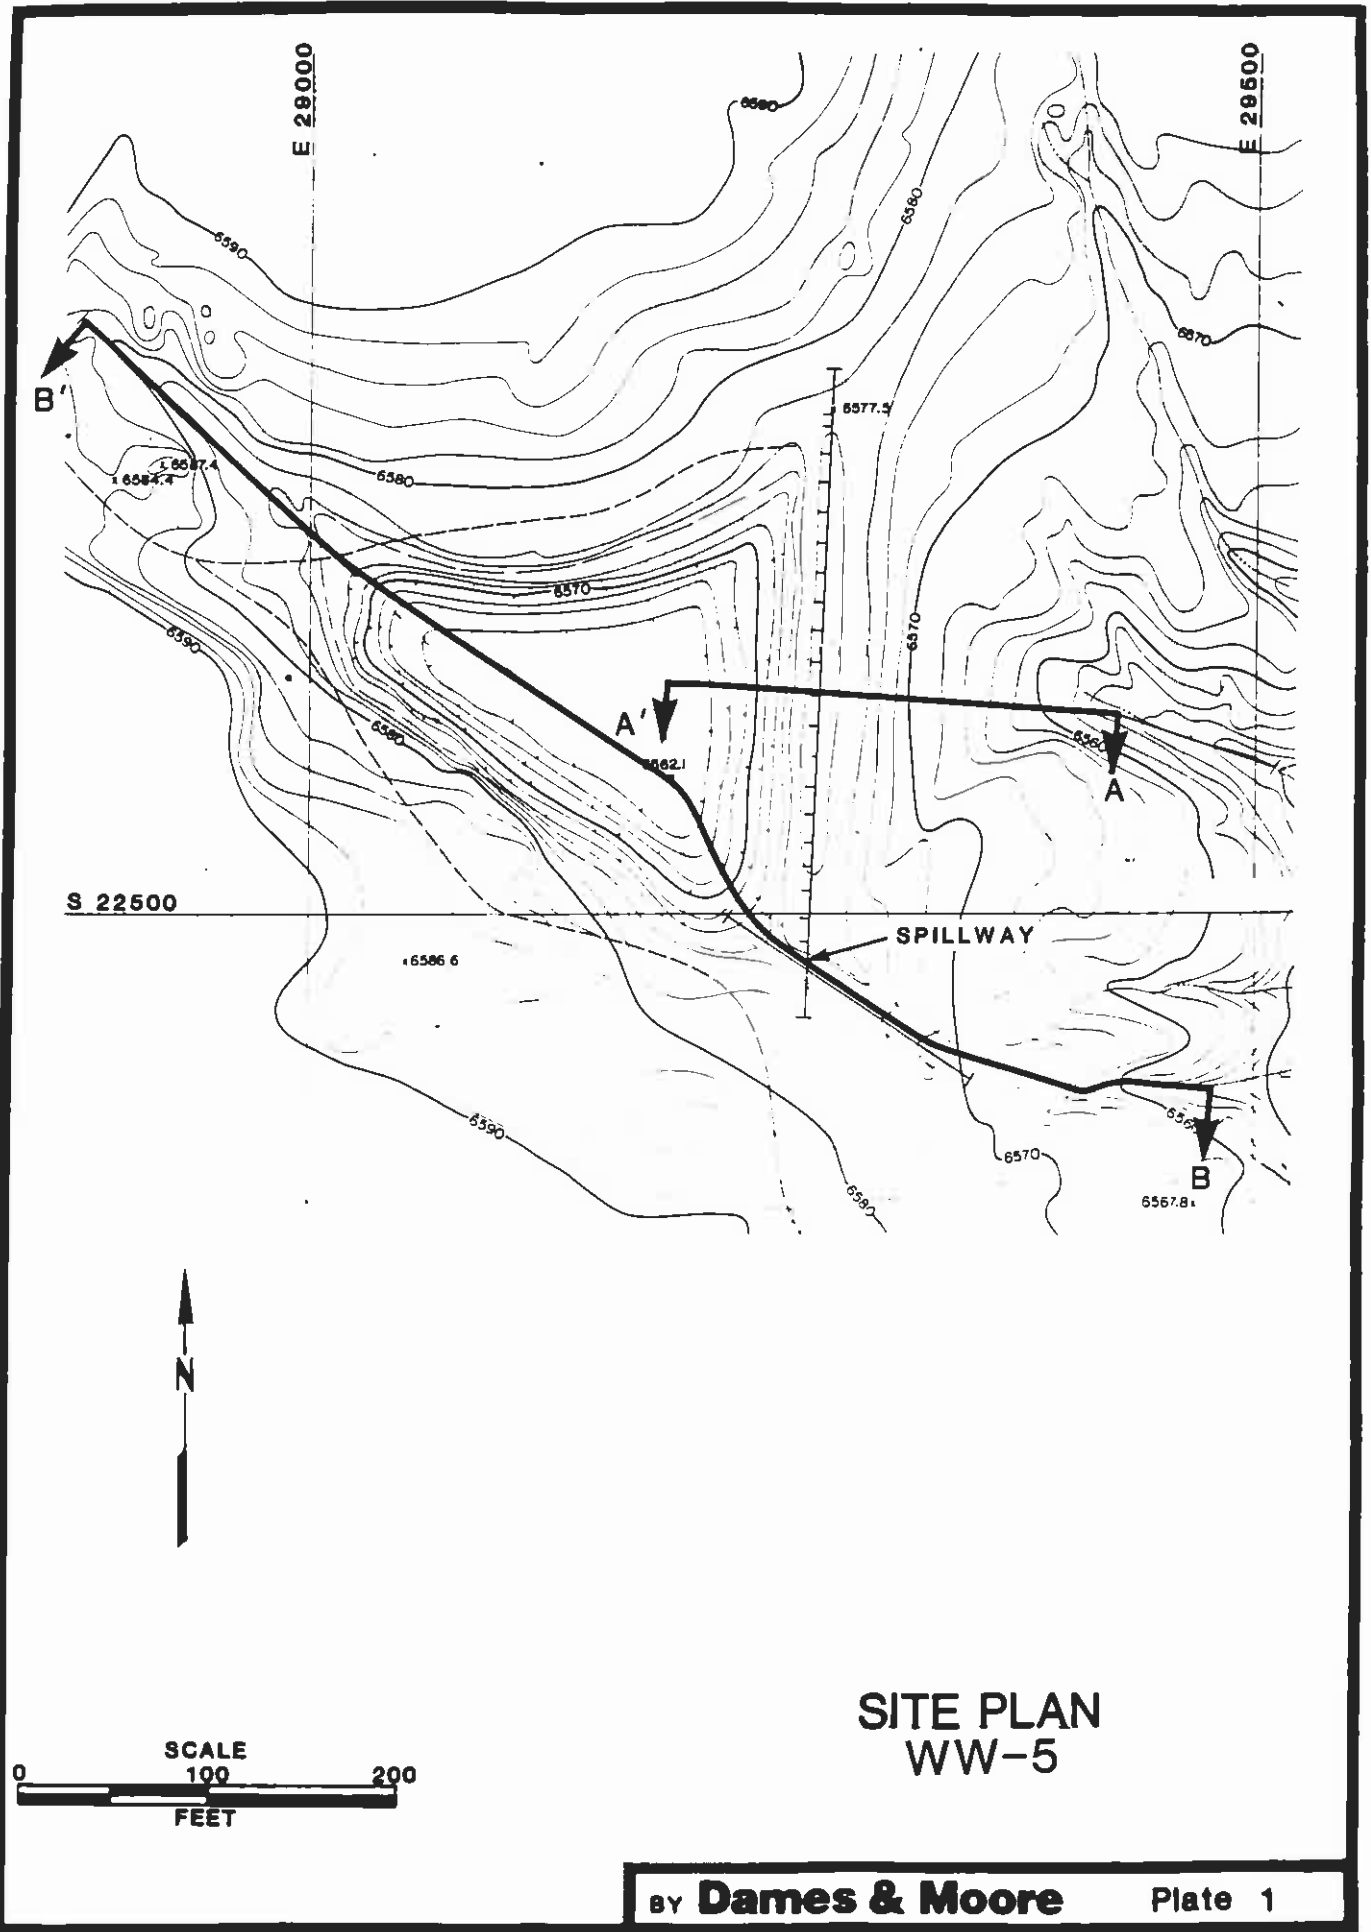
**SITE PLAN
WW-5**

Sedimentation Structure WW-5 is an earthen embankment, designed and constructed in 1981 by Peabody Coal Company as a temporary sedimentation structure to control runoff and sediment from the disturbed mining areas of the Black Mesa Mine. The location of Structure WW-5 is shown on Plate 1, Site Plan.

The storage capacity and spillway capacity of Structure WW-5 are adequate; however, the spillway does not have an adequate outflow channel or adequate erosion protection. A trapezoidal outflow channel should be constructed along the alignment B-B' shown in Plate 1. The channel profile is shown in Plate 4 and the required dimensions are shown in Plate 5. Both the spillway and outflow channel should be protected against erosion using geotextile and gravel as shown in Plate 5.

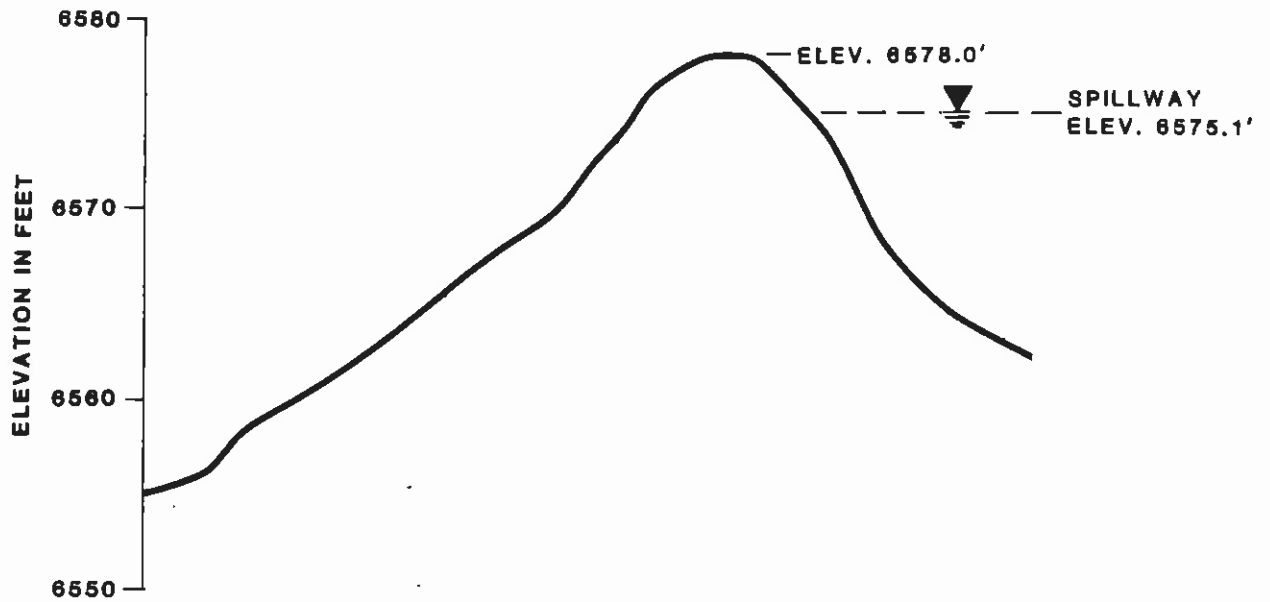
Plate 2

A cross-section of the embankment is shown on Plate 2, Existing Maximum Cross Section WW-5, A-A'. Grass provides erosion protection on the upstream slope of the embankment.

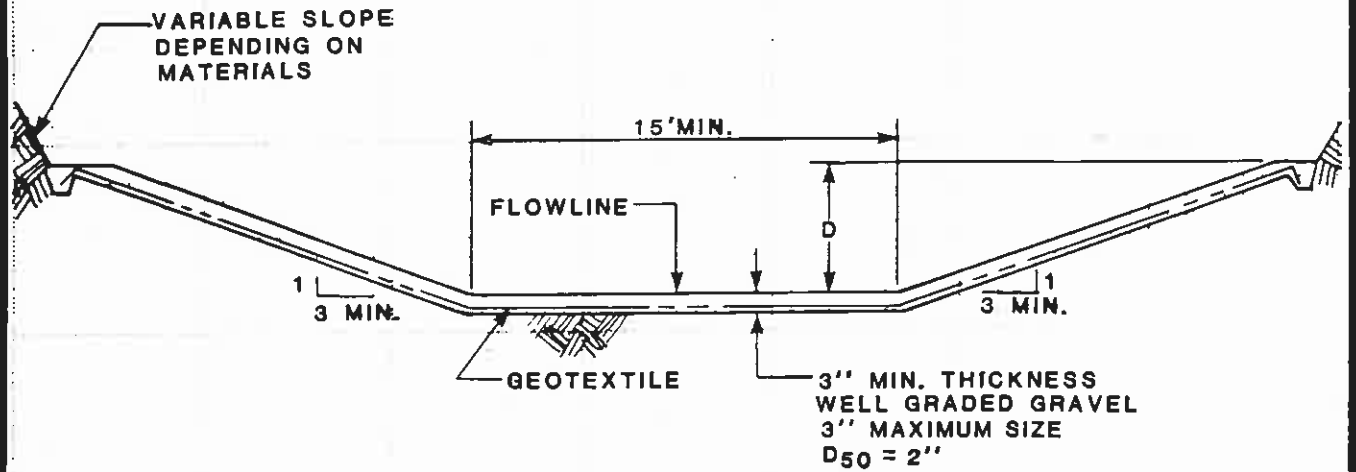
SPILLWAY AND
 OUTFLOW CHANNEL
 CROSS SECTION
 WW-5

There is presently no erosion protection within the channel.
