INSPECTION REPORT  
Sedimentation Structure  
WW-6  
Black Mesa Mine  
Navajo County, Arizona  
for  
PEABODY COAL COMPANY

Dames & Moore  
10139-011-22

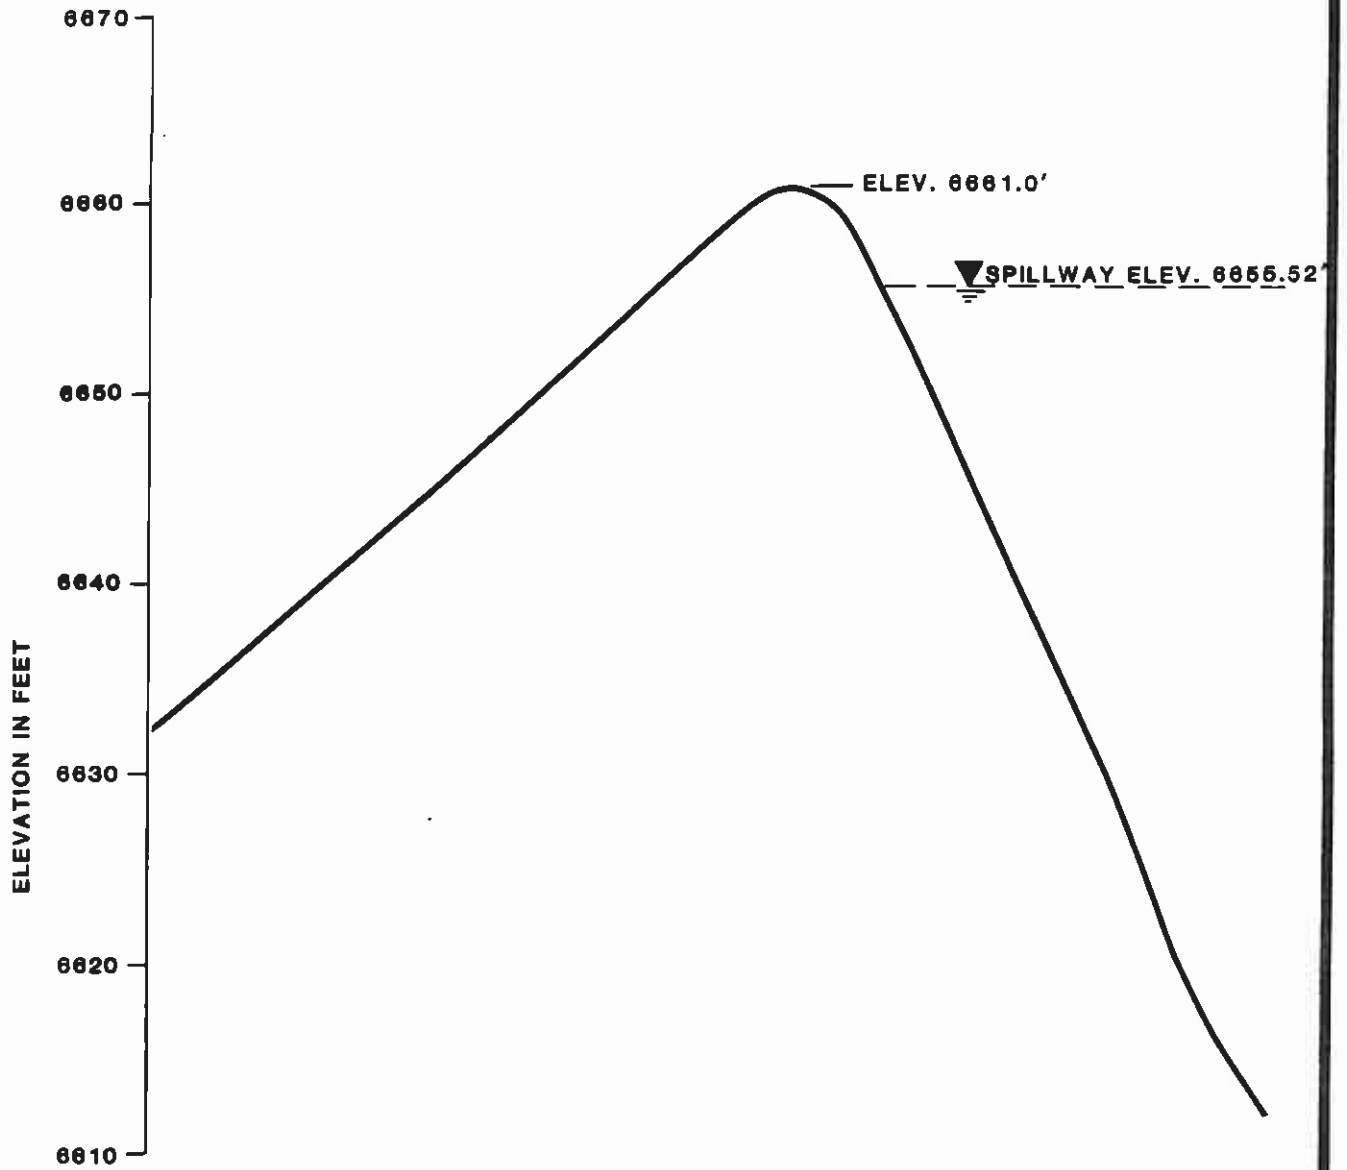
Plate 2

A cross-section of the embankment is shown on Plate 2, Existing Maximum Cross Section WW-6, A-A'. Grass provides erosion protection on the downstream slope of the embankment.

The WW-6 embankment is lower in height and has flatter slopes than the category standard; therefore, the embankment has factors of safety greater than the design minimum.

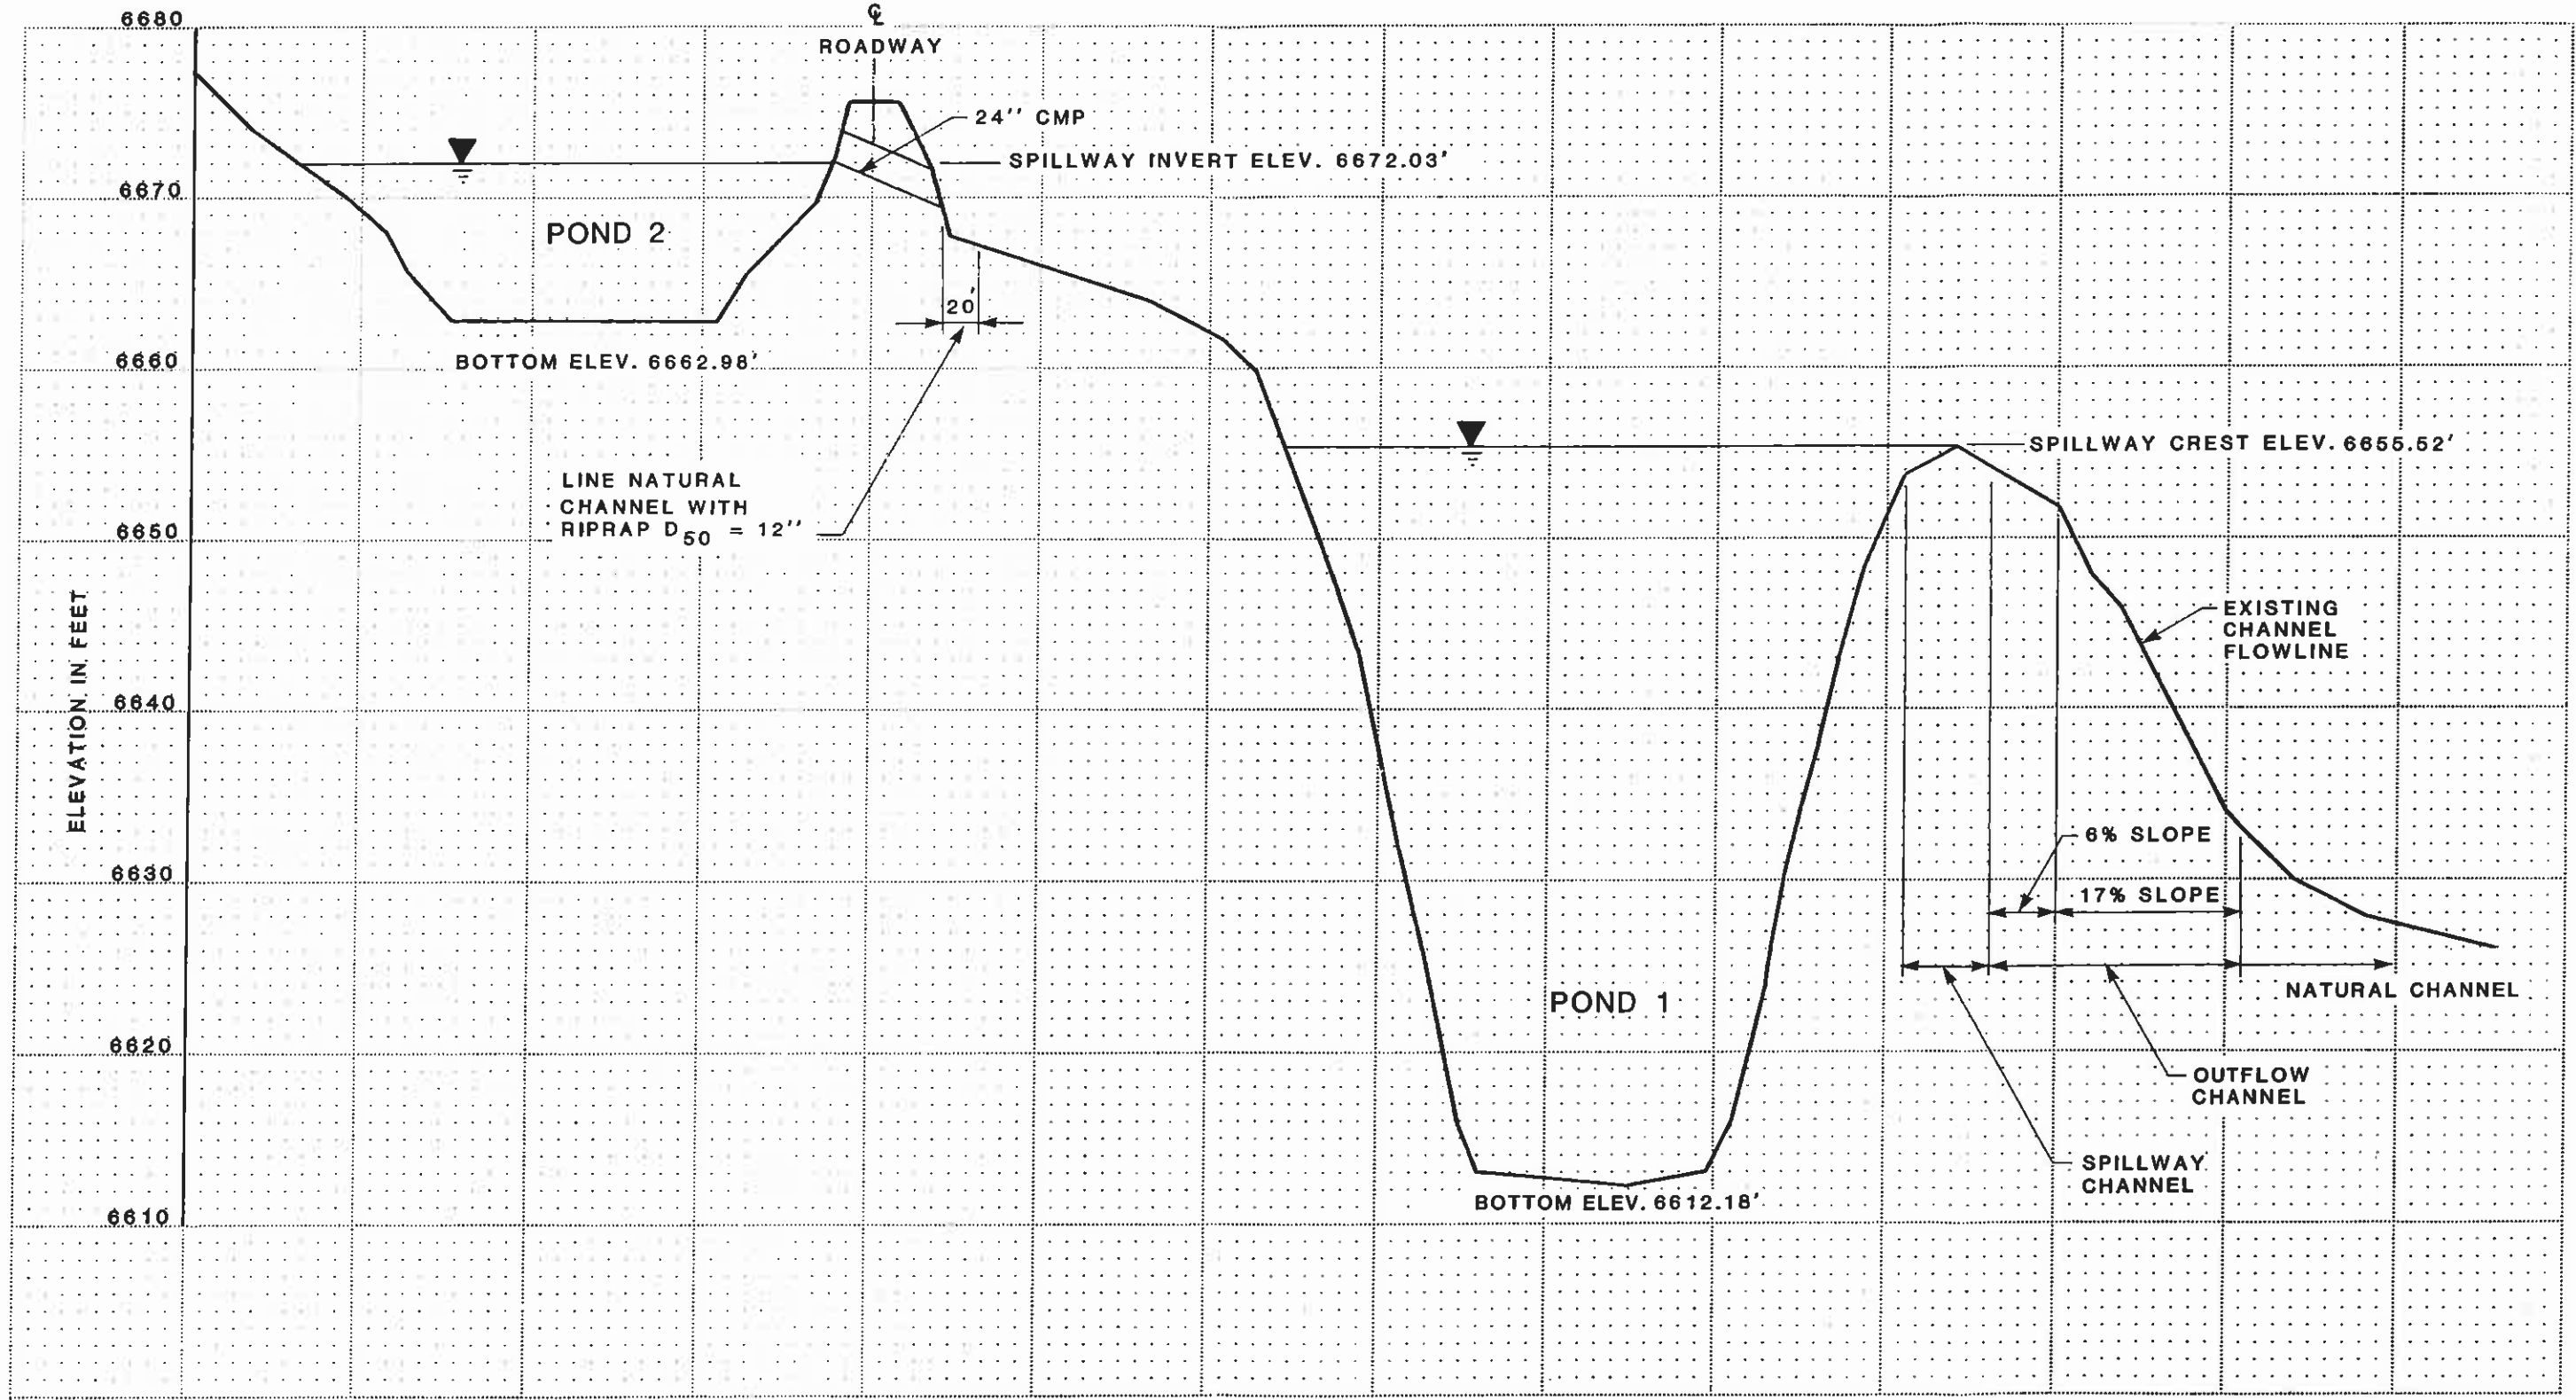
CHANNEL PROFILE B-B'  
WW-6

There is presently no erosion protection within the channel.

A trashrack should be installed on the inlet of the spillway pipe for Pond 2. The natural channel below the pipe should be lined with riprap to prevent erosion (see Plate 4).
