INSPECTION REPORT
Sedimentation Structure
WW-9
Black Mesa Mine
Navajo County, Arizona
for
PEABODY COAL COMPANY

Dames & Moore
10139-011-22

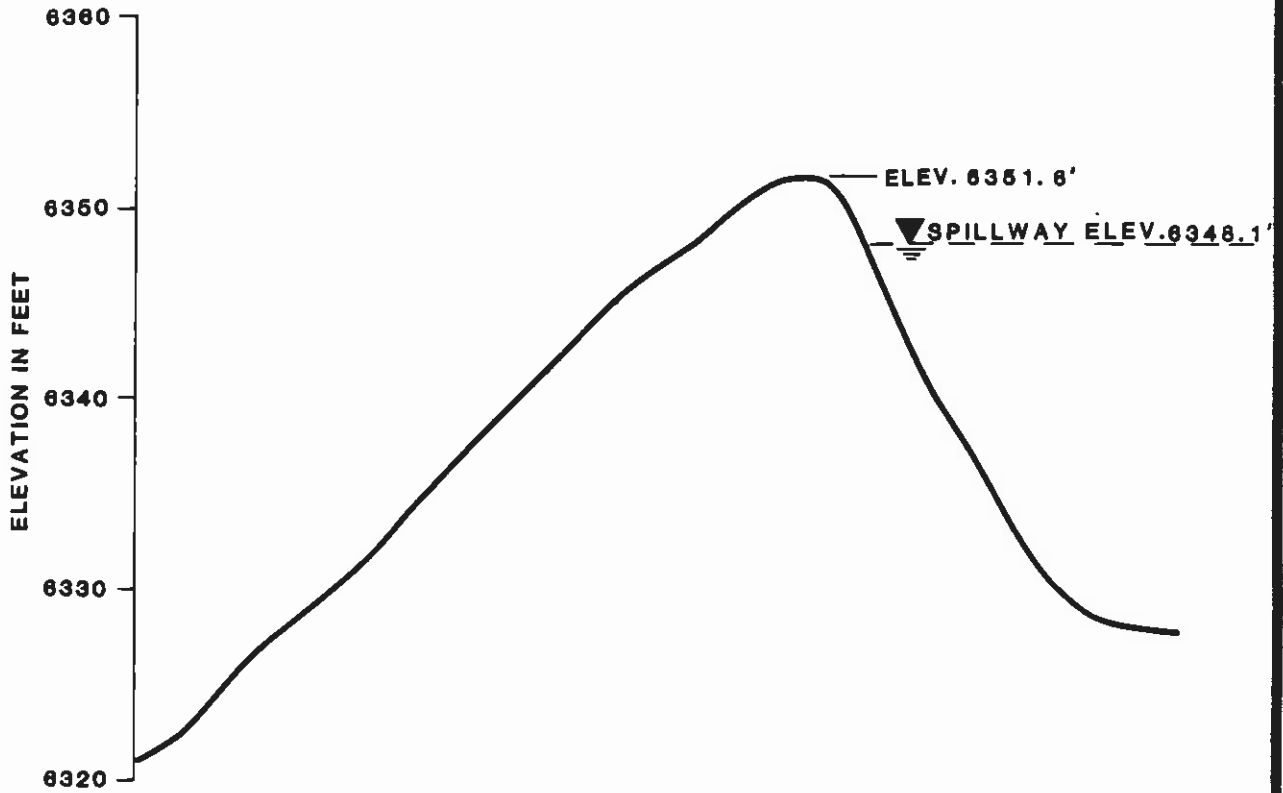
Plate 2

A cross-section of the embankment is shown on Plate 2, Existing Maximum Cross Section WW-9, A-A'. Grass provides erosion protection on the upstream and downstream slopes of the embankment.

The inspection of Structure WW-9 indicated that the only geotechnical problems are rills on the downstream slopes and the right and left abutments. Correction of erosion is considered a periodic maintenance task and does not require remedial action.

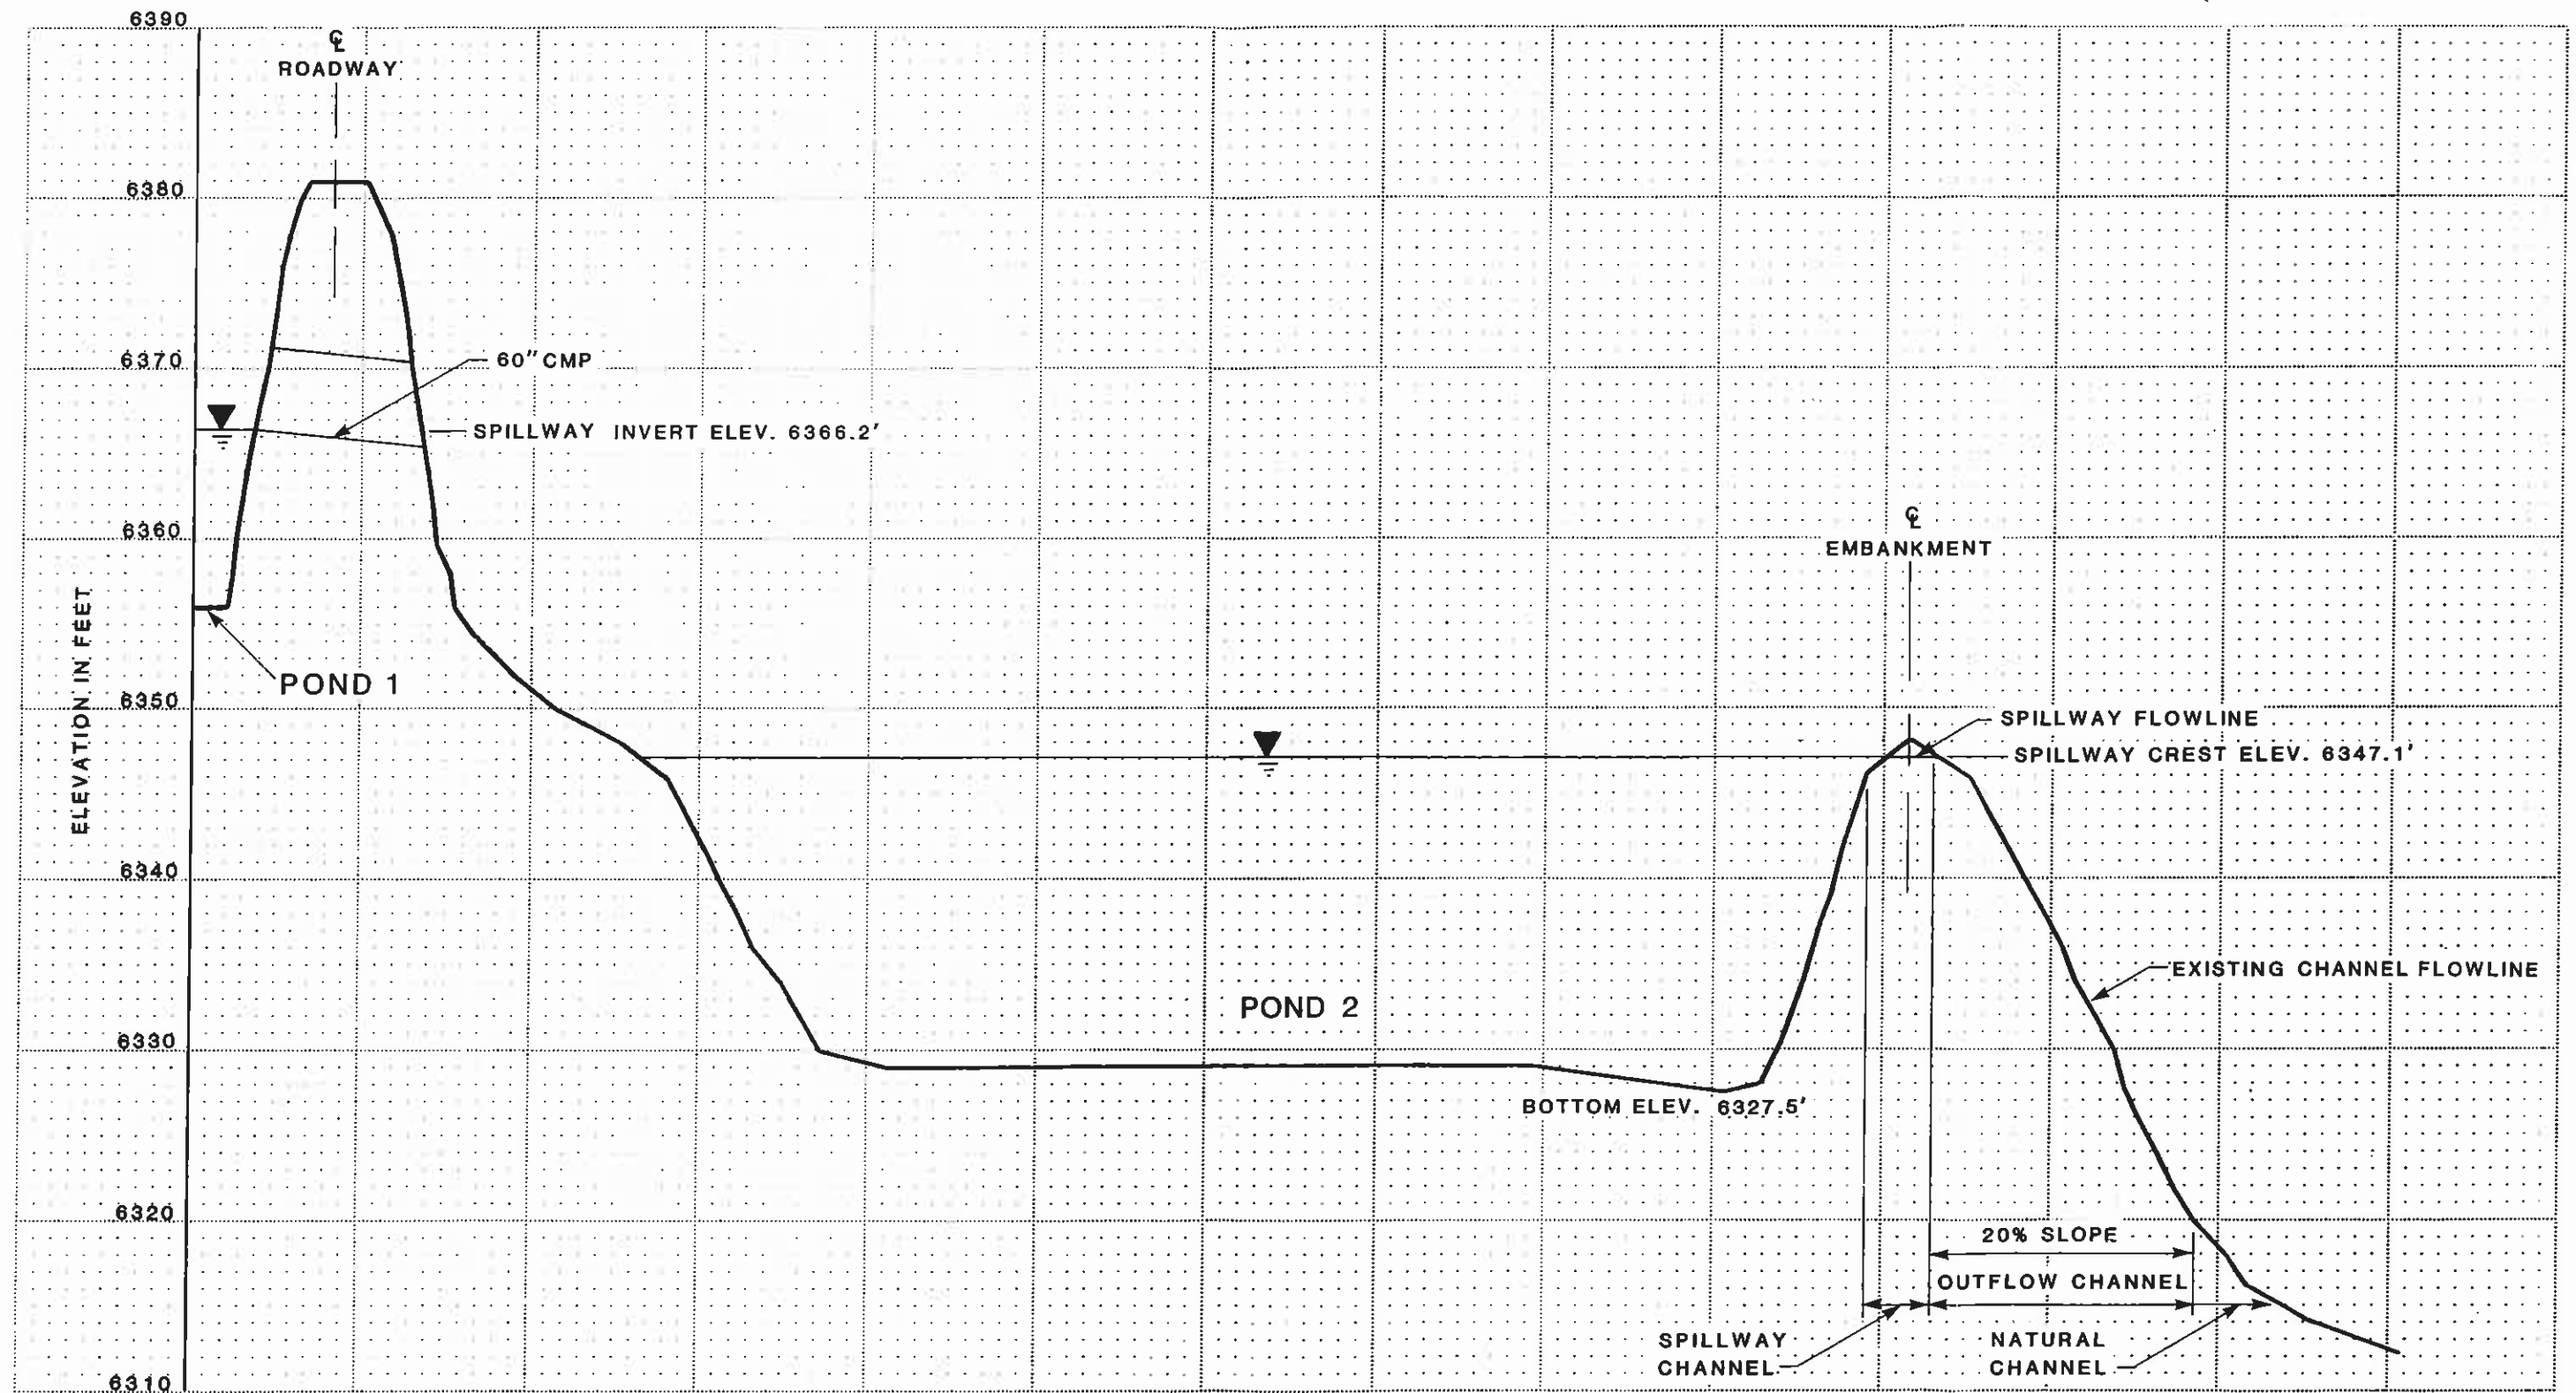
BY **Dames & Moore** Plate 4B

The existing outflow channel for WW-9 has a trapezoidal channel with the following dimensions:

Channel width 55 ft
Channel length 150 ft
Side slopes (horizontal to vertical). . 2:1
Average exit slope 17 percent

There is presently no erosion protection within the channel.

The storage capacity and spillway capacity of Structure WW-9 are adequate but the storage capacity exceeds 20 acre-feet. The bottom elevation of the existing spillway channel should be lowered to elevation 6347.10 feet while maintaining the bottom width of 65 feet. The spillway and outflow channel profiles are shown in Plates 4A and 4B. The spillway and outflow channel do not require any modifications.

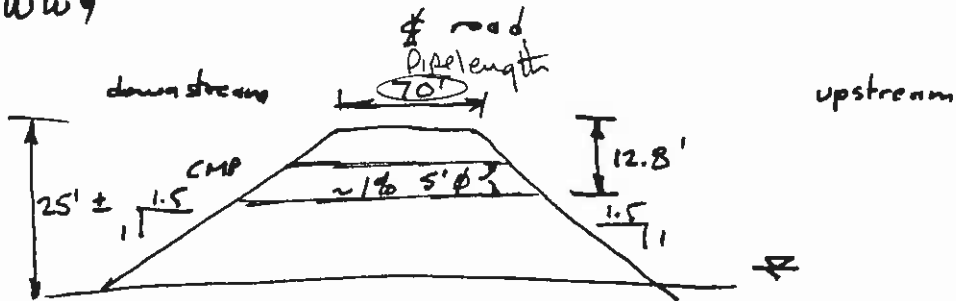
Additional Structure

Road embankment crossing wash about 600' U/S from WW 9

- moderate gully erosion on both slopes

- potential flood hazard due to blocking of culvert, overtopping / breaching of embankment and flood surge entering WW 9
- does pipeline from well follow road bed? is pipeline susceptible to failure if road washes out
- embankment material highly susceptible to erosion
 - no slope protection present
