INSPECTION REPORT
Sedimentation Structure
WW-9A
Black Mesa Mine
Navajo County, Arizona
for
PEABODY COAL COMPANY

Dames & Moore
10139-011-22

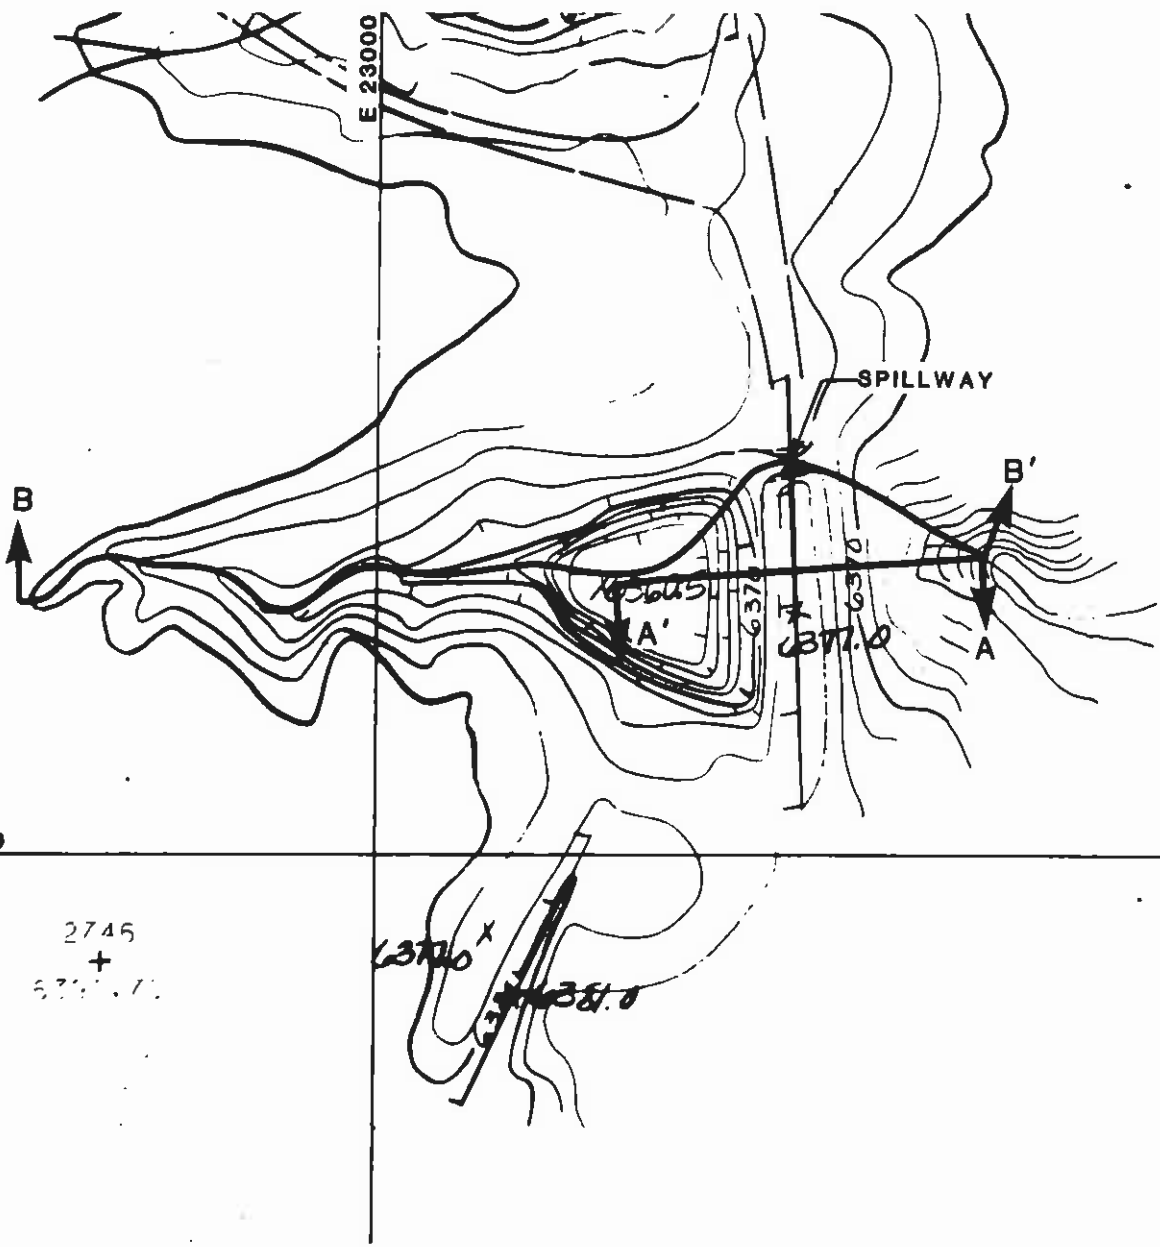
**SITE PLAN
WW-9A**

Sedimentation Structure WW-9A is an earthen embankment, designed and constructed in 1983 by Peabody Coal Company as a temporary sedimentation structure to control runoff and sediment from the disturbed mining areas of the Black Mesa Mine. The location of Structure WW-9A is shown on Plate 1, Site Plan.

The storage capacity and spillway capacity of Structure WW-9A are adequate; however, the spillway does not have an outflow channel or adequate erosion protection. A trapezoidal outflow channel should be constructed along the alignment B-B' shown in Plate 1. The channel profile is shown in Plate 4 and the required dimensions are shown in Plate 5. Both the spillway and outflow channel should be protected against erosion using geotextile and gravel as shown in Plate 5.

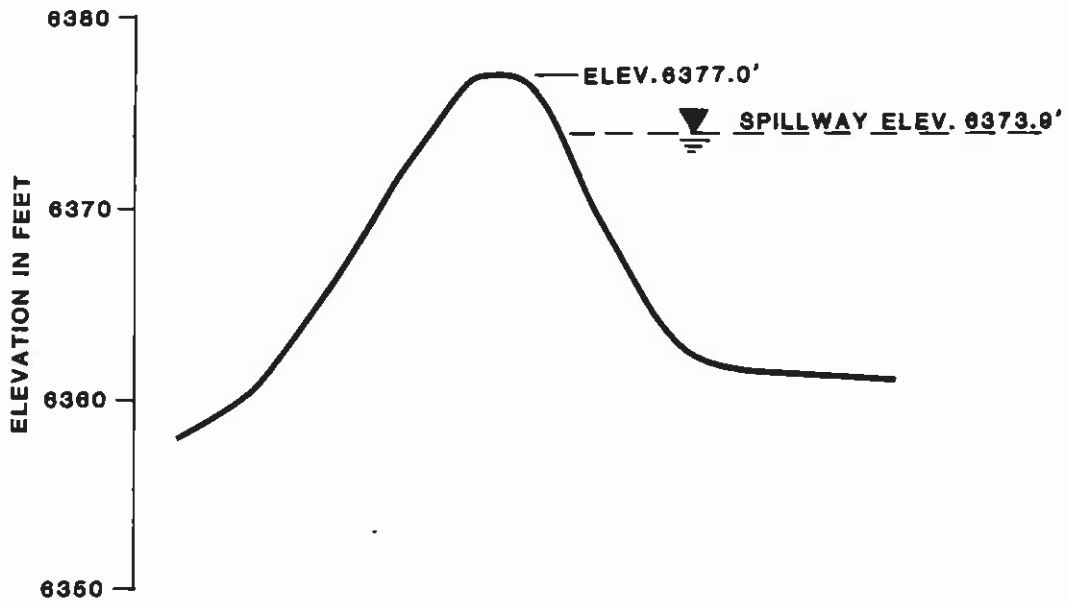
EXISTING
 MAXIMUM CROSS-SECTION
 A-A'
 WW-9A

A cross-section of the embankment is shown on Plate 2, Existing Maximum Cross Section WW-9A, A-A'. Grass provides erosion protection on the upstream and downstream slopes of the embankment.

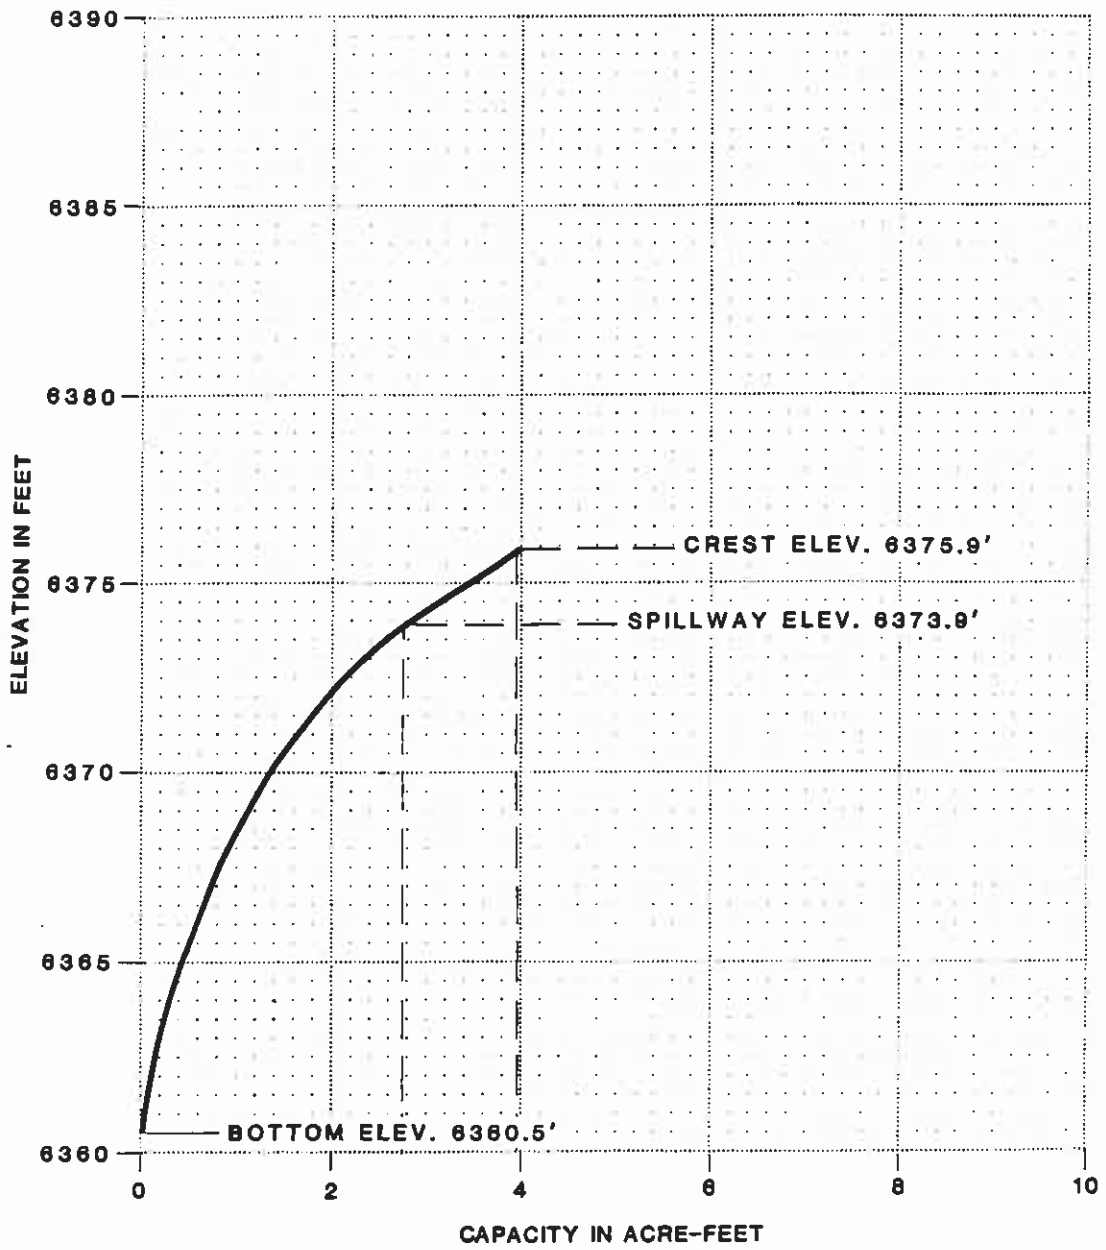
VOLUME-ELEVATION
CURVE
WW-9A

The impoundment volume-elevation curve is based on site specific surveys conducted for Peabody Coal Company's August 1984 inspection, and 1985 resurveys, where available. Additionally, the most current topographic maps available were used in developing Plate 3, Volume-Elevation Curve, WW-9A.

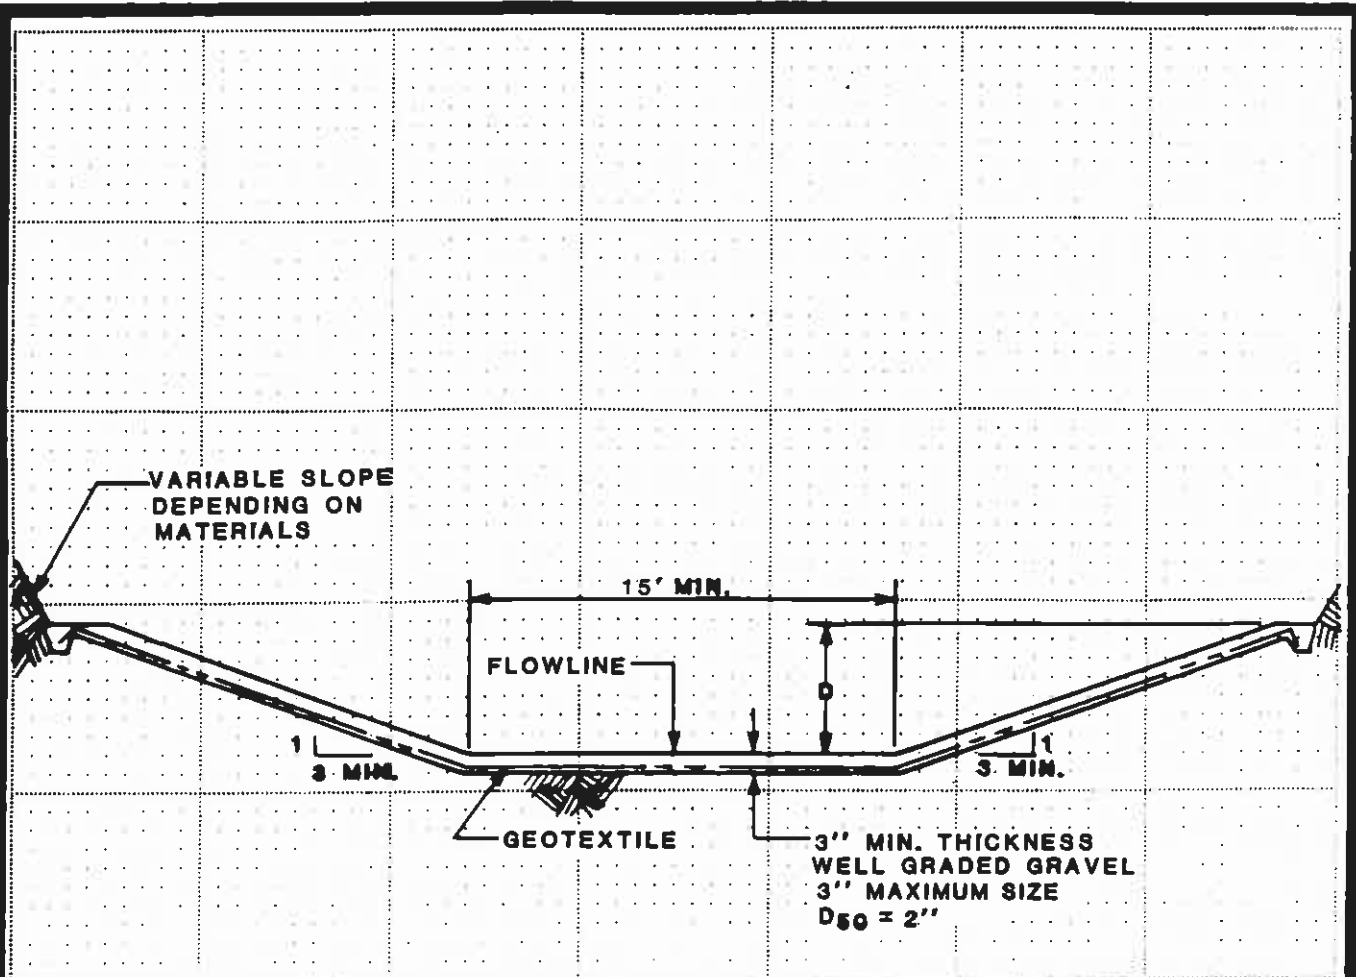
**SPILLWAY AND
 OUTFLOW CHANNEL
 CROSS SECTION
 WW-9A**

There is presently no erosion protection within the channel.

The structure presently has no outflow channel.
