INSPECTION REPORT  
Sedimentation Structure  
WW-9B  
Kayenta Mine  
Navajo County, Arizona  
for  
PEABODY COAL COMPANY

Dames & Moore  
10139-011-22

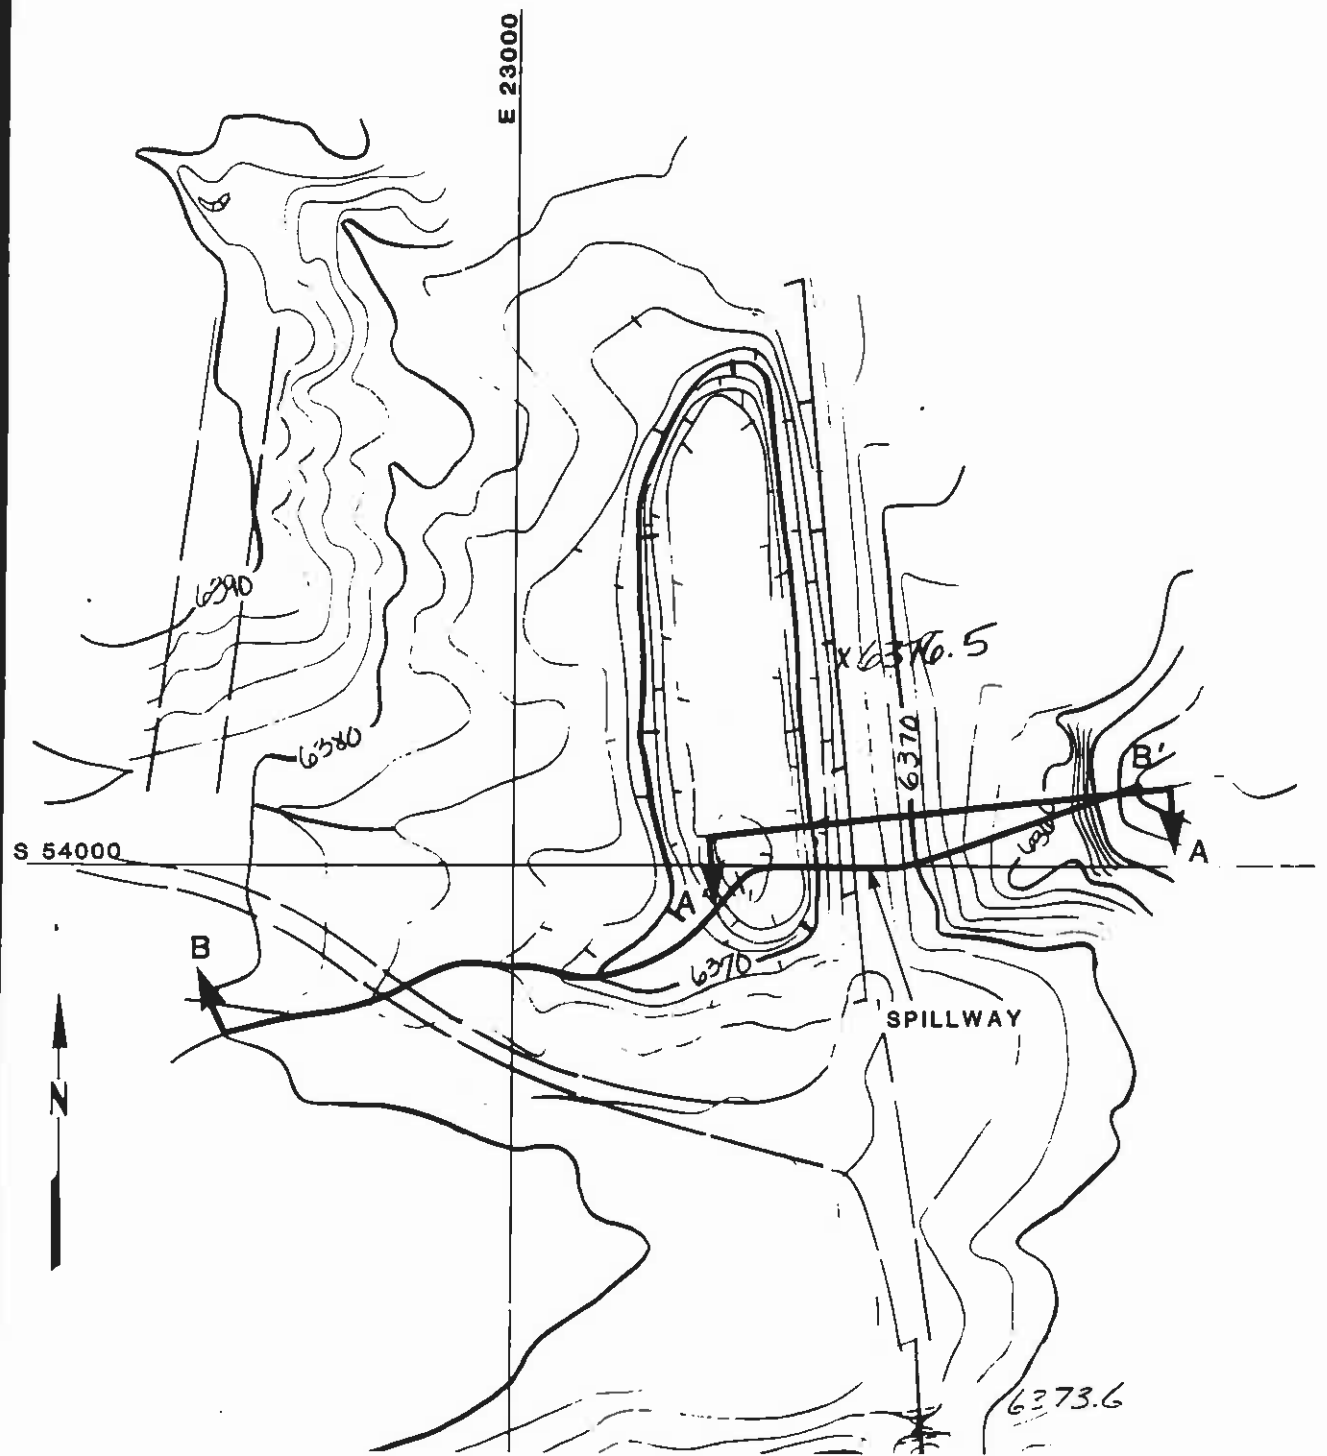
**SITE PLAN  
WW-9B**

The storage capacity and spillway capacity of Structure WW-9B are adequate; however, the spillway does not have an outflow channel or adequate erosion protection. A trapezoidal outflow channel should be constructed along the alignment B-B' shown in Plate 1. The channel profile is shown in Plate 4 and the required dimensions are shown in Plate 5. Both the spillway and outflow channel should be protected against erosion using geotextile and gravel as shown in Plate 5.

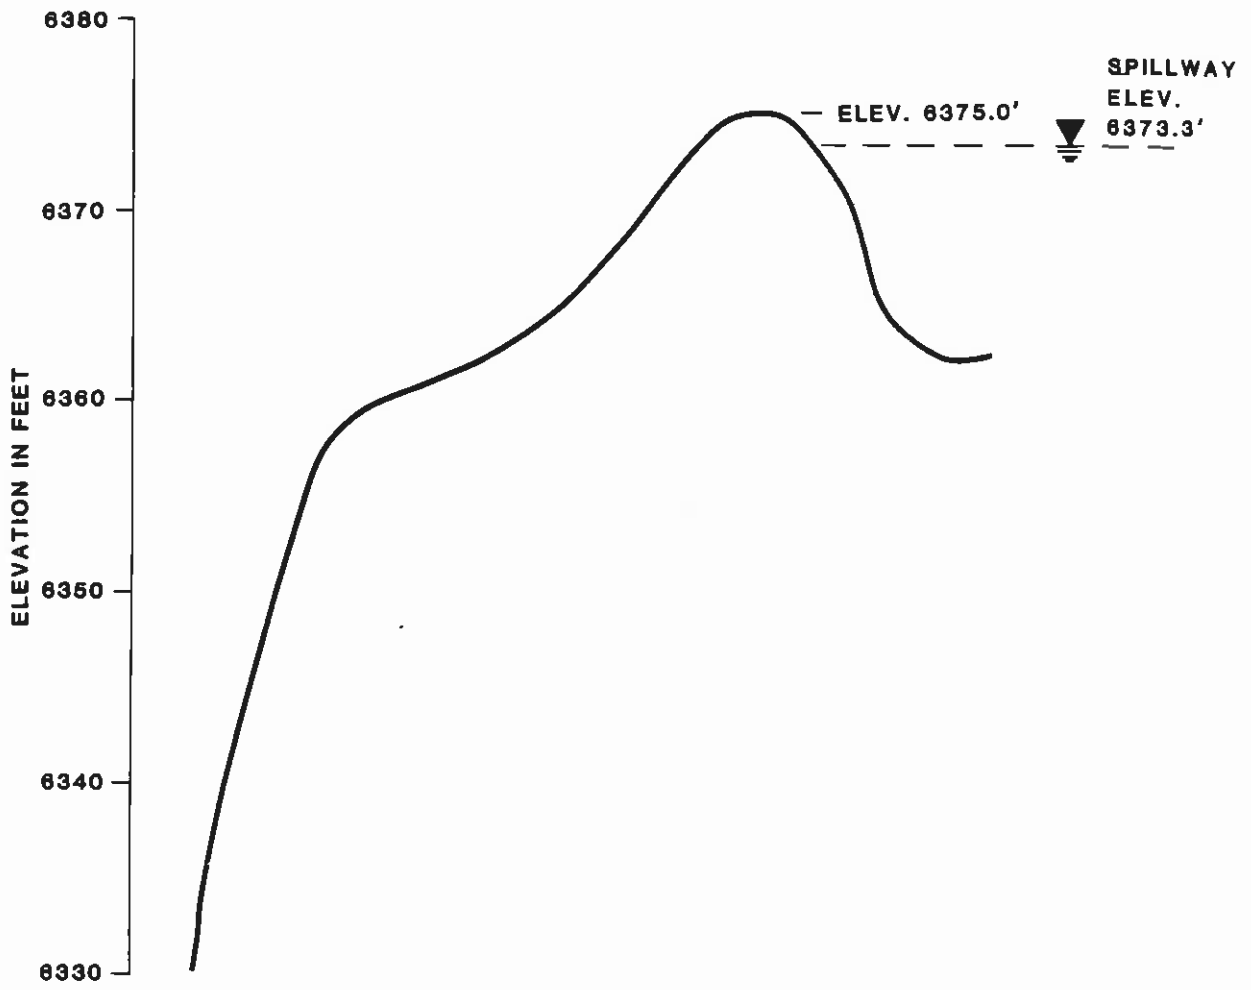
EXISTING  
MAXIMUM CROSS-SECTION  
A-A'  
WW-9B

A cross-section of the embankment is shown on Plate 2, Existing Maximum Cross Section WW-9B, A-A'. Grass provides erosion protection on the upstream slope of the embankment.

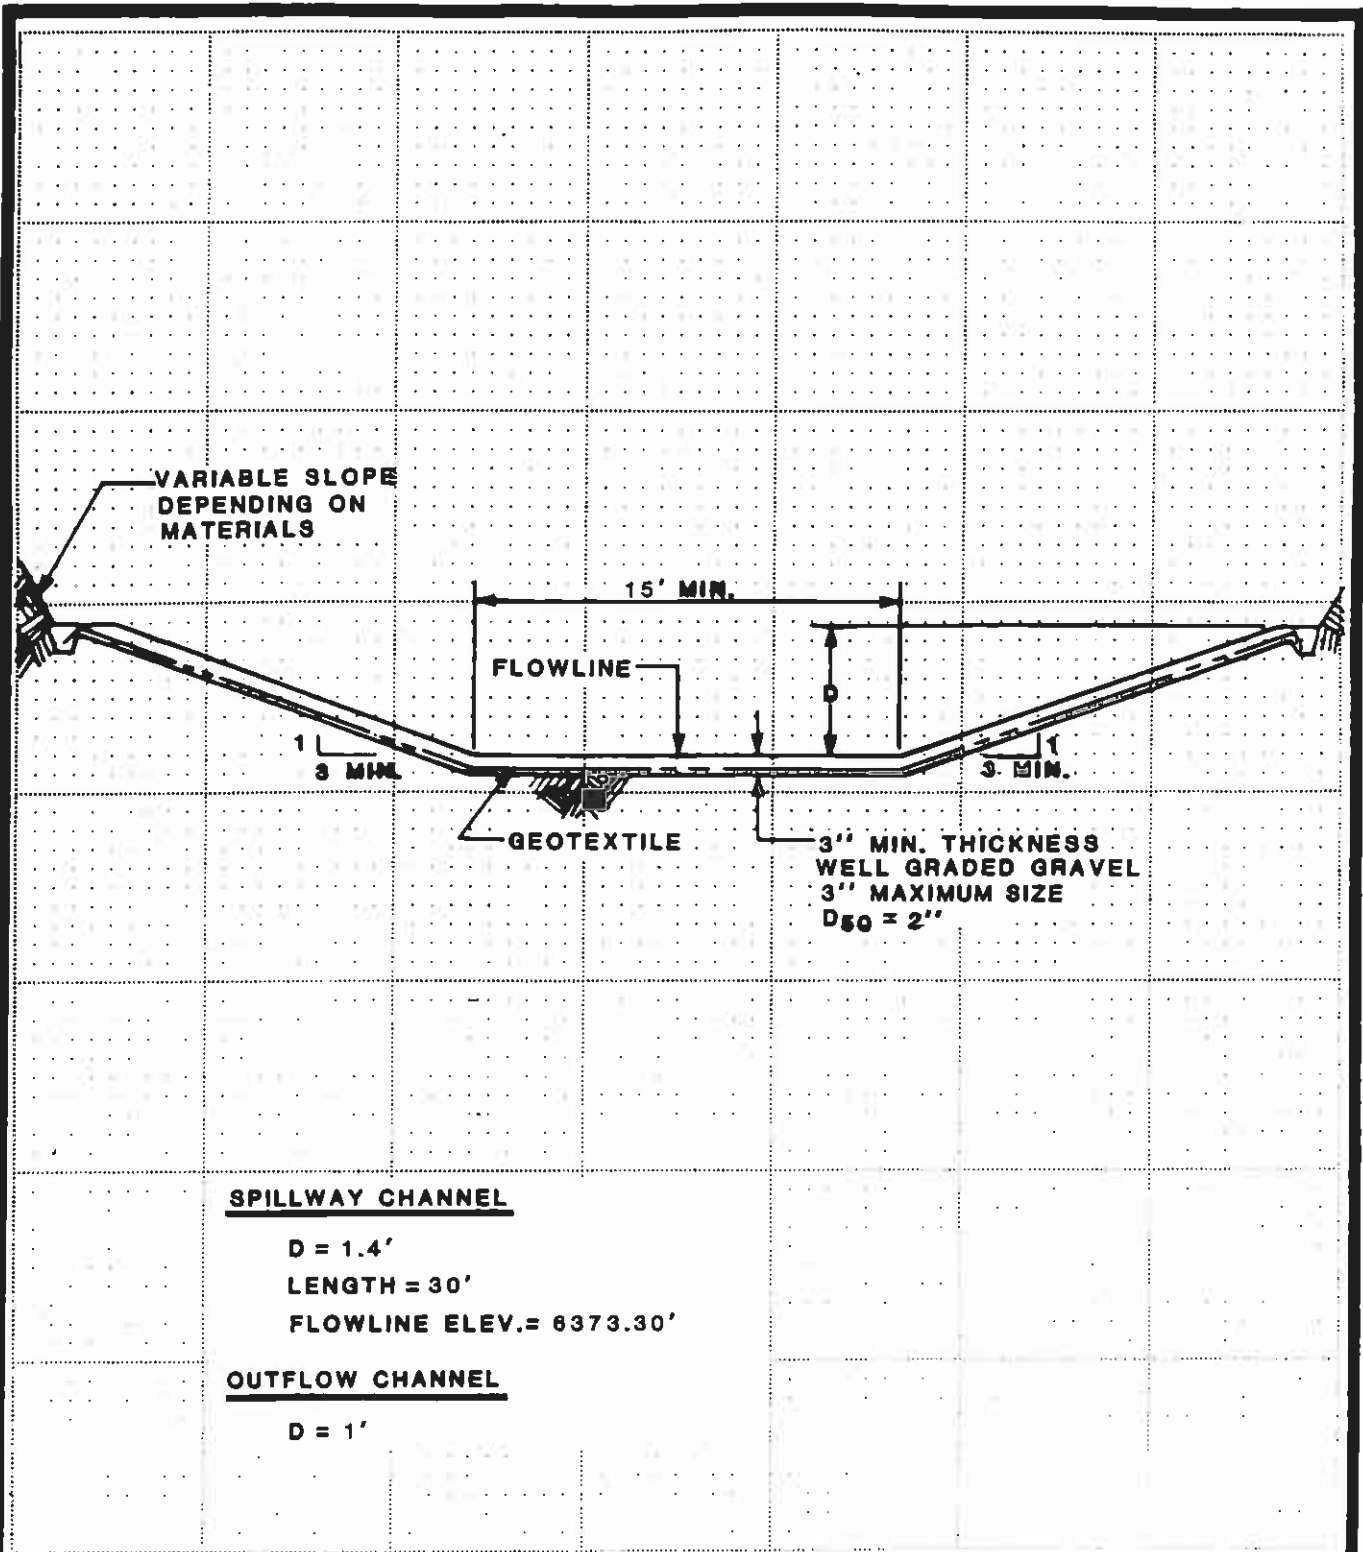
**SPILLWAY AND  
OUTFLOW CHANNEL  
CROSS SECTION  
WW-9B**

There is presently no erosion protection within the channel.
