INSPECTION REPORT
Sedimentation Structure
WW-9C
Black Mesa Mine
Navajo County, Arizona
for
PEABODY COAL COMPANY

Dames & Moore
10139-011-22

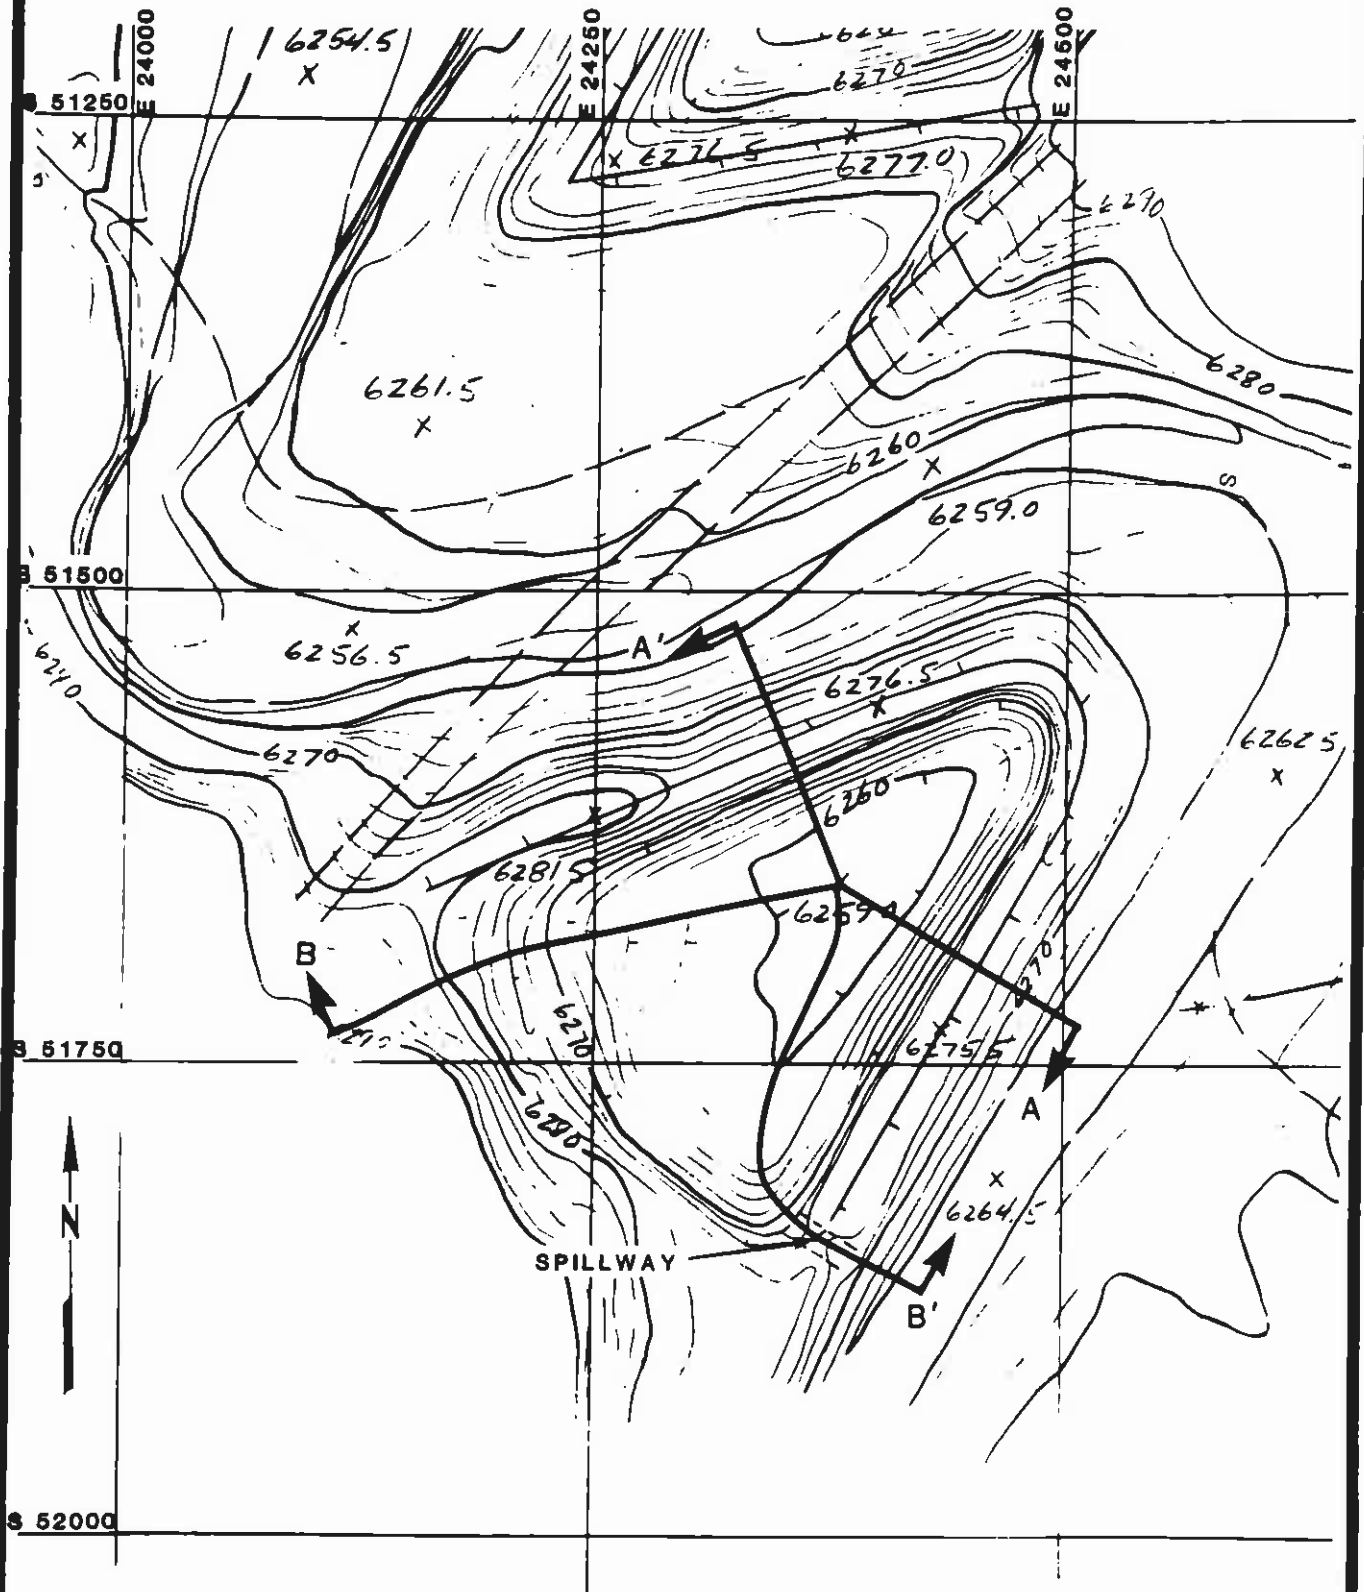
SITE PLAN
WW-9C

The storage capacity and spillway capacity of Structure WW-9C are adequate; however, the spillway does not have an adequate outflow channel or adequate erosion protection. A trapezoidal outflow channel should be constructed along the alignment B-B' shown in Plate 1. The channel profile is shown in Plate 4 and the required dimensions are shown in Plate 5. Both the spillway and outflow channel should be protected against erosion using geotextile and gravel as shown in Plate 5.

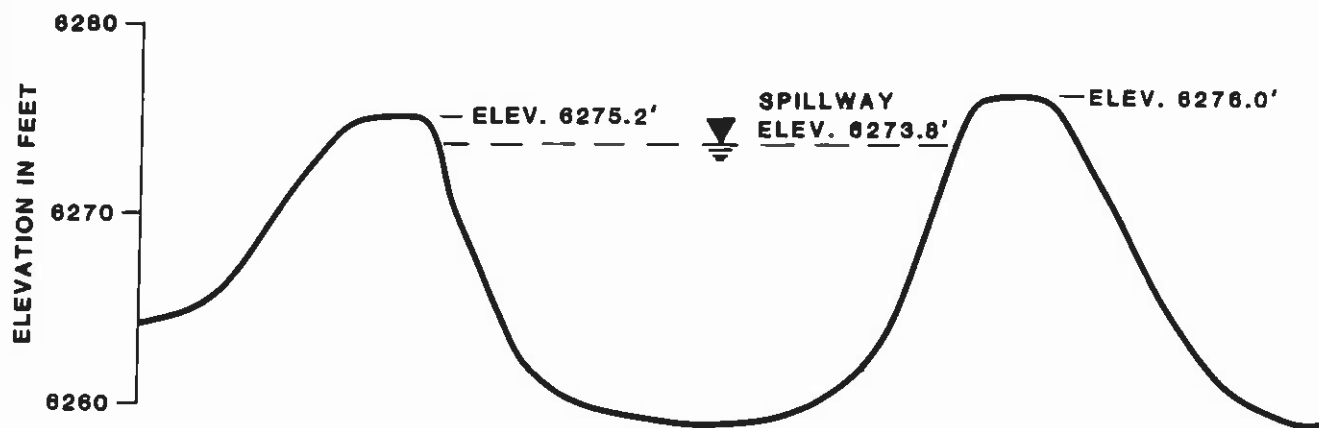
EXISTING
MAXIMUM CROSS-SECTION
A-A'
WW-9C

A cross-section of the embankment is shown on Plate 2, Existing Maximum Cross Section WW-9C, A-A'. Grass and rock provide erosion protection on the downstream slope of the embankment.

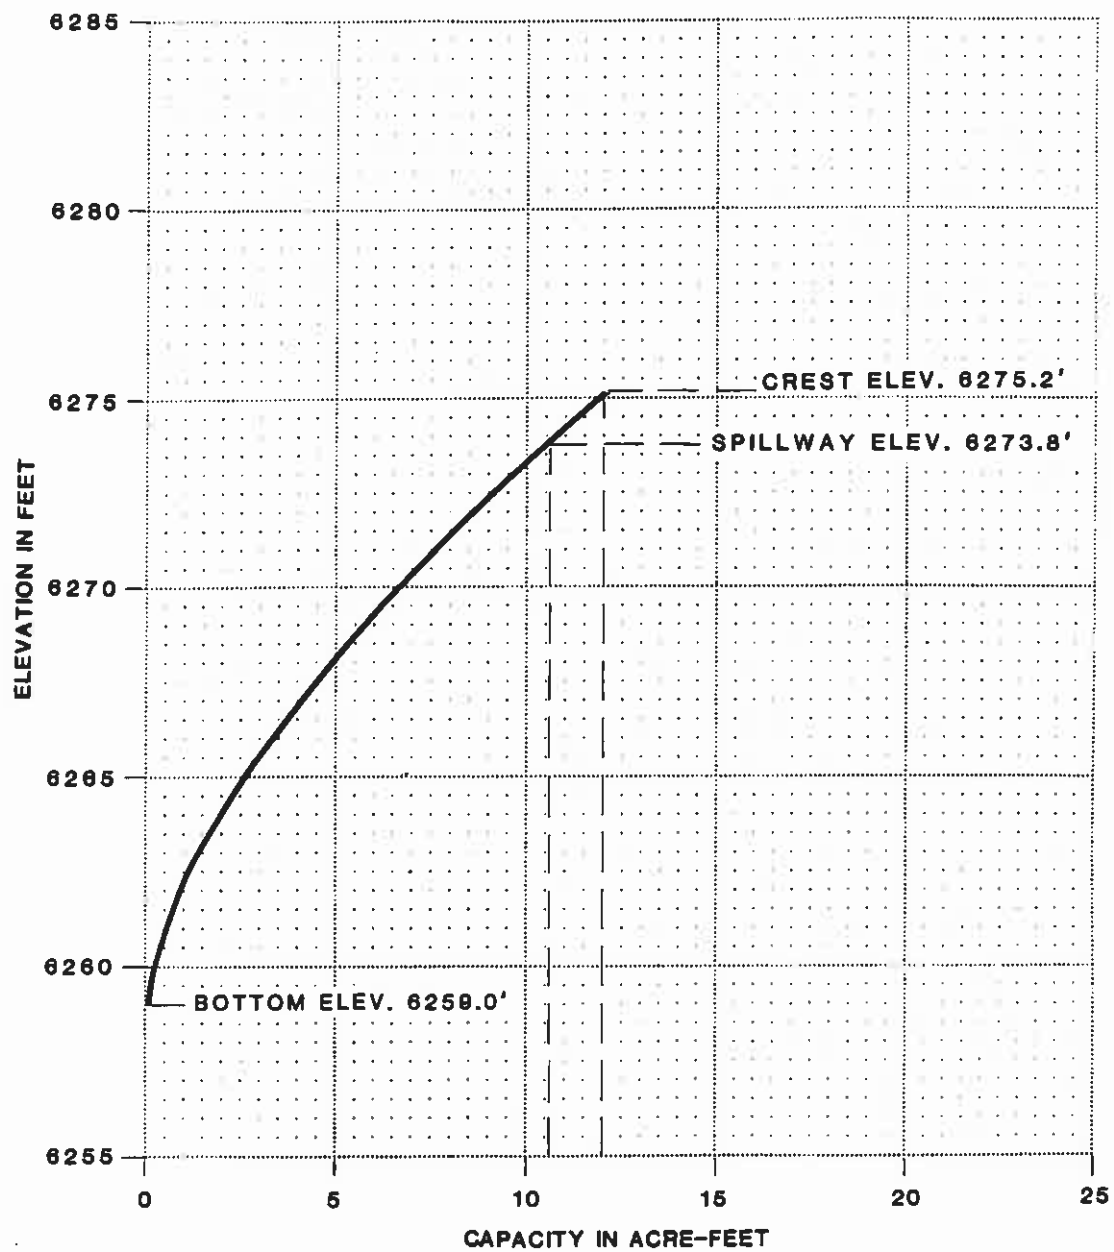
VOLUME-ELEVATION
CURVE
WW-9C

The impoundment volume-elevation curve is based on site specific surveys conducted for Peabody Coal Company's August 1984 inspection, and 1985 resurveys, where available. Additionally, the most current topographic maps available were used in developing Plate 3, Volume-Elevation Curve, WW-9C.

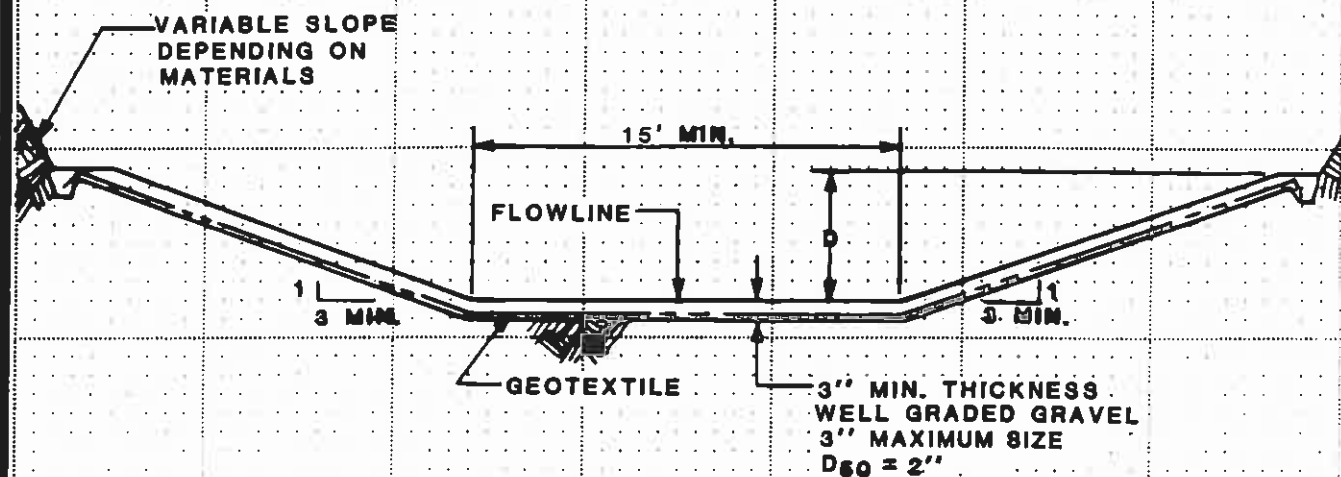
**SPILLWAY AND
 OUTFLOW CHANNEL
 CROSS SECTION
 WW-9C**

Rock provides no erosion protection within the channel.

The structure presently has no outflow channel.
