## APPENDIX H

### PHOTOGRAPHS OF TEST PITS

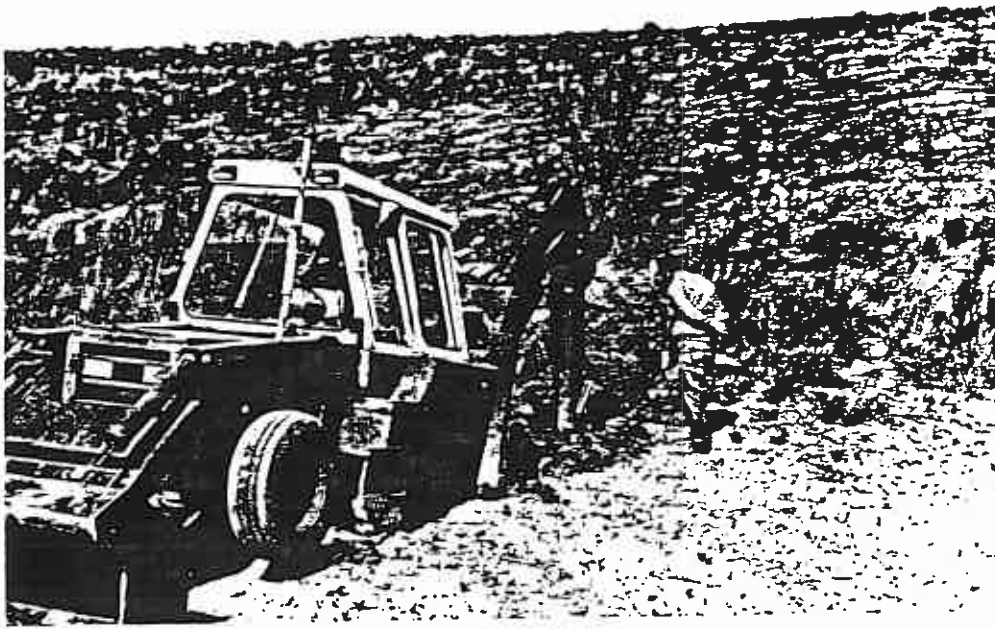
B-1 Backhoe Excavating Test Pit TP-1 in J-3 area.

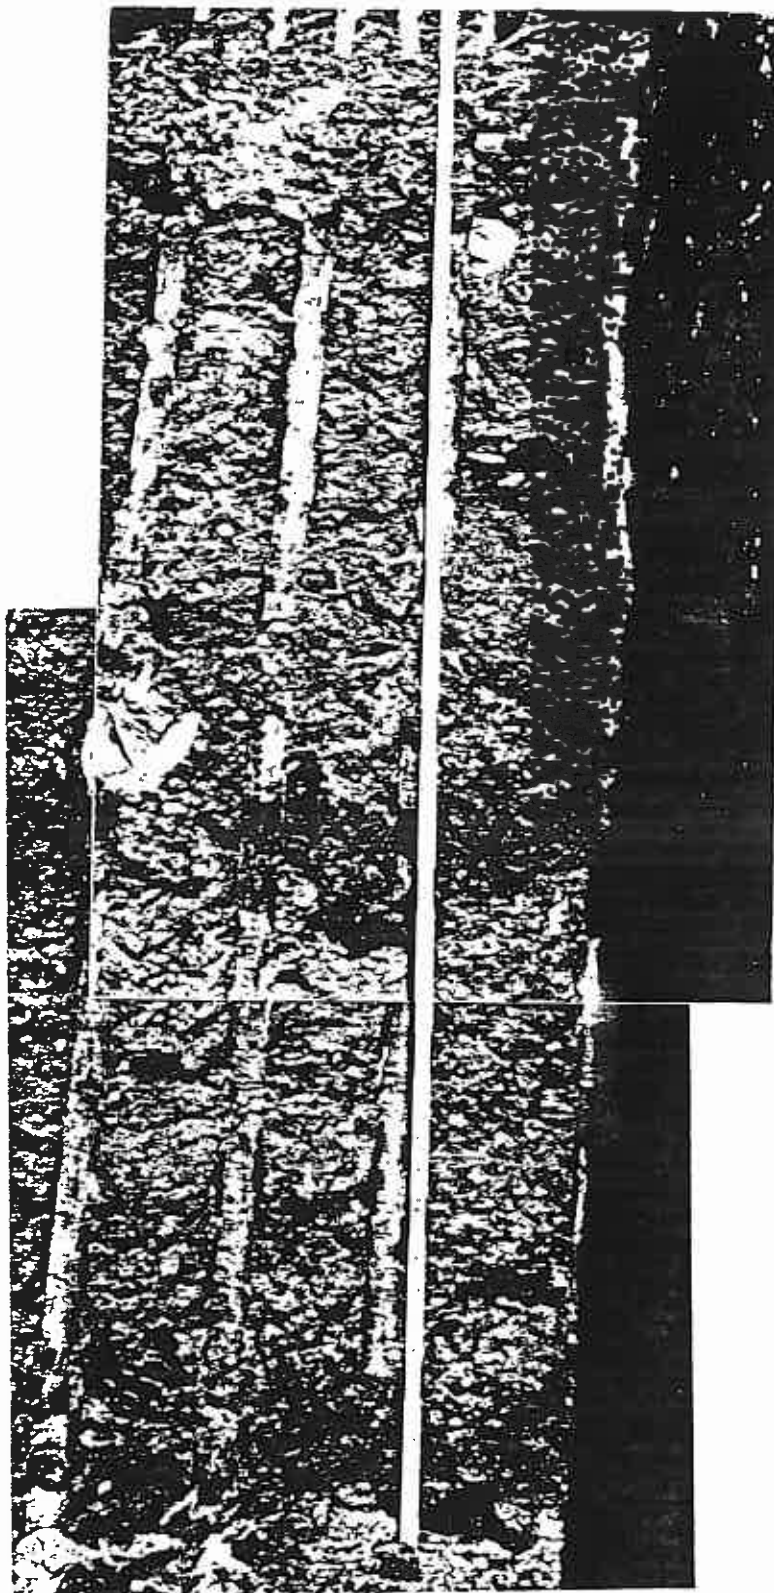
B-3 Mosaic showing West side of Test Pit TP-1.

The clayey nature of the fines can be seen by the shiny surfaces of the tooth marks from the backhoe. Some oversized material up to approximately 12 inches in size can be seen at the bottom of the figure.

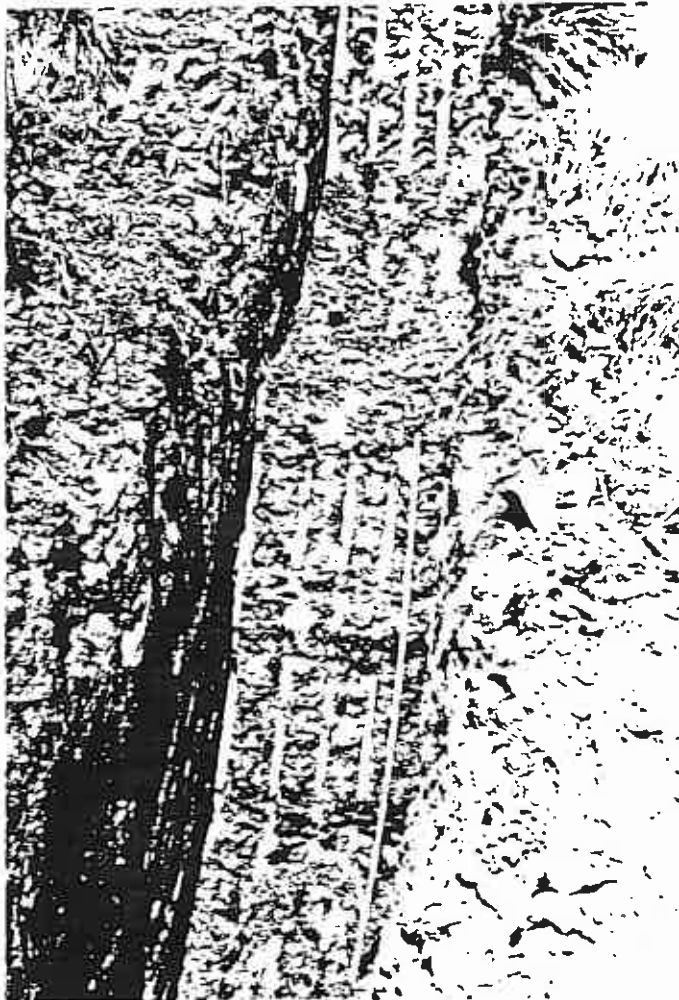
B-4 General View of Test Pit TP-1 facing West.

The nature of the oversize material can be observed in the excavated material on the sides of the pit.

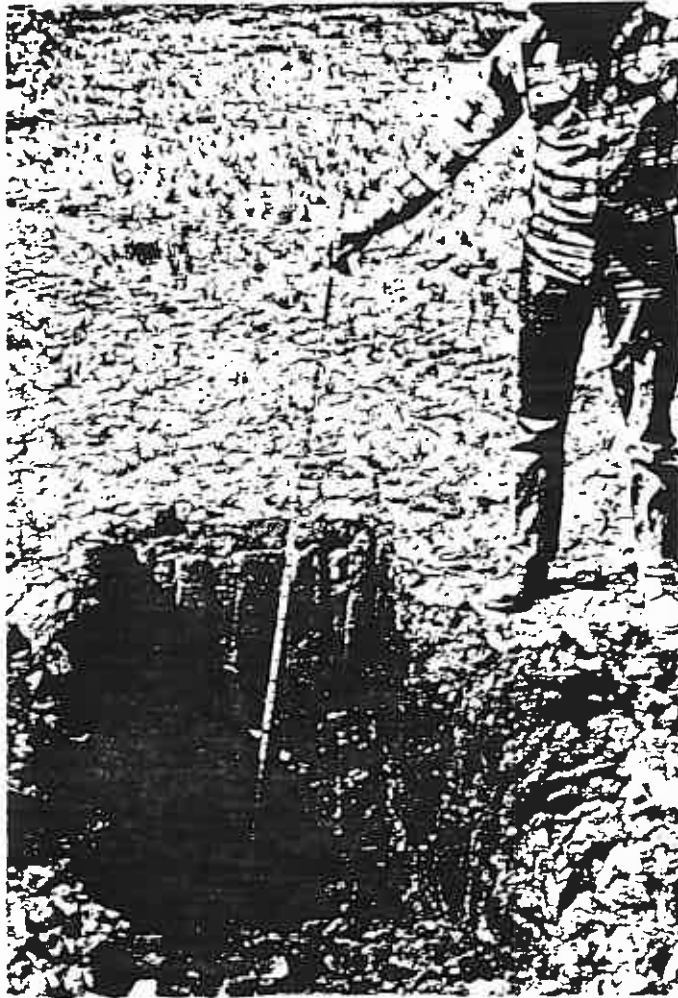
B-5 Small Excavation made at Botton of Pond.

This pit was dug at the bottom of the pond in the J-3 area. Silt can be seen extending to a depth of 12-18 inches. This test pit was not numbered or logged.

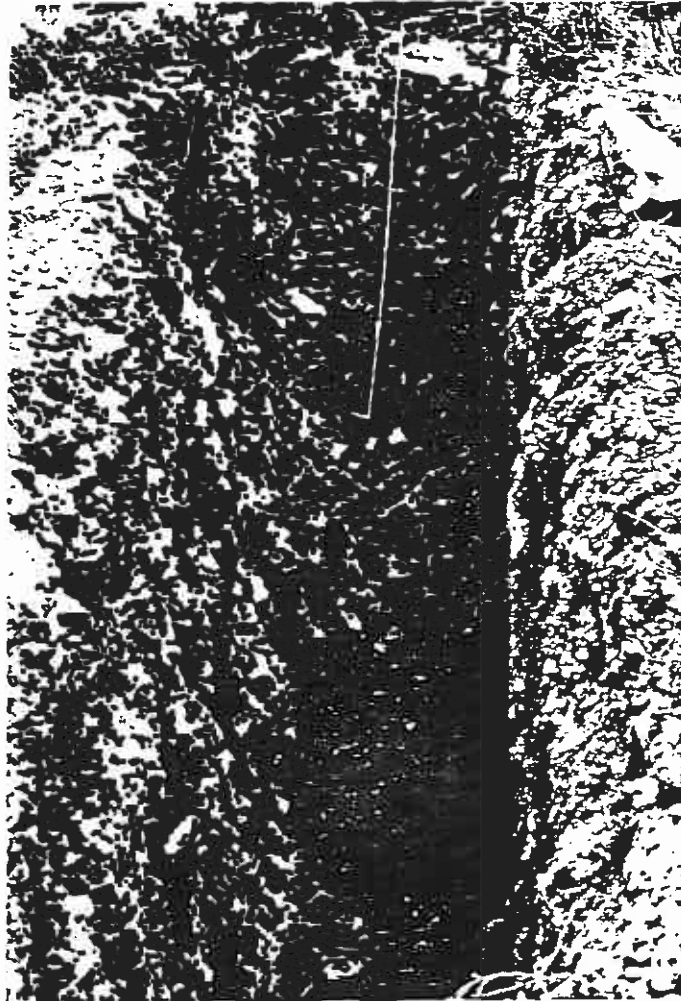
B-6 Test Pit TP-2 looking East.

The material in this test pit was very sandy and silty in nature. The spoil was not carbonaceous and little or no coal was observed. Oversize material up to 2-3 feet can be seen in the figure. A layer of black material near the top of the north face of the Test Pit can be seen.

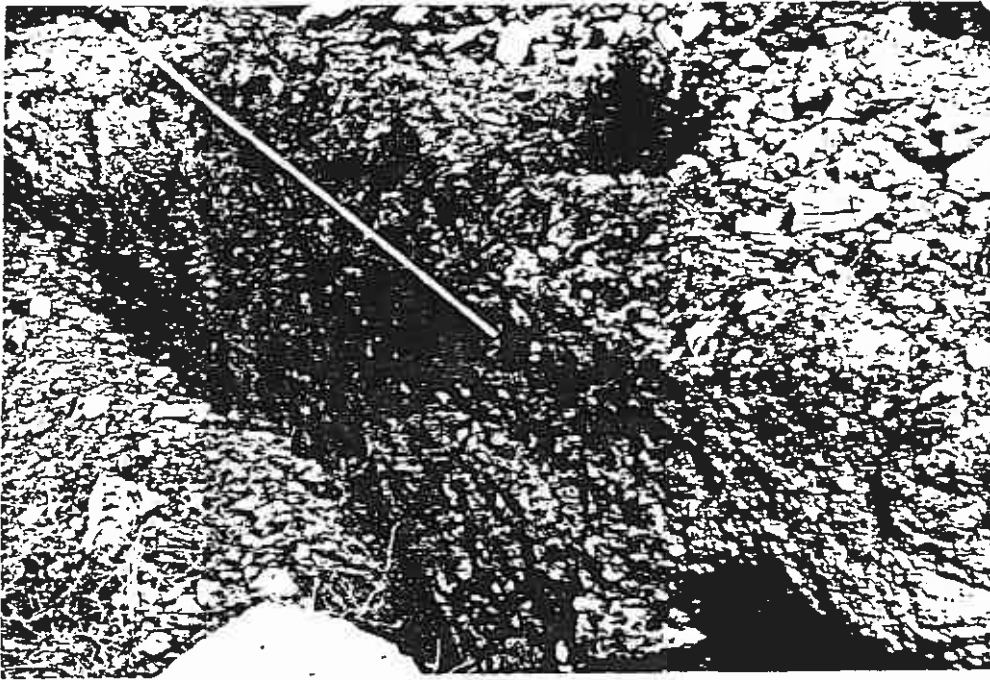
B-7 North Face of Test Pit TP-2

The ruler is pointing to the black layer observed near the top of Test Pit TP-2 as noted in Figure B-6.

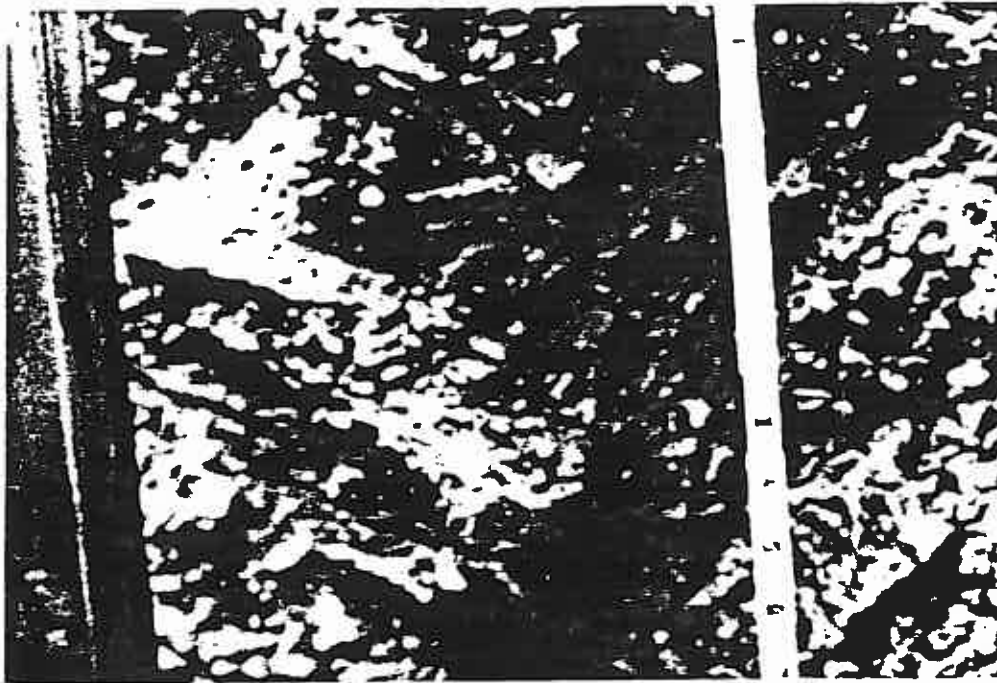
B-8 South Wall Test Pit

The silty and sandy nature of the fine material can be seen in this photograph. A relatively large amount of oversize material is also present.

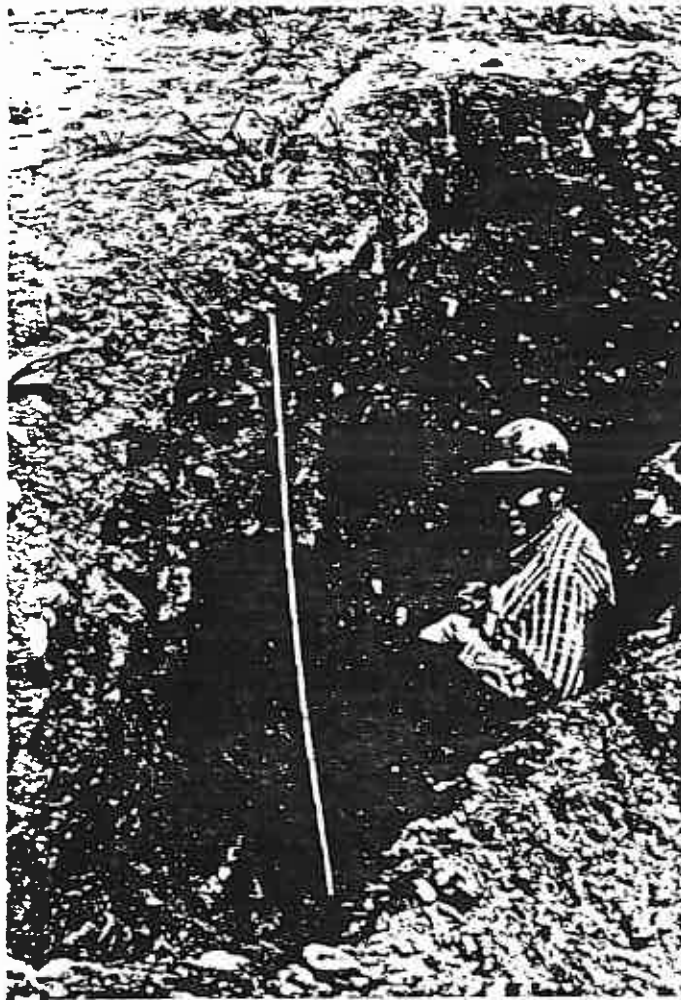
B-10 Test Pit TP-3 looking towards the Northeast

This Test Pit is located in the J-1/N-6 area. The spoils in this area were very carbonaceous and contained many pieces of coal. Approximately 1 foot of topsoil was present over the entire area. A considerable amount of oversize material is present in this spoil.

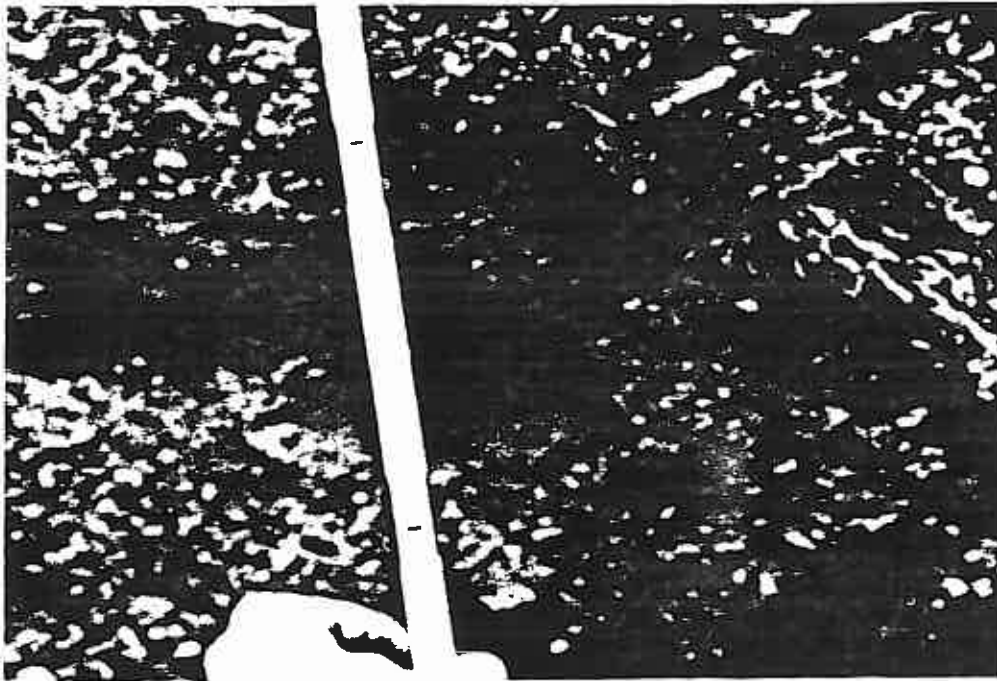
B-11 South Face of Test Pit TP-3

The lighter color is due to top soil falling in. The fine material was clayey in nature.

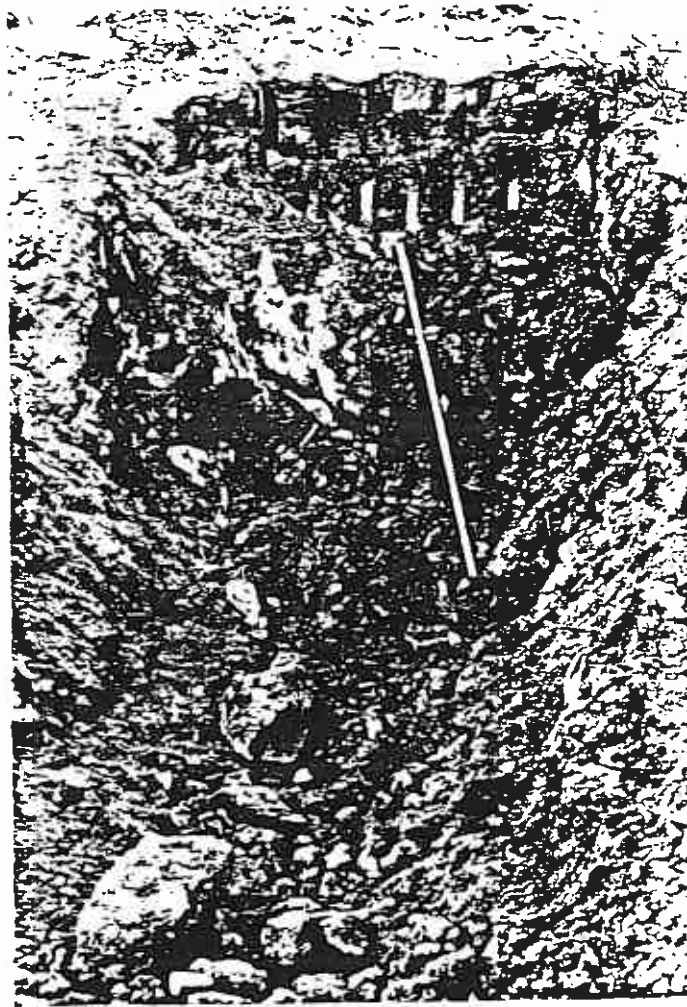
B-12 Aborted Test Pit

This excavation was made in the general area of Test Pit TP-4. However, due to the presence of large rocks the backhoe could not excavate. The pit was therefore abandoned.

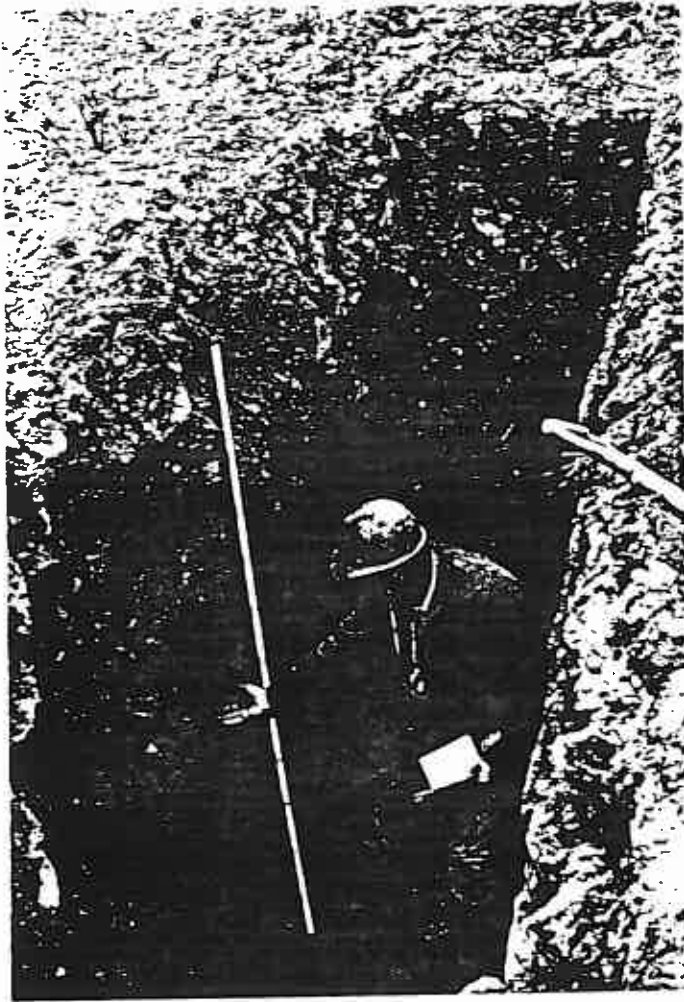
B-13 Test Pit TP-4 Facing Southeast.

The material in Test Pit TP-4 was similar to that observed in TP-3. A considerable amount of oversize material with rocks up to 3 or 4 feet in size were observed.

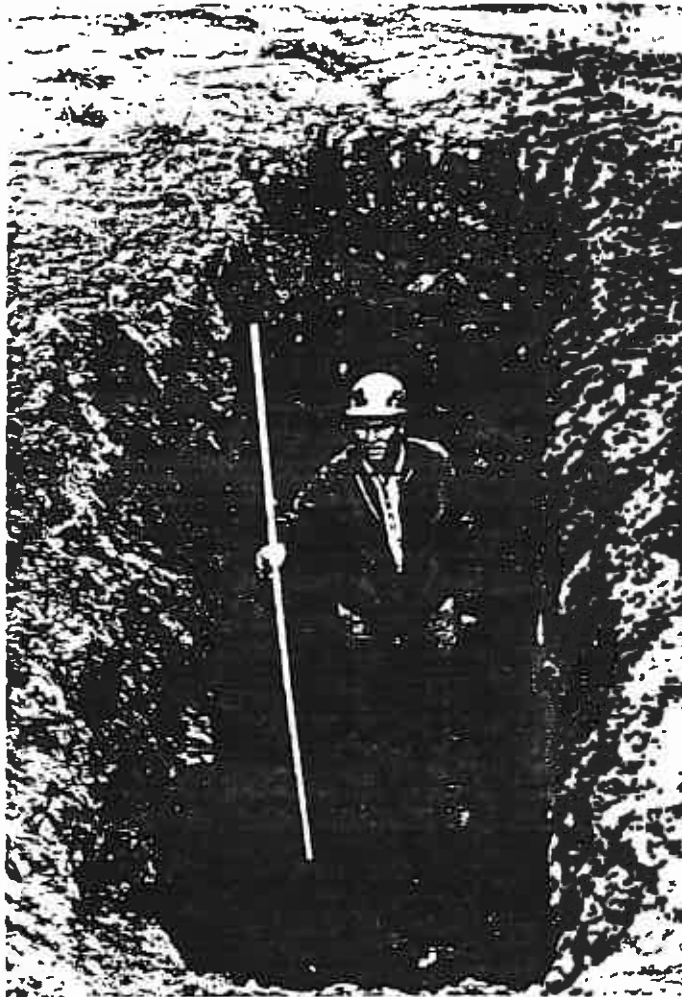
B-15 Test Pit TP-5 looking Northeast.

This Test Pit was located near the bottom of the slope. The spoil material was similar to that shown in Test Pits TP-3 and TP-4.

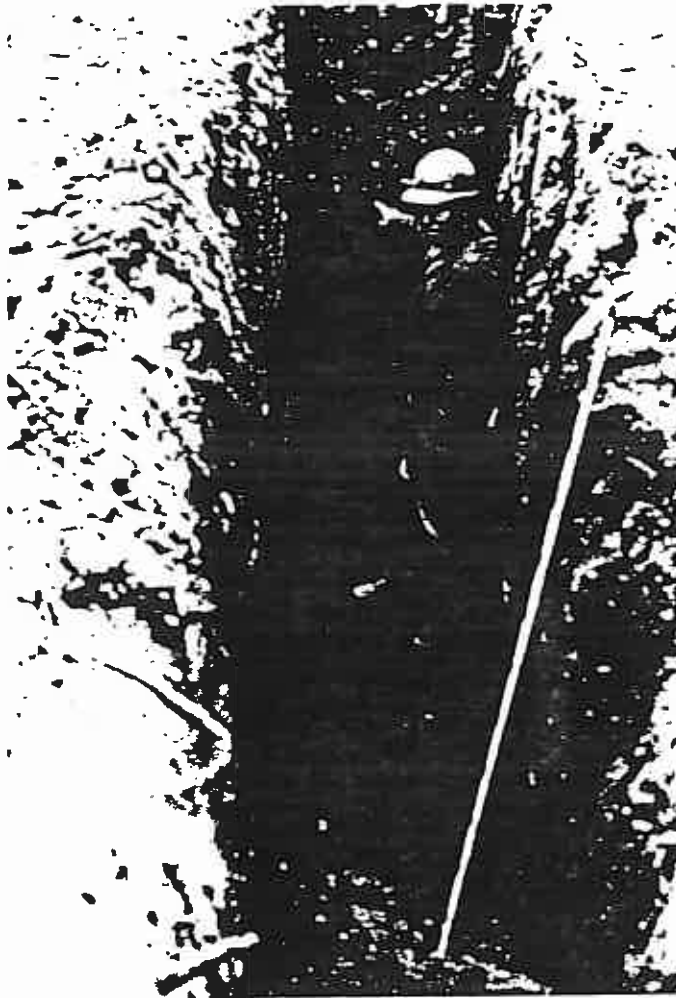
B-16 Test Pit TP-6 looking West.

This Test Pit was excavated near the bottom of the slope. The spoil material was similar to that shown in Test Pits TP-3 and TP-4.

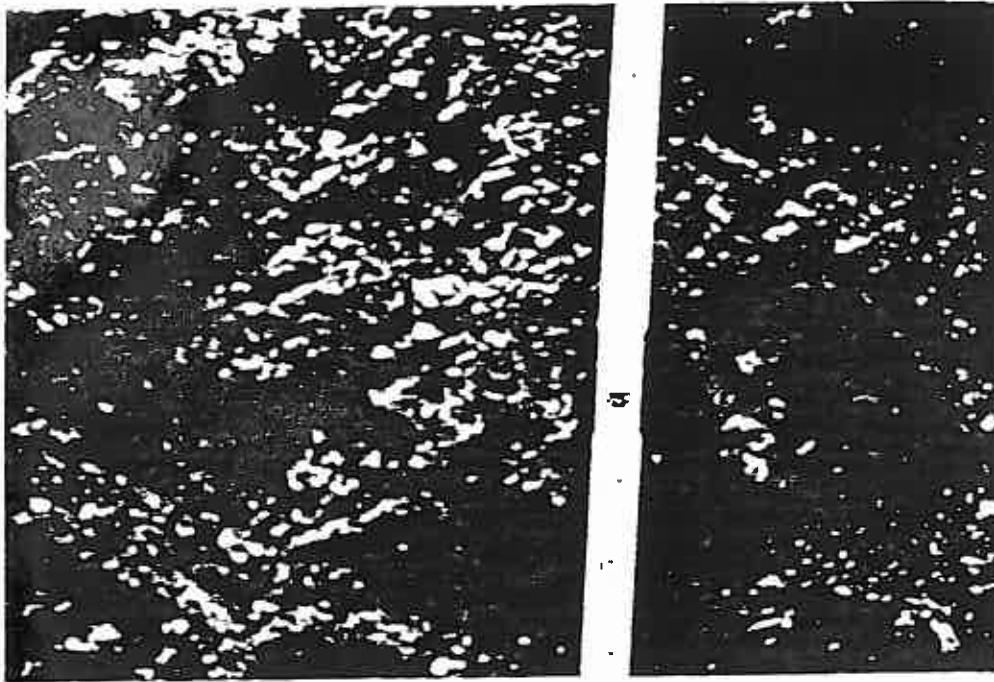
B-17 South Face of Test Pit TP-6

The generally finer nature of the spoil in this Test Pit can be seen.

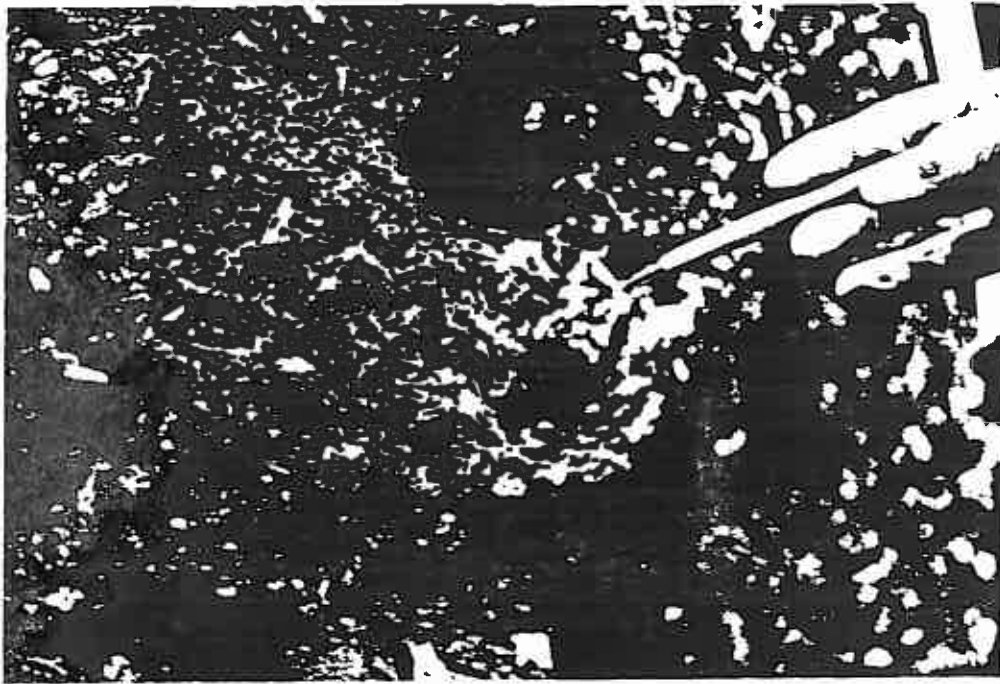
B-19 North Face of Test Pit TP-6.

The pencil is pointing to a piece of coal in the side of the Test Pit.

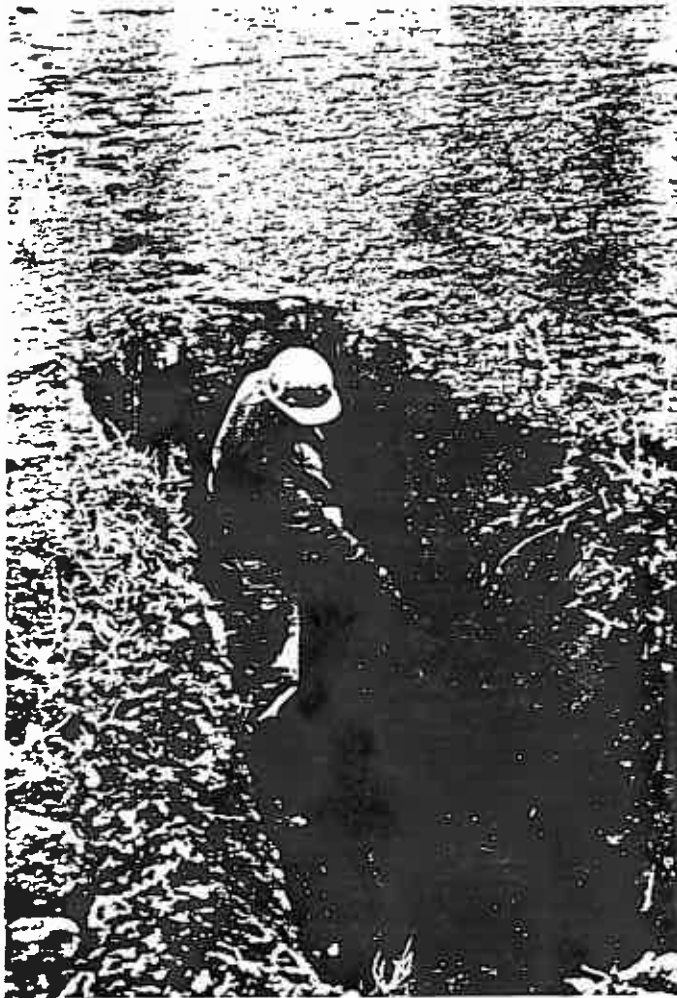
B-20 Test Pit TP-7 facing Southeasterly.

This was a small Test Pit located in the bottom of the pond area in J-1/N-6. The spoil material was similar to that in all of the Test Pits. Sediment was accumulated by runoff from slopes.
