INSPECTION REPORT
Sedimentation Structure
J3-A
Black Mesa Mine
Navajo County, Arizona
for
PEABODY COAL COMPANY

Dames & Moore
10139-011-22

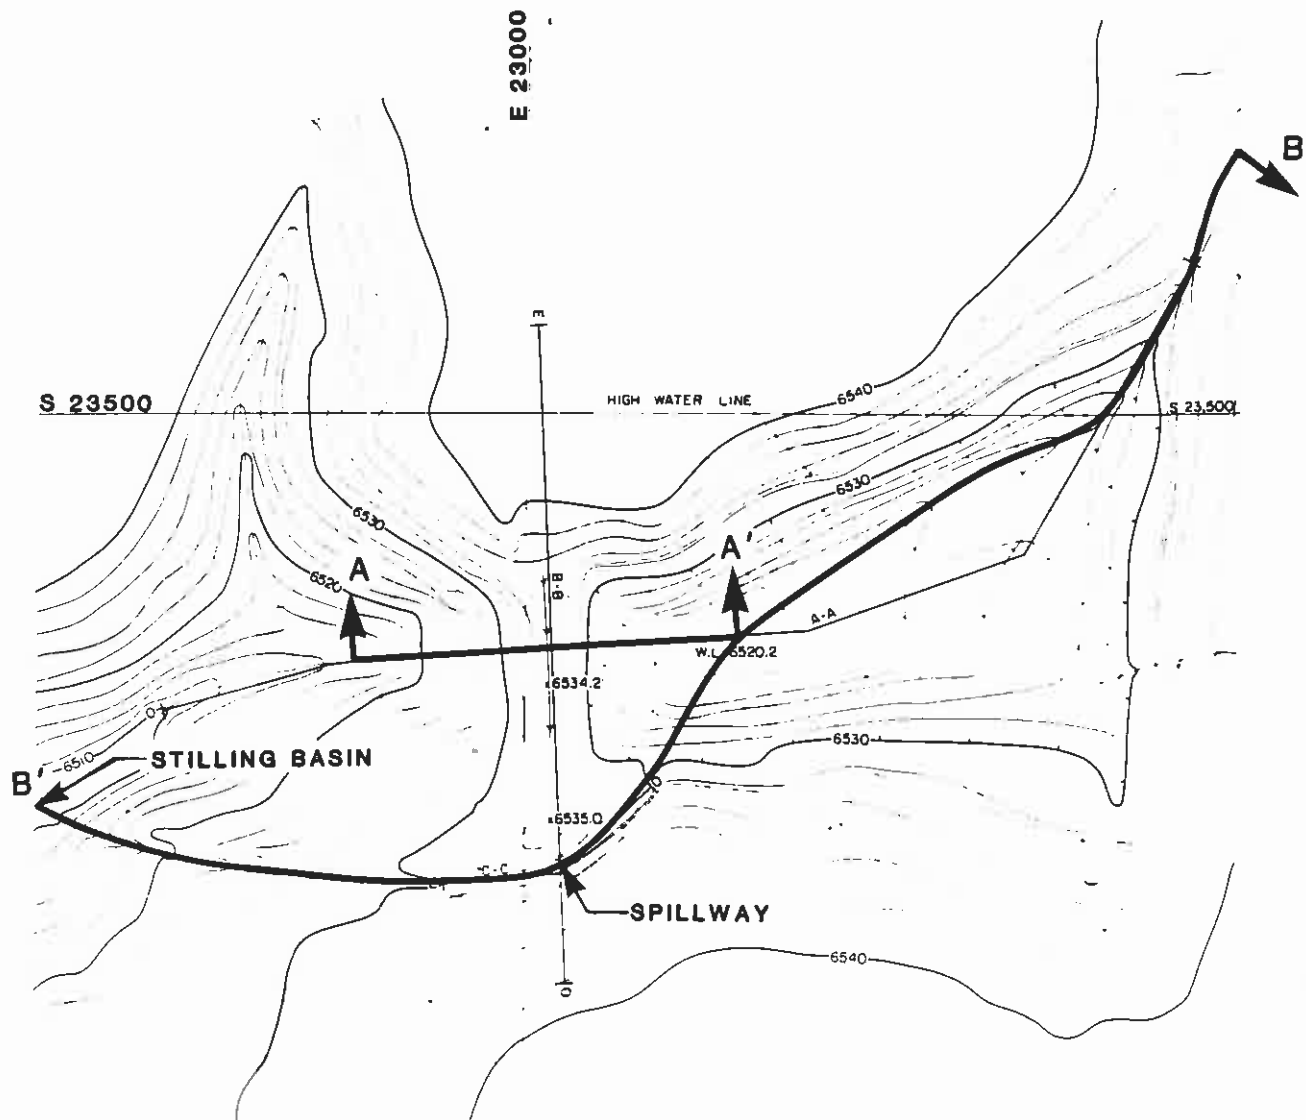
SITE PLAN J3-A

Sedimentation Structure J3-A is an earthen embankment, designed and constructed in 1979 by Peabody Coal Company as a temporary sedimentation structure to control runoff and sediment from the disturbed mining areas of the Black Mesa Mine. The location of Structure J3-A is shown on Plate 1, Site Plan.
