INSPECTION REPORT
Sedimentation Structure
J3-D
Black Mesa Mine
Navajo County, Arizona
for
PEABODY COAL COMPANY

Dames & Moore
10139-011-22

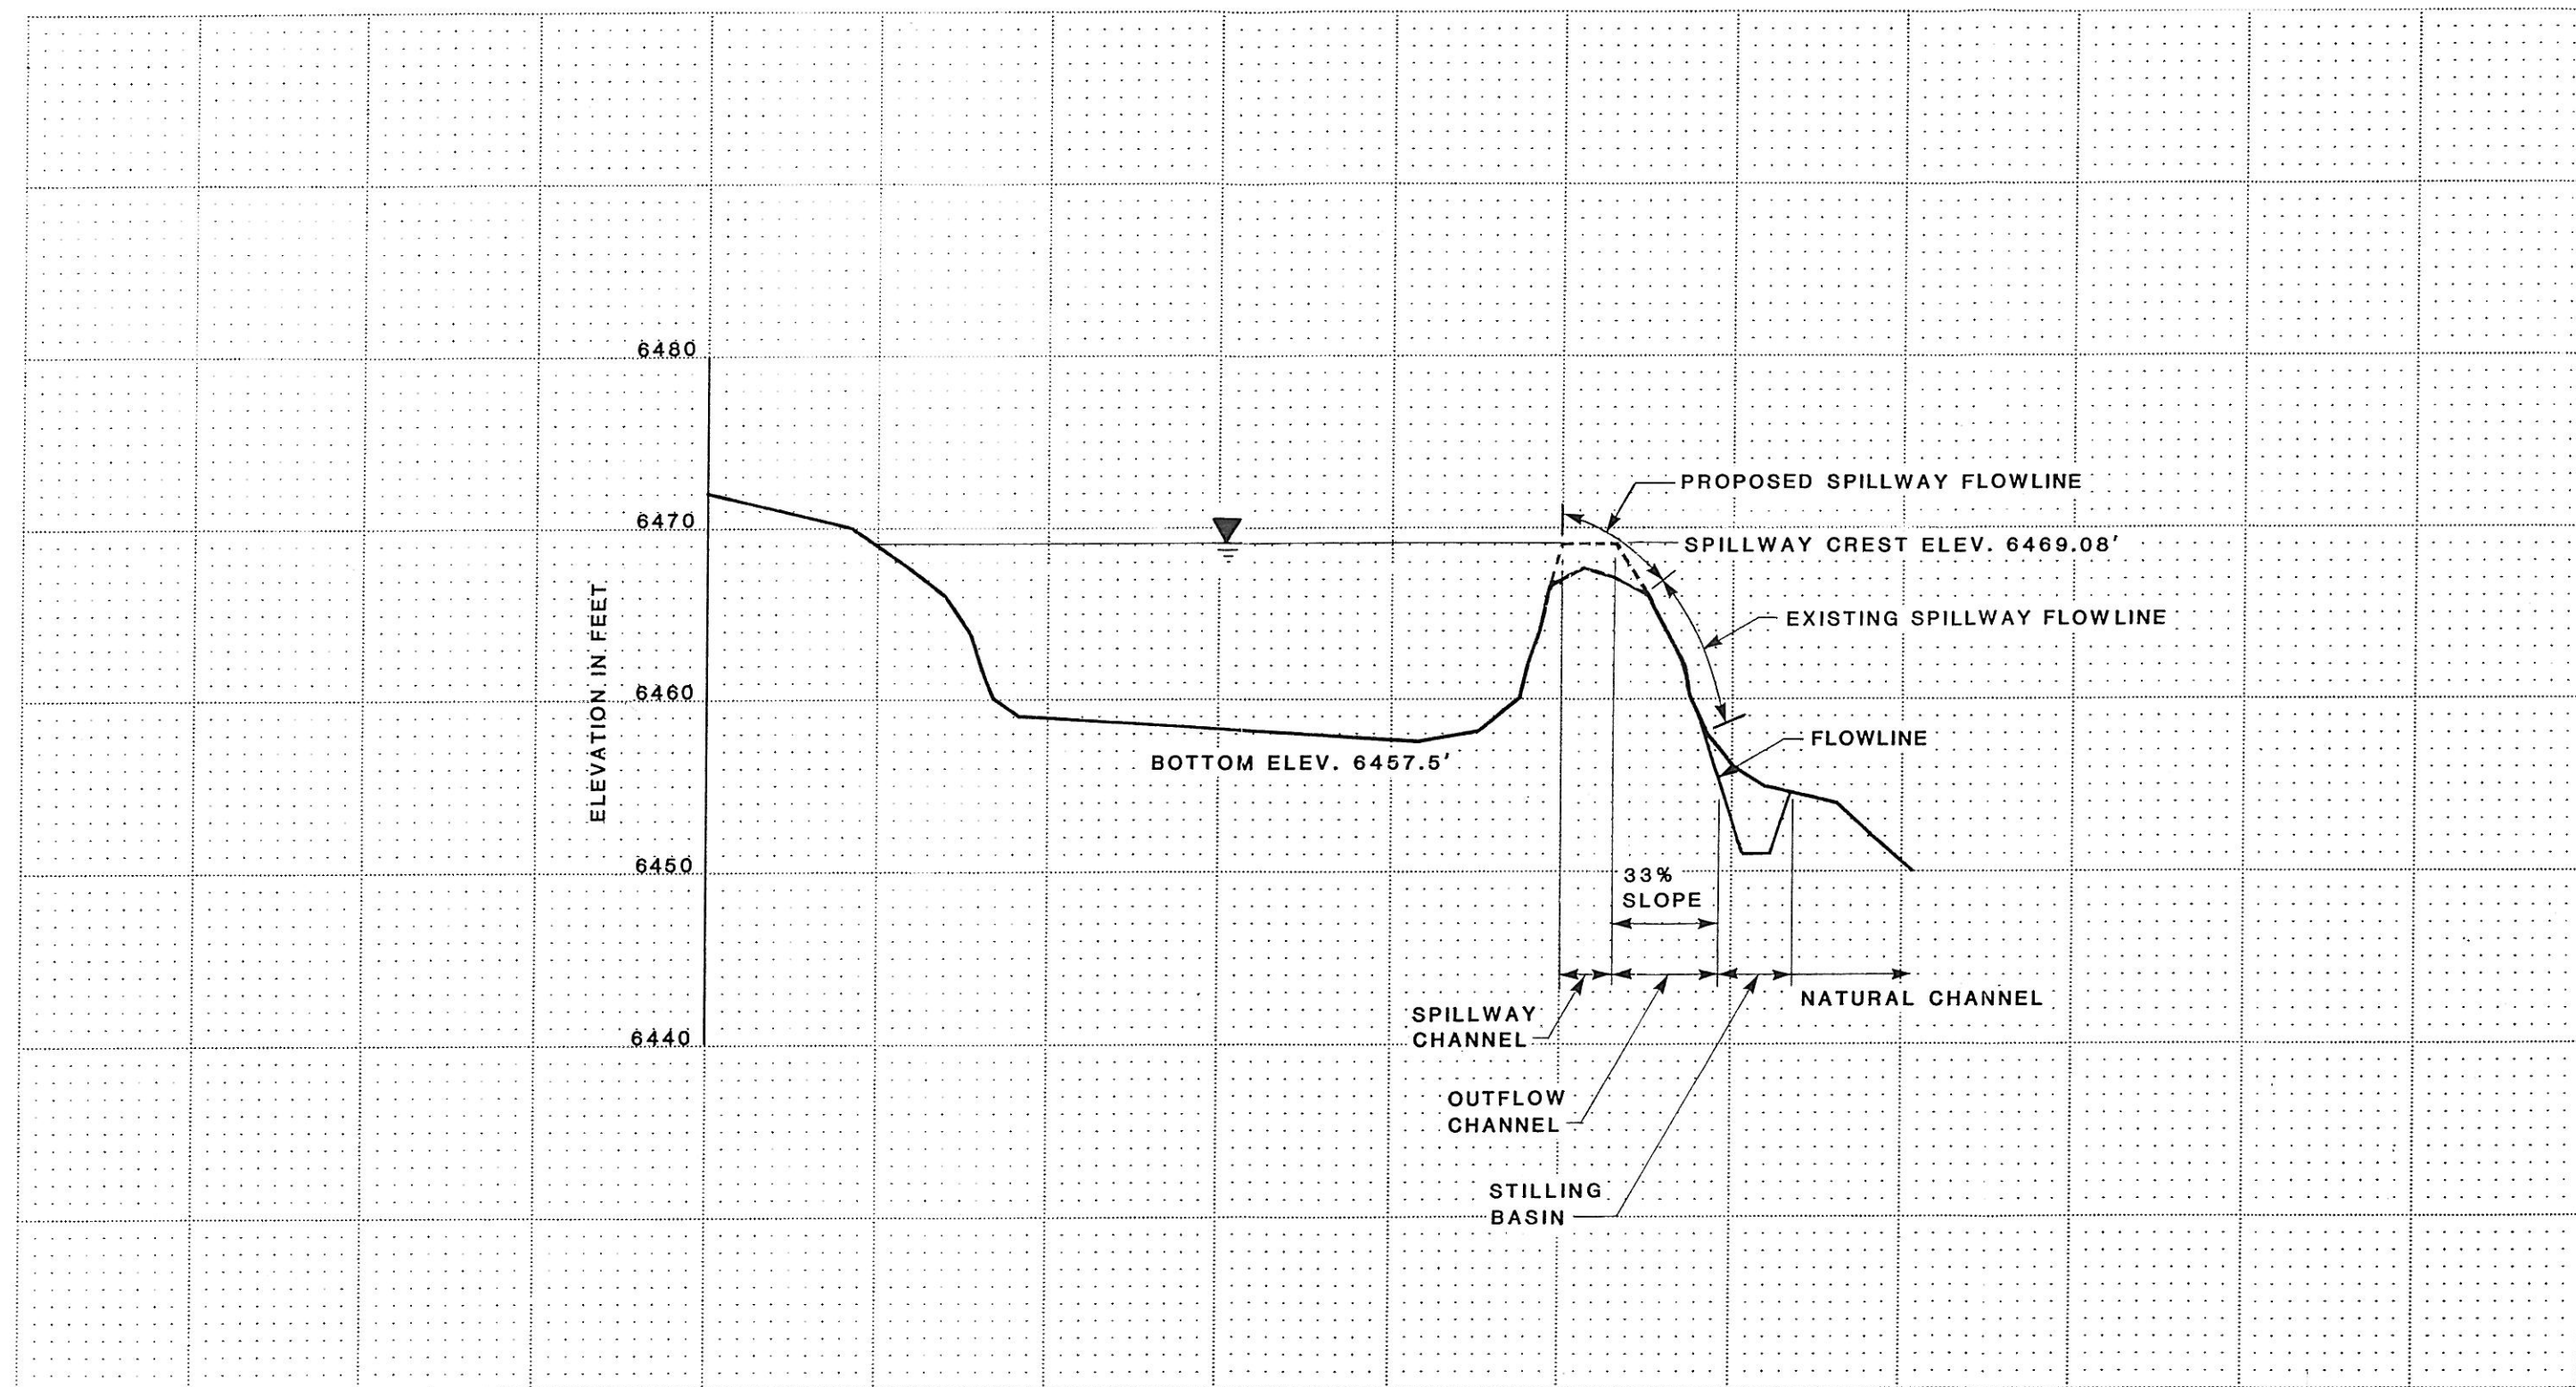
CHANNEL PROFILE B-B'
J3-D

Half the channel has rock providing some erosion protection within the channel, however the protection is inadequate based on the calculated velocities in the channel.

Rock provides some erosion protection within the channel, however the protection is inadequate based on the calculated velocities in the channel.
