INSPECTION REPORT  
Sedimentation Structure  
J3-E  
Black Mesa Mine  
Navajo County, Arizona  
for  
PEABODY COAL COMPANY

Dames & Moore  
10139-011-22

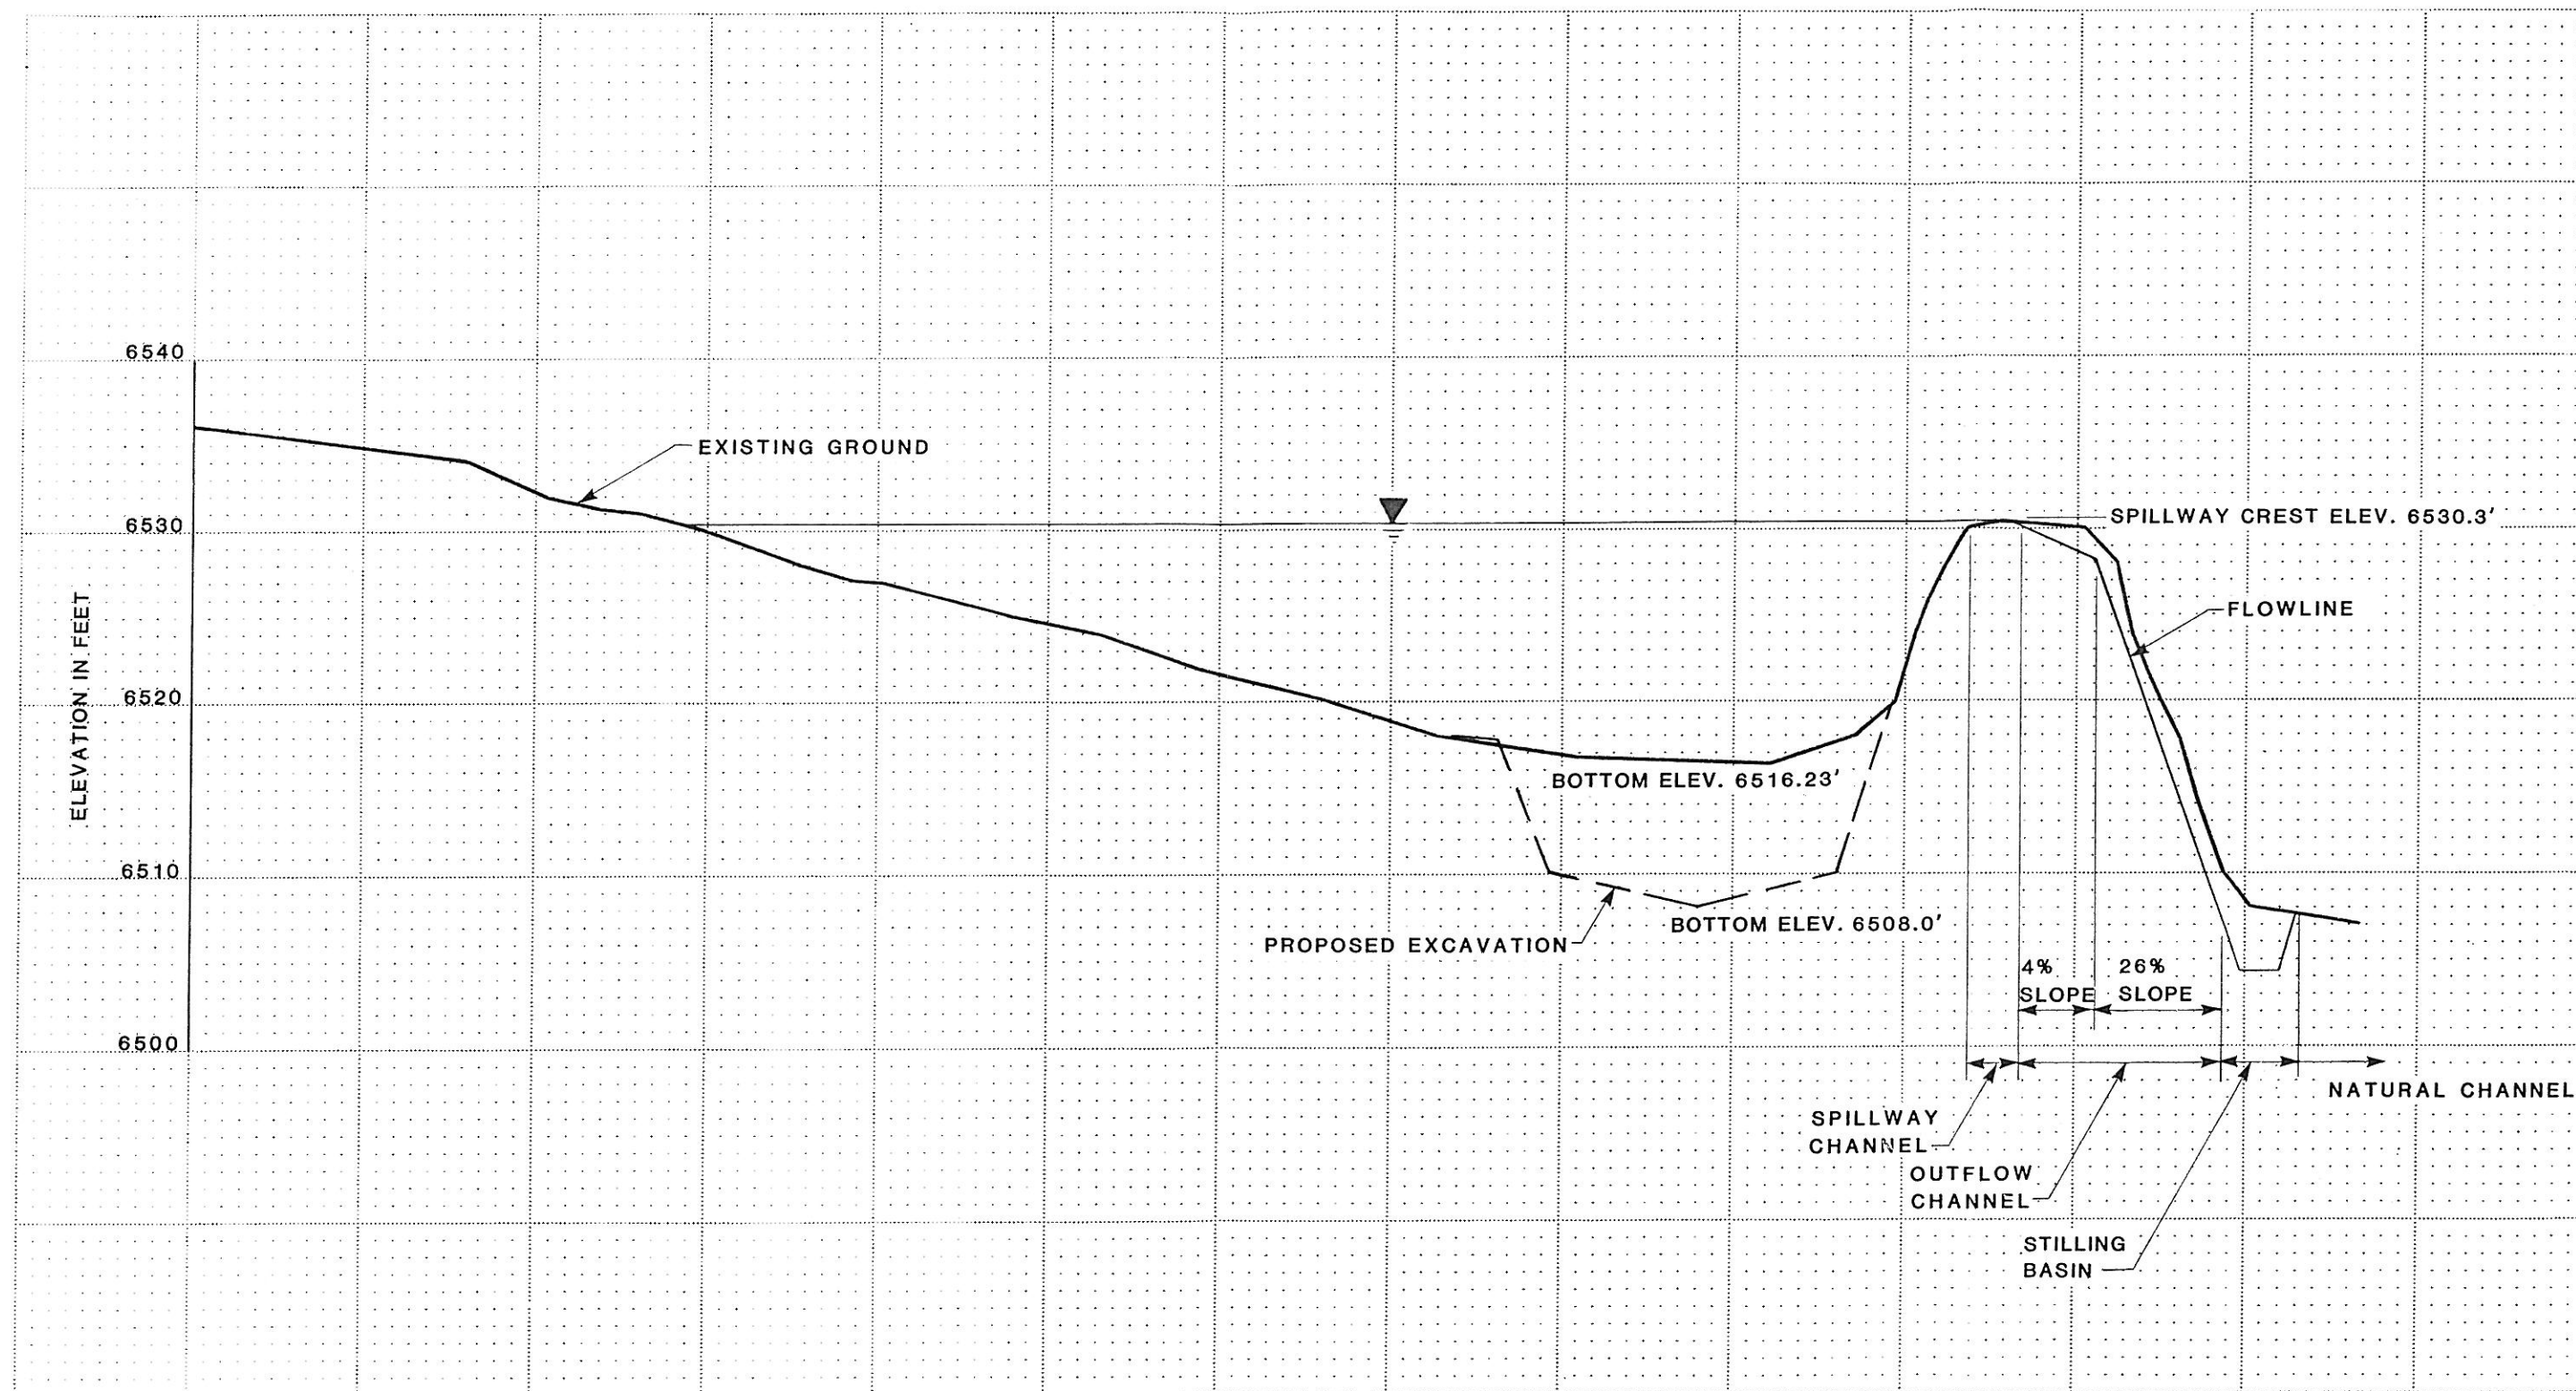
## VOLUME-ELEVATION CURVE J3-E

The spillway capacity of Structure J3-E is adequate but the storage capacity is inadequate. The structure does not have an adequate outflow channel. The storage capacity should be increased to 18.8 acre-feet by excavating the pond as shown on Plates 1 and 5. A trapezoidal outflow channel and a stilling basin should be constructed along the alignment shown in Plate 1. The channel and stilling basin profile is shown in Plate 4 and the required dimensions are shown in Plate 5 and Plate 6. The spillway, outflow channel and stilling basin should be protected against erosion using geotextile and riprap as shown in Plate 5.

Enlarging the storage capacity to 18.8 acre-feet gives additional sediment storage. The analysis of these conditions is summarized in the following table.
