INSPECTION REPORT
Sedimentation Structure
J16-D
Kayenta Mine
Navajo County, Arizona
for
PEABODY COAL COMPANY

Dames & Moore
10139-011-22

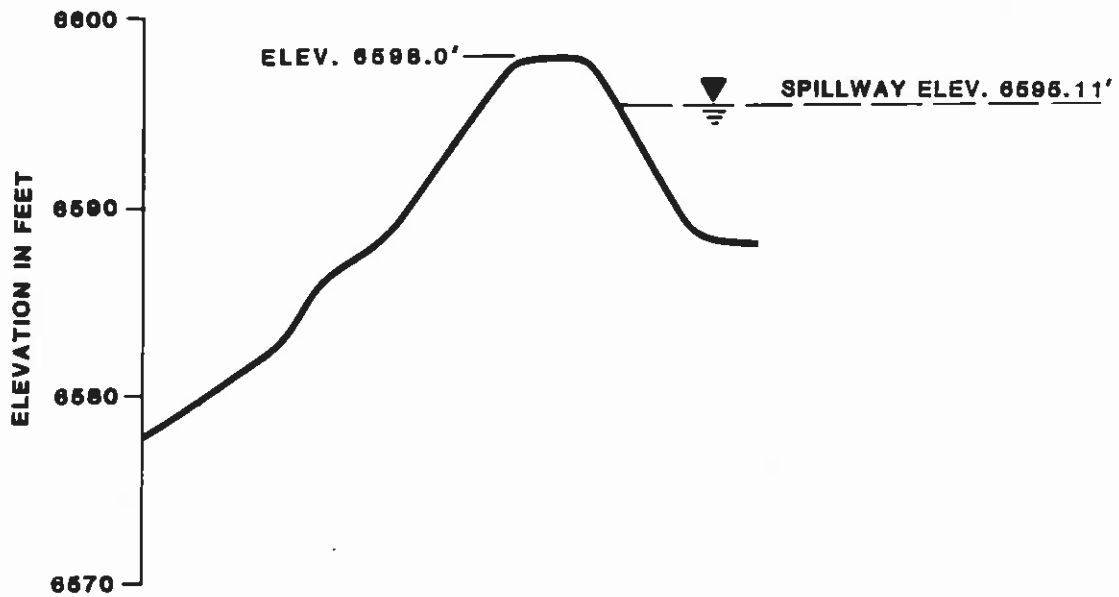
Plate 1

Sedimentation Structure J16-D is an earthen embankment, designed and constructed in 1982 by Peabody Coal Company as a temporary sedimentation structure to control runoff and sediment from the disturbed mining areas of the Kayenta Mine. The location of Structure J16-D is shown on Plate 1, Site Plan.

The spillway capacity of Structure J16-D is adequate but the storage capacity is inadequate. The storage capacity should be increased to 7.24 acre-feet by excavating the pond as shown on Plates 1 and 4. The trapezoidal outflow channel should be extended 20 feet along the alignment shown in Plate 1. The channel profile is shown in Plate 4 and the required dimensions are shown in Plate 5. Both the spillway and outflow channel extension should be protected against erosion using geotextile and riprap as shown in Plate 5.
