INSPECTION REPORT
Sedimentation Structure
J16-E
Kayenta Mine
Navajo County, Arizona
for
PEABODY COAL COMPANY

Dames & Moore
10139-011-22

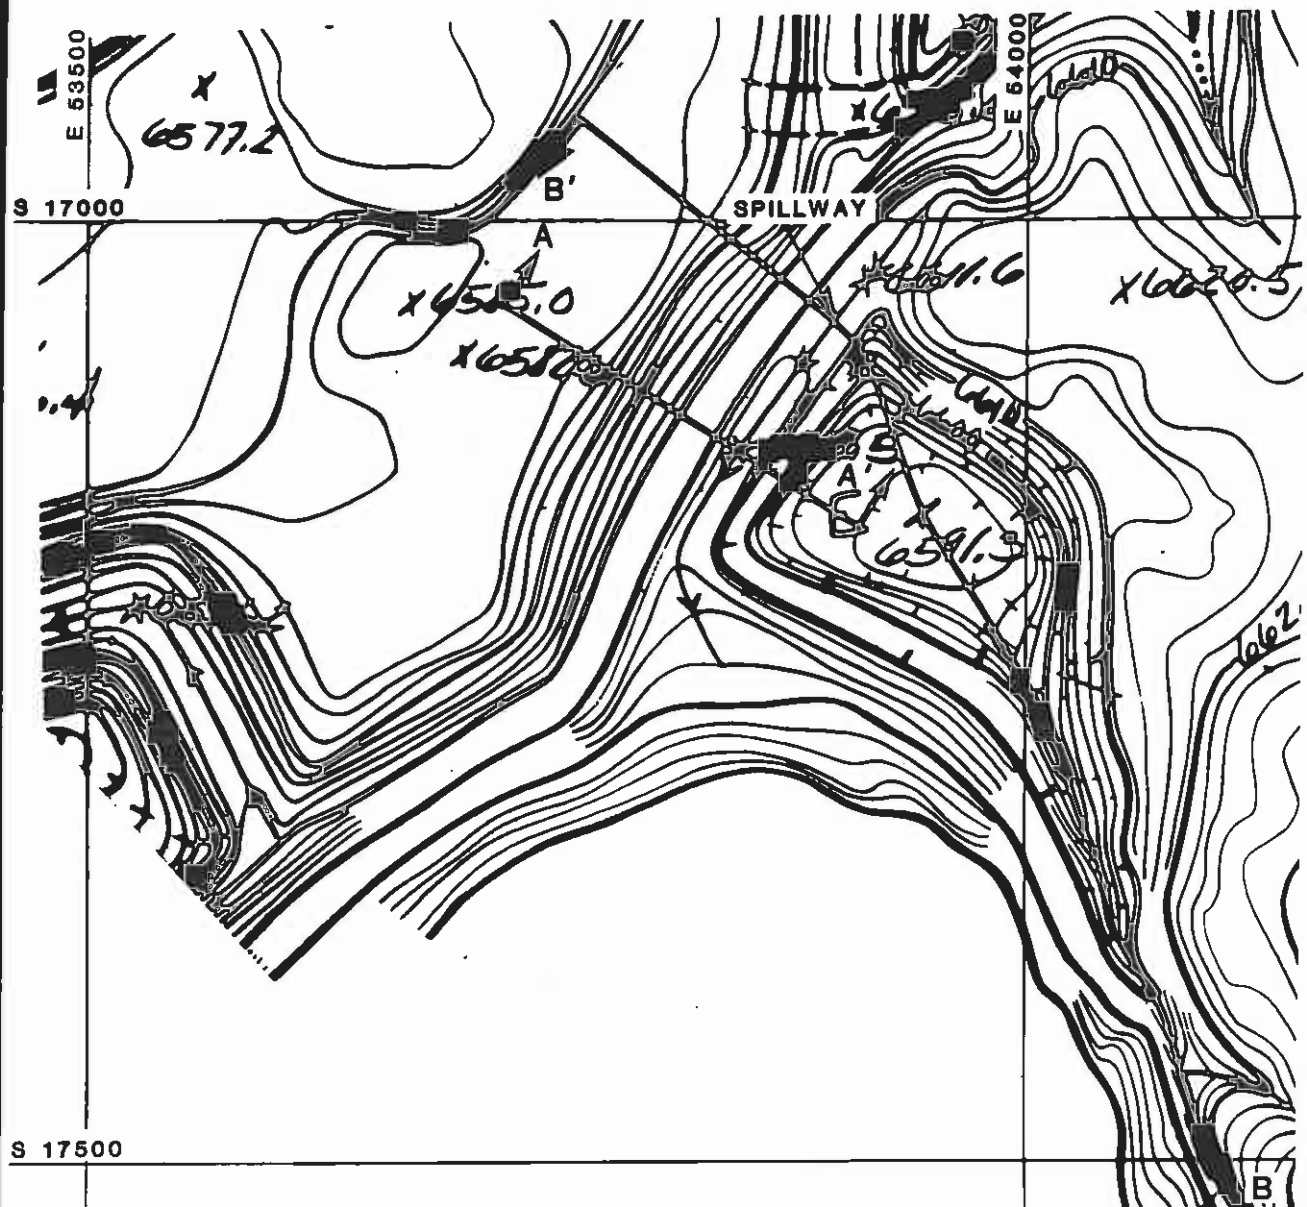
Plate 1

SITE PLAN J16-E

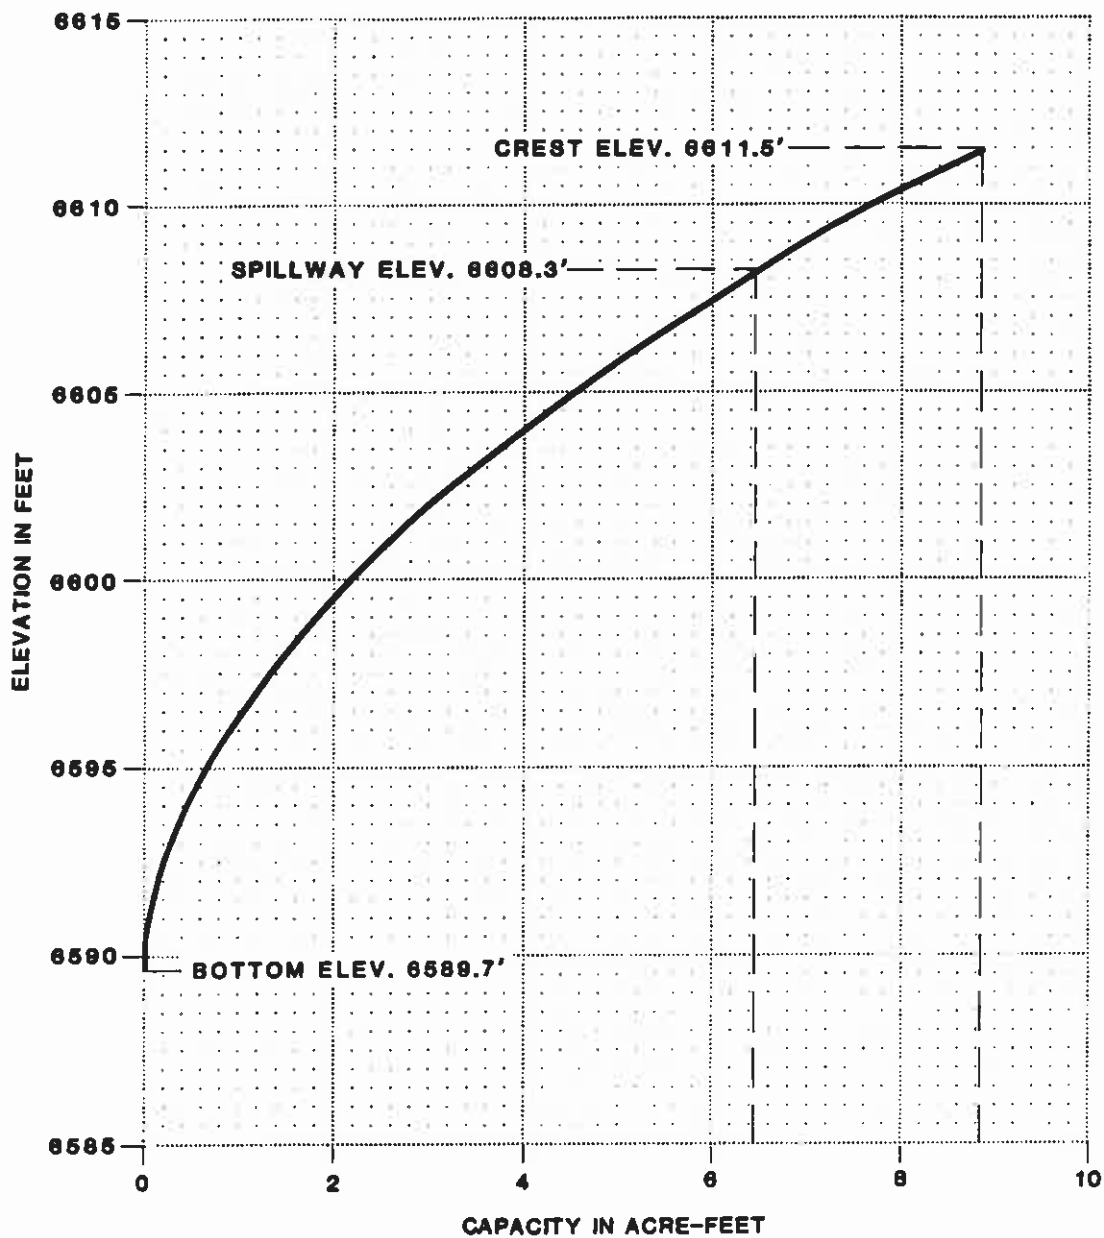
VOLUME-ELEVATION
CURVE
J16-E

The impoundment volume-elevation curve is based on site specific surveys conducted for Peabody Coal Company's August 1984 inspection, and 1985 resurveys, where available. Additionally, the most current topographic maps available were used in developing Plate 3, Volume-Elevation Curve, J16-E.
