INSPECTION REPORT
Sedimentation Structure
J16-F
Kayenta Mine
Navajo County, Arizona
for
PEABODY COAL COMPANY

Dames & Moore
10139-011-22

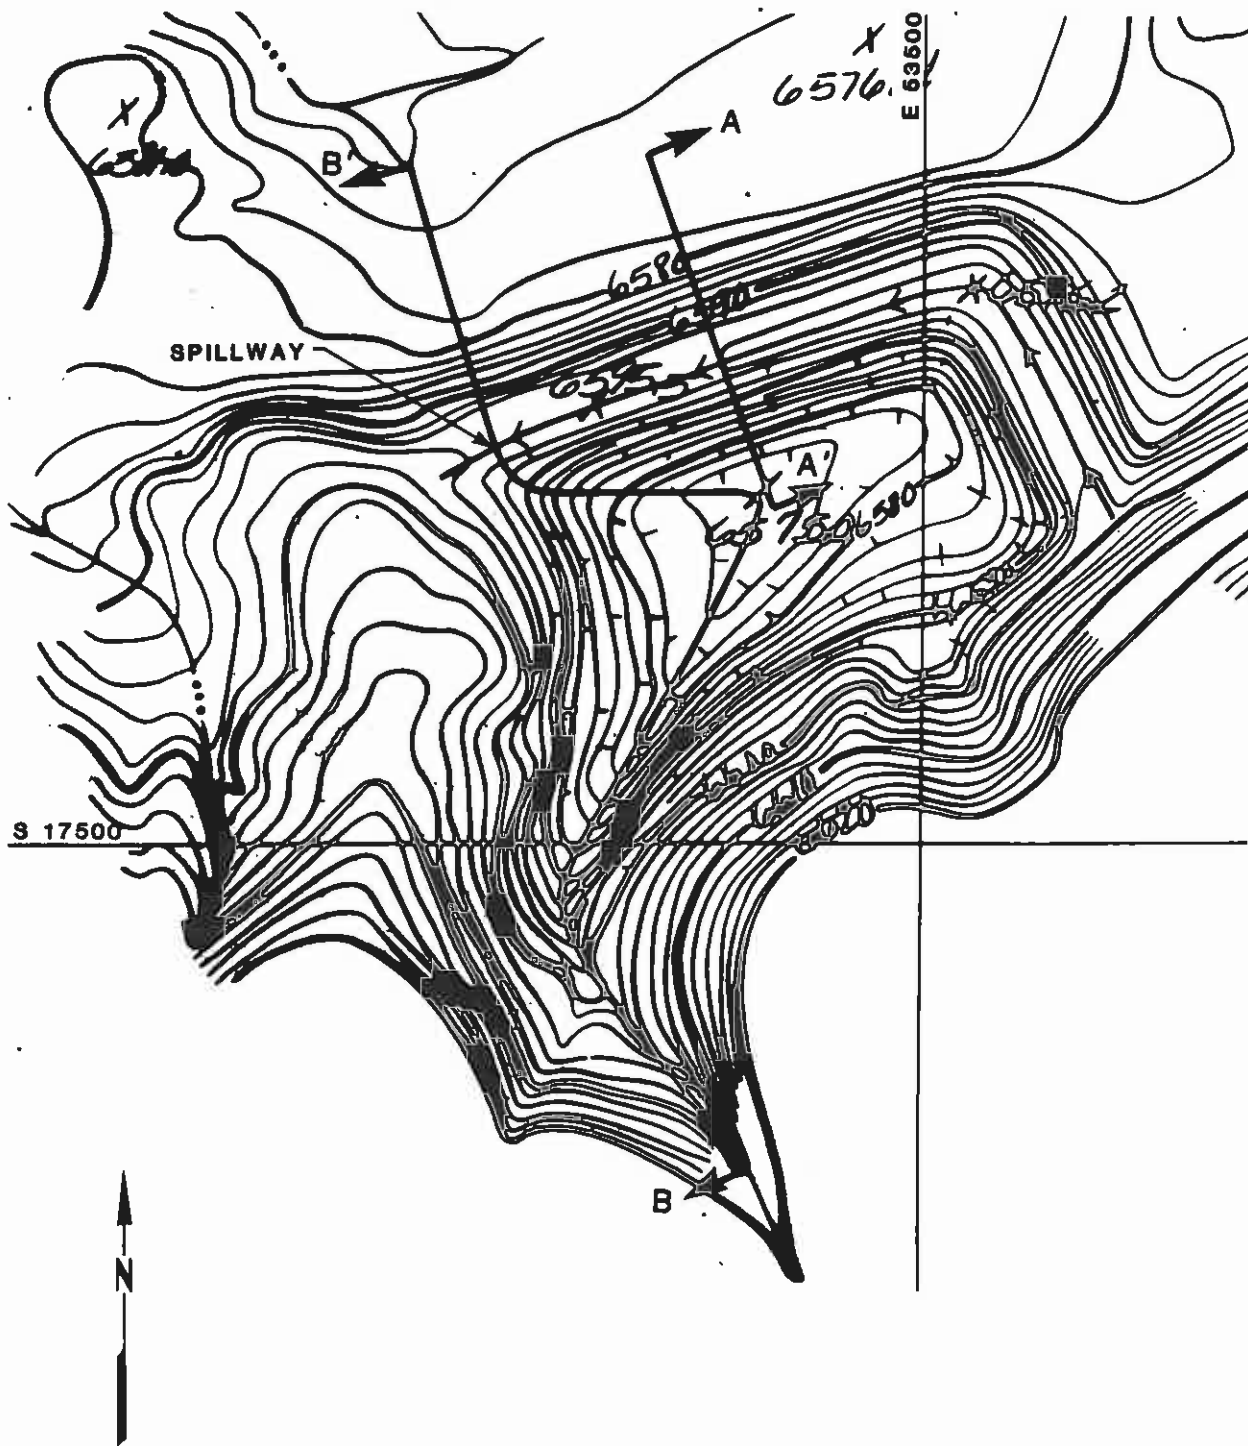
Plate 1

Sedimentation Structure J16-F is an earthen embankment, designed and constructed in 1982 by Peabody Coal Company as a temporary sedimentation structure to control runoff and sediment from the disturbed mining areas of the Kayenta Mine. The location of Structure J16-F is shown on Plate 1, Site Plan.

**SITE PLAN
J16-F**
