INSPECTION REPORT
Sedimentation Structure
J16-I
Kayenta Mine
Navajo County, Arizona

for
PEABODY COAL COMPANY

Dames & Moore
10139-011-22

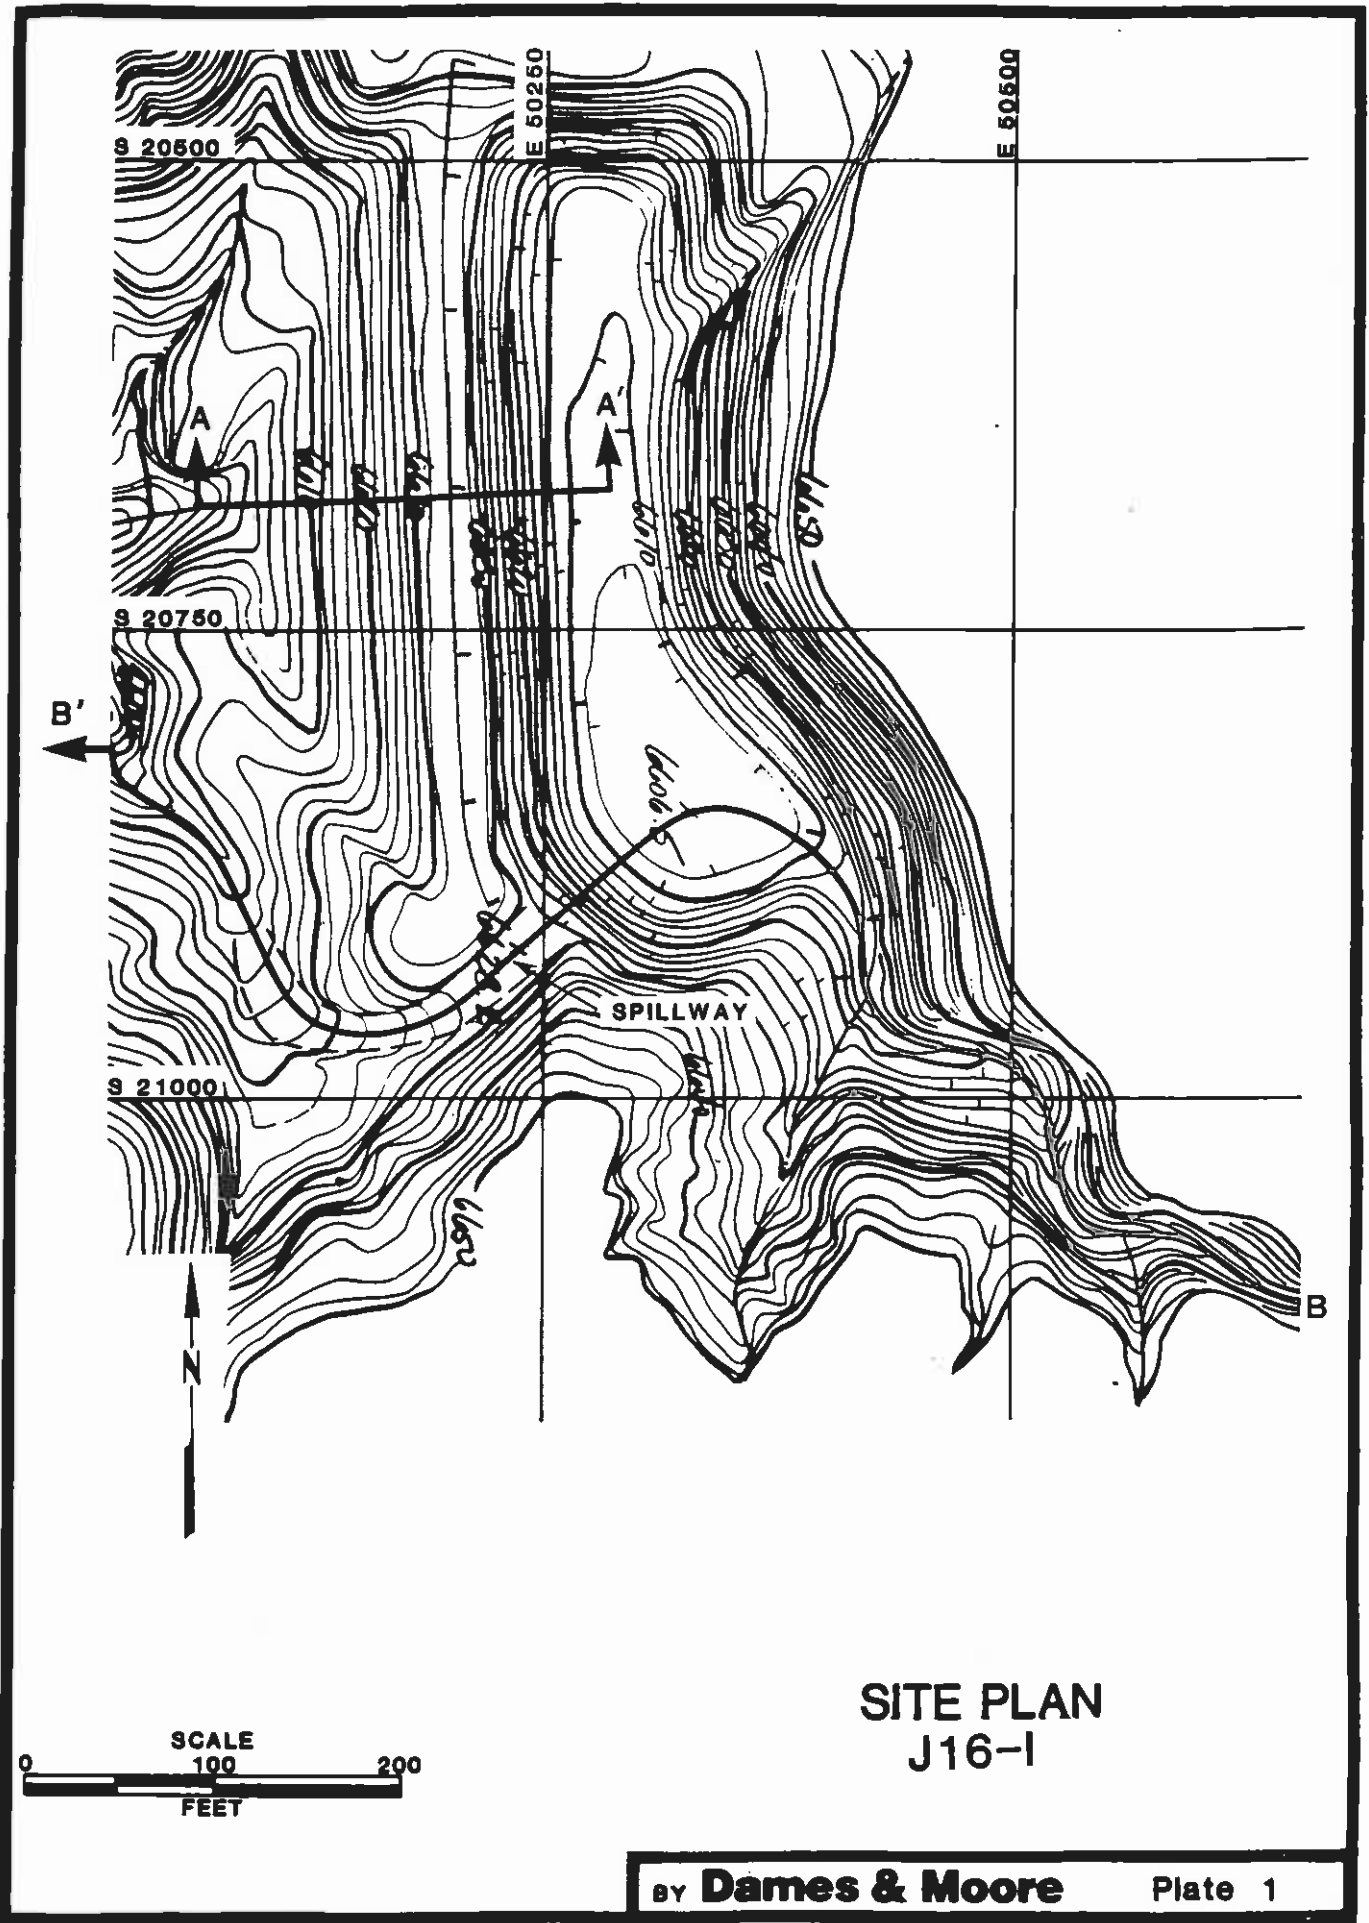
Plate 1

Sedimentation Structure J16-I is a partially incised structure with an earthen embankment, designed and constructed in 1984 by Peabody Coal Company as a temporary sedimentation structure to control runoff and sediment from the disturbed mining areas of the Kayenta Mine. The location of Structure J16-I is shown on Plate 1, Site Plan.

**SITE PLAN
J16-1**
