INSPECTION REPORT
Sedimentation Structure
J16-J
Kayenta Mine
Navajo County, Arizona
for
PEABODY COAL COMPANY

Dames & Moore
10139-011-22

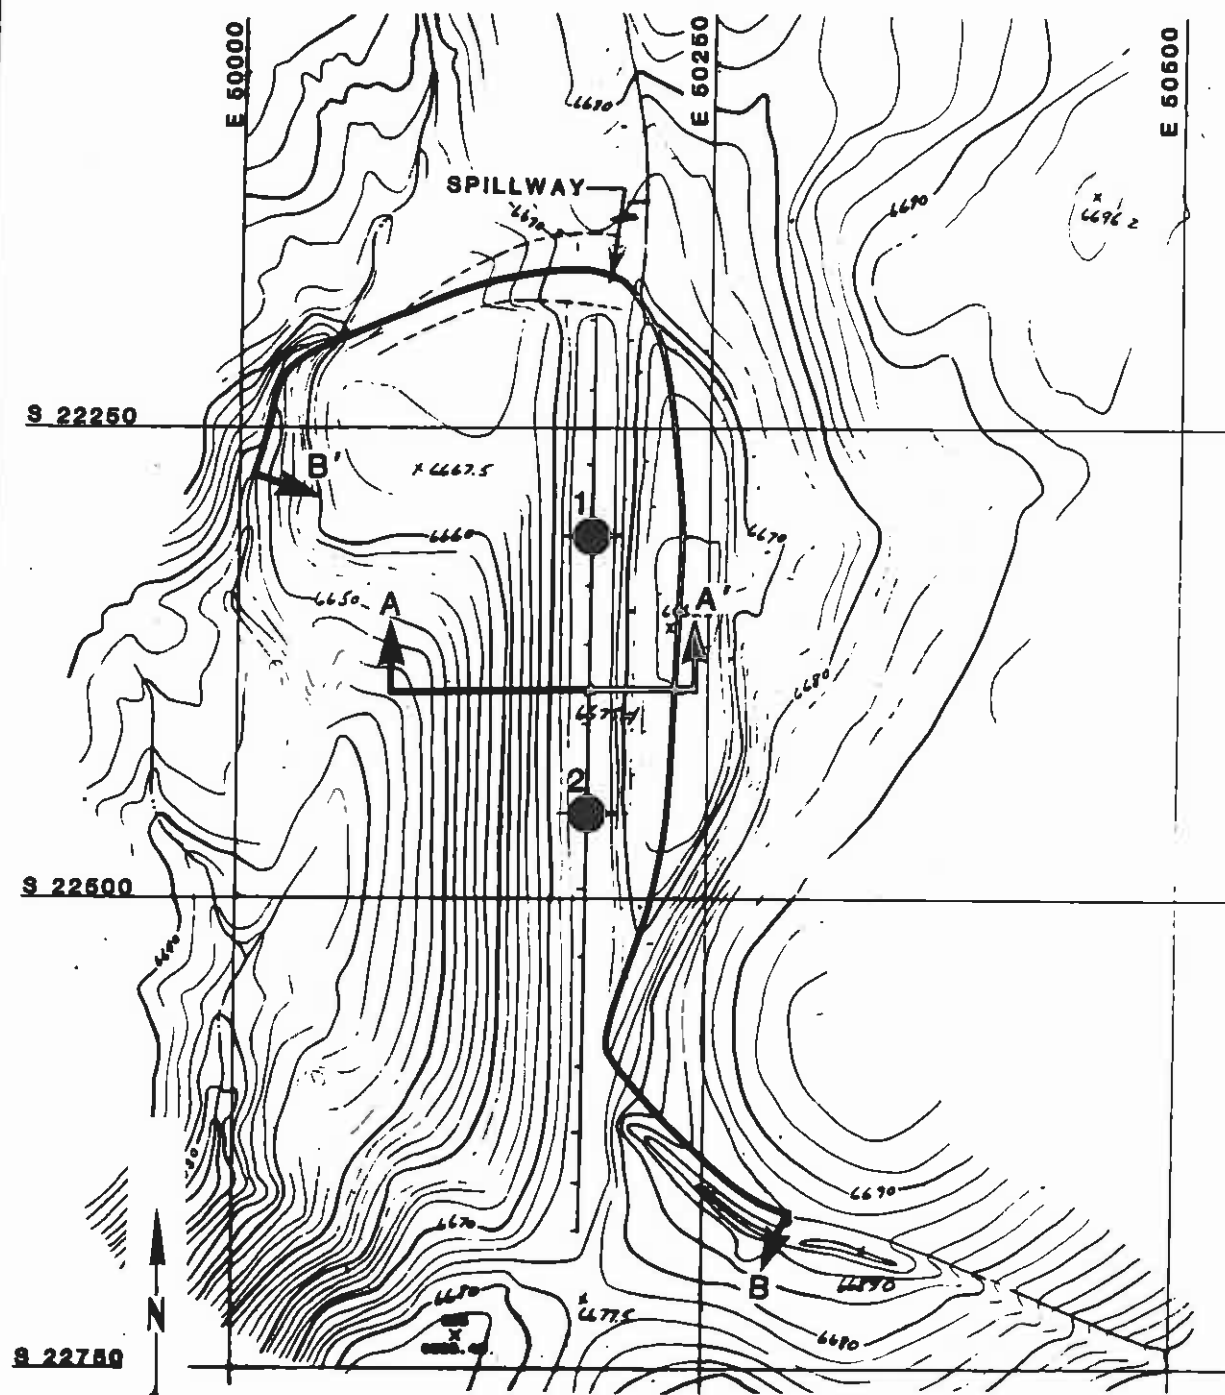
**SITE PLAN
J16-J**

Sedimentation Structure J16-J is an earthen embankment, designed and constructed in 1983 by Peabody Coal Company as a temporary sedimentation structure to control runoff and sediment from the disturbed mining areas of the Kayenta Mine. The location of Structure J16-J is shown on Plate 1, Site Plan.
