INSPECTION REPORT  
Sedimentation Structure  
J16-K  
Kayenta Mine  
Navajo County, Arizona  
for  
PEABODY COAL COMPANY

Dames & Moore  
10139-011-22

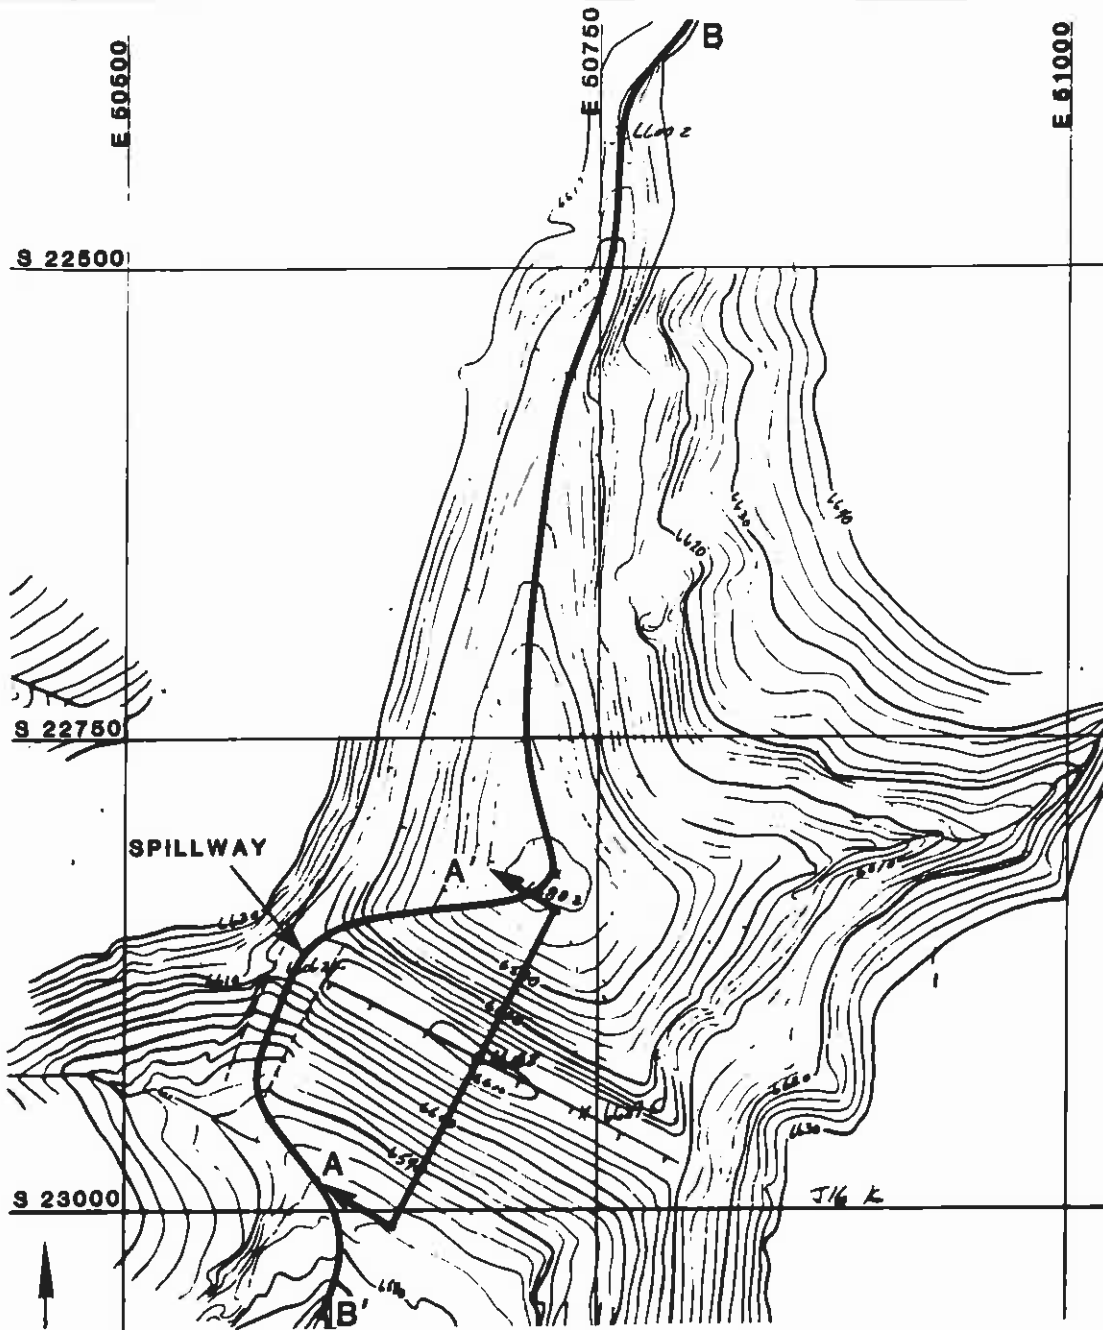
**SITE PLAN  
J16-K**

Sedimentation Structure J16-K is an earthen embankment, designed and constructed in 1983 by Peabody Coal Company as a temporary sedimentation structure to control runoff and sediment from the disturbed mining areas of the Kayenta Mine. The location of Structure J16-K is shown on Plate 1, Site Plan.

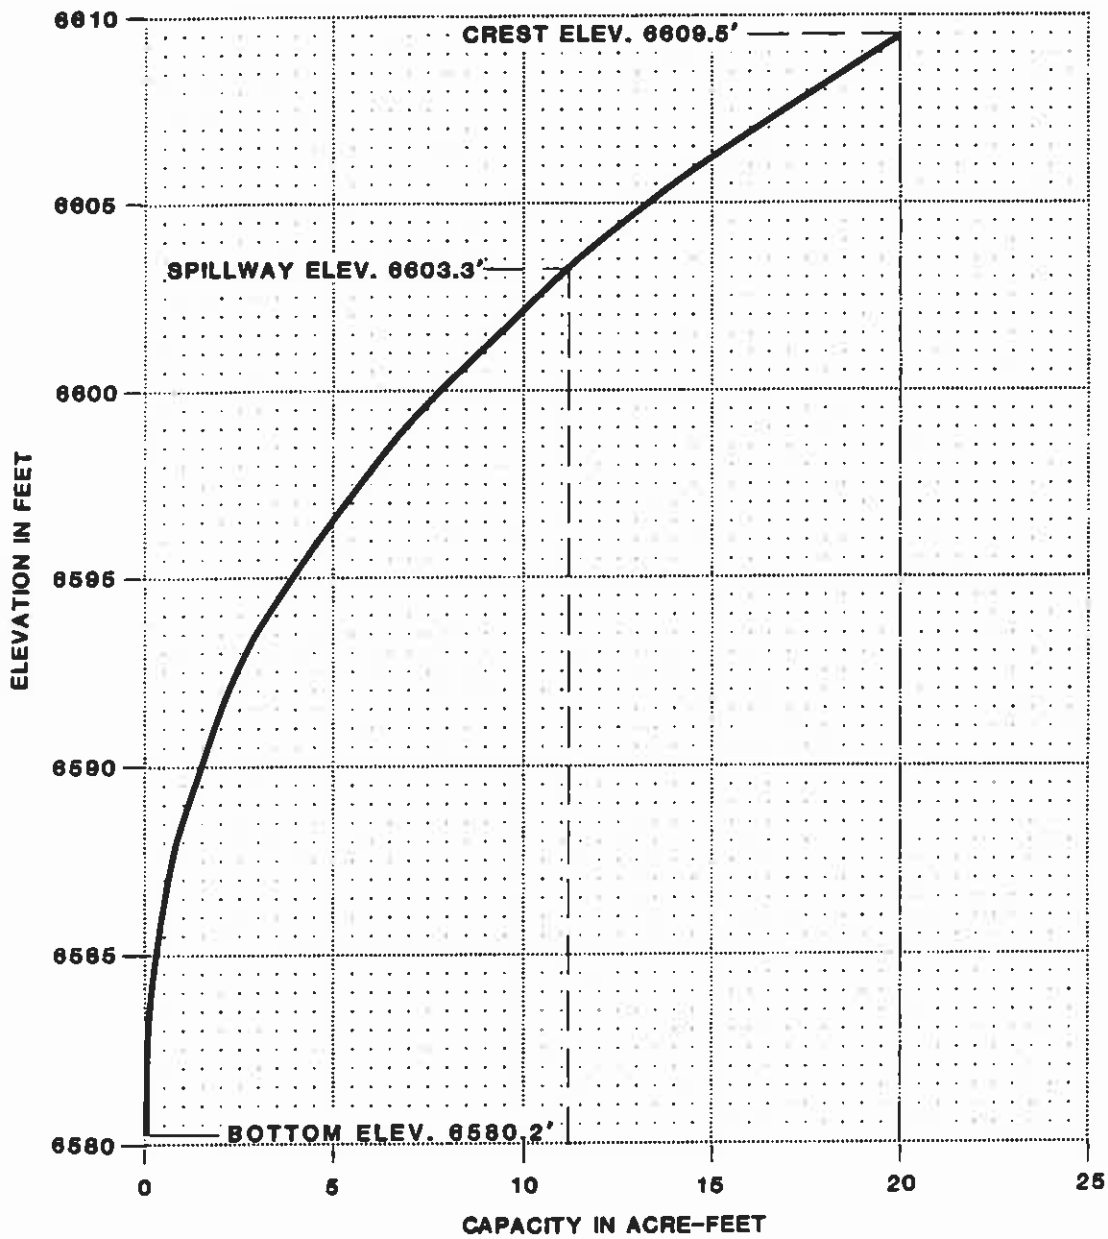
VOLUME-ELEVATION  
CURVE  
J16-K

The impoundment volume-elevation curve is based on site specific surveys conducted for Peabody Coal Company's August 1984 inspection, and 1985 resurveys, where available. Additionally, the most current topographic maps available were used in developing Plate 3, Volume-Elevation Curve, J16-K.
