INSPECTION REPORT  
Sedimentation Structure  
KM-B  
Kayenta Mine  
Navajo County, Arizona  
for  
PEABODY COAL COMPANY

Dames & Moore  
10139-011-22

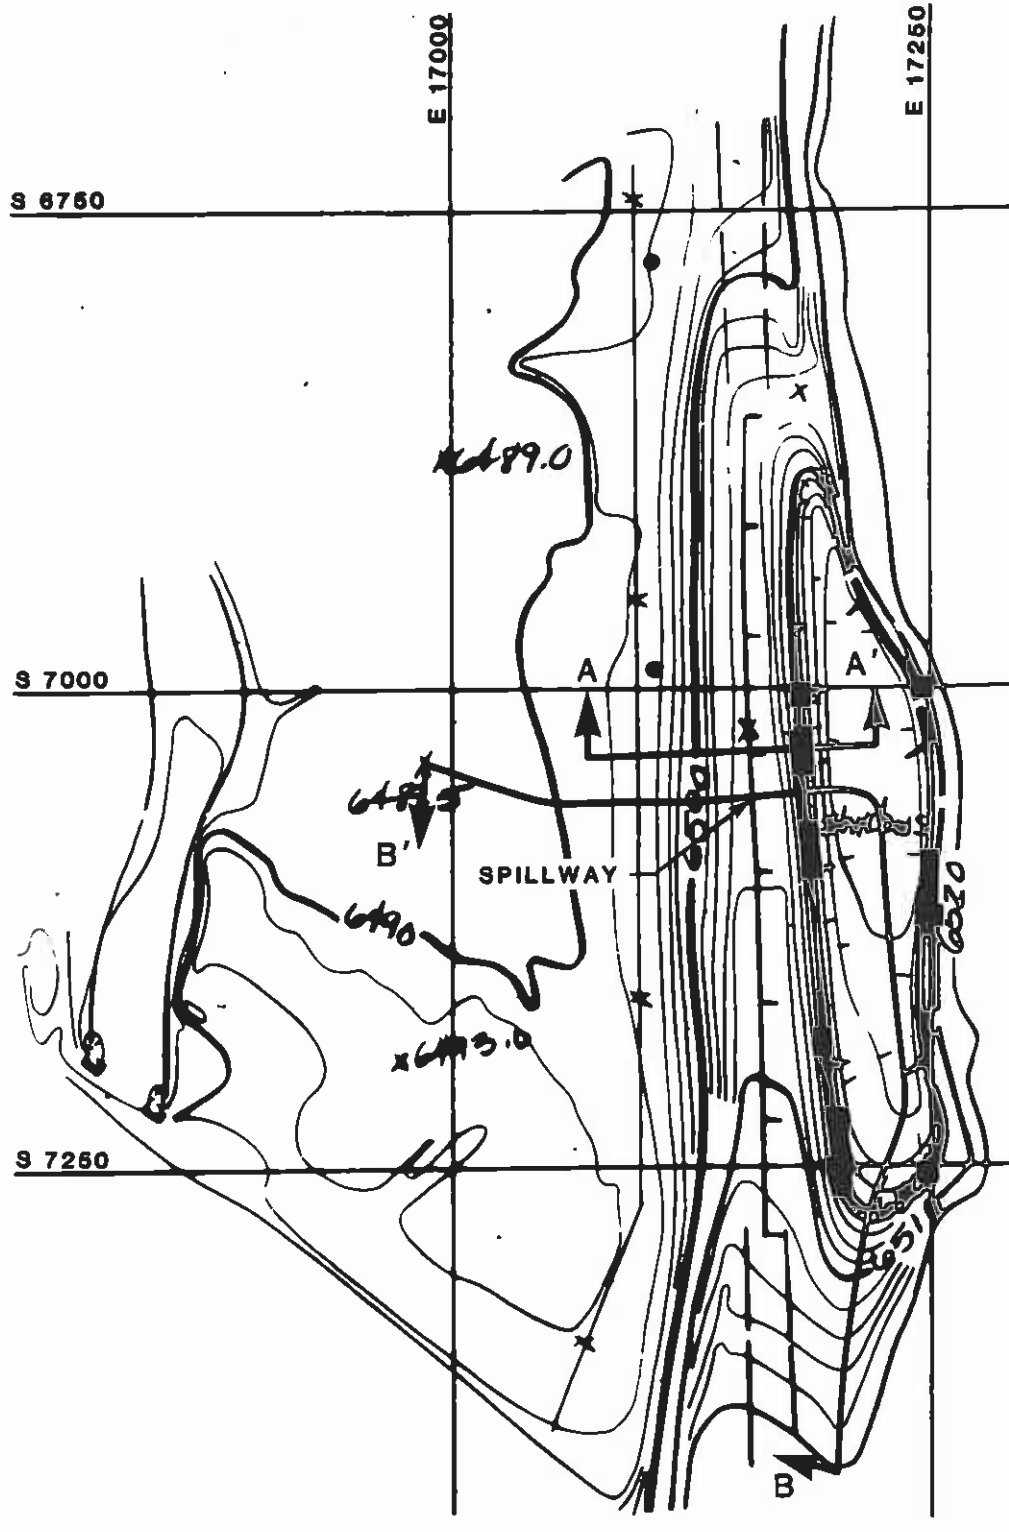
# SITE PLAN KM-B

Sedimentation Structure KM-B is an earthen embankment, designed and constructed in 1983 by Peabody Coal Company as a temporary sedimentation structure to control runoff and sediment from the disturbed mining areas of the Kayenta Mine. The location of Structure KM-B is shown on Plate 1, Site Plan.

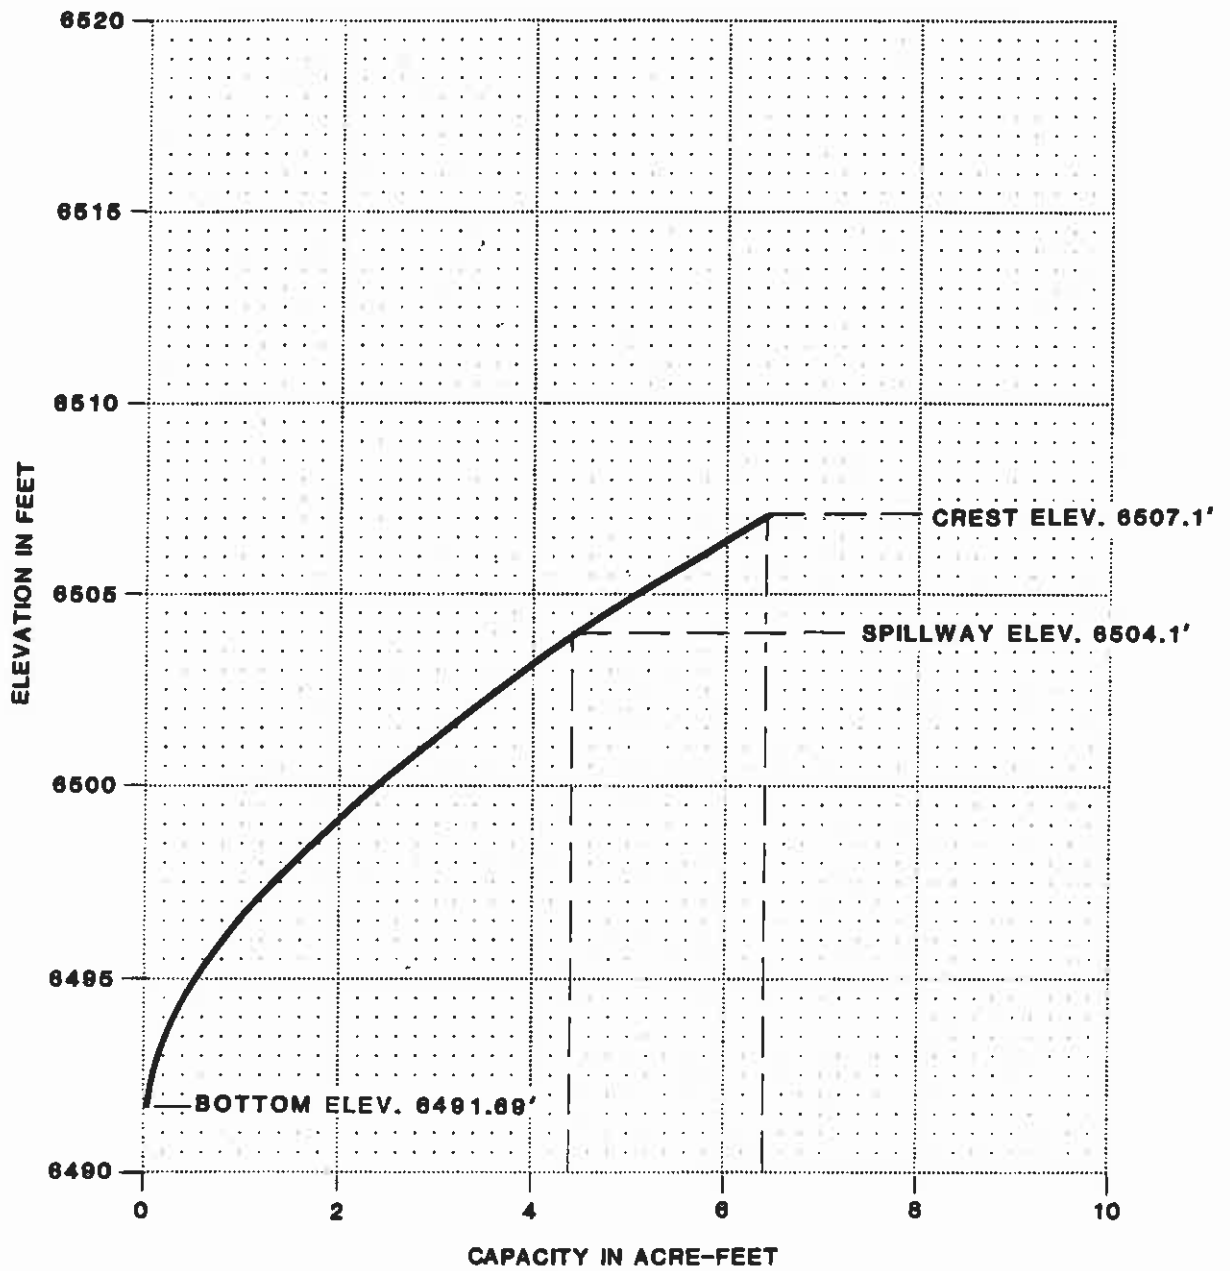
VOLUME-ELEVATION  
CURVE  
KM-B

The impoundment volume-elevation curve is based on site specific surveys conducted for Peabody Coal Company's August 1984 inspection, and 1985 resurveys, where available. Additionally, the most current topographic maps available were used in developing Plate 3, Volume-Elevation Curve, KM-B.
