INSPECTION REPORT
Sedimentation Structure
KM-C
Kayenta Mine
Navajo County, Arizona

for
PEABODY COAL COMPANY

Dames & Moore
10139-011-22

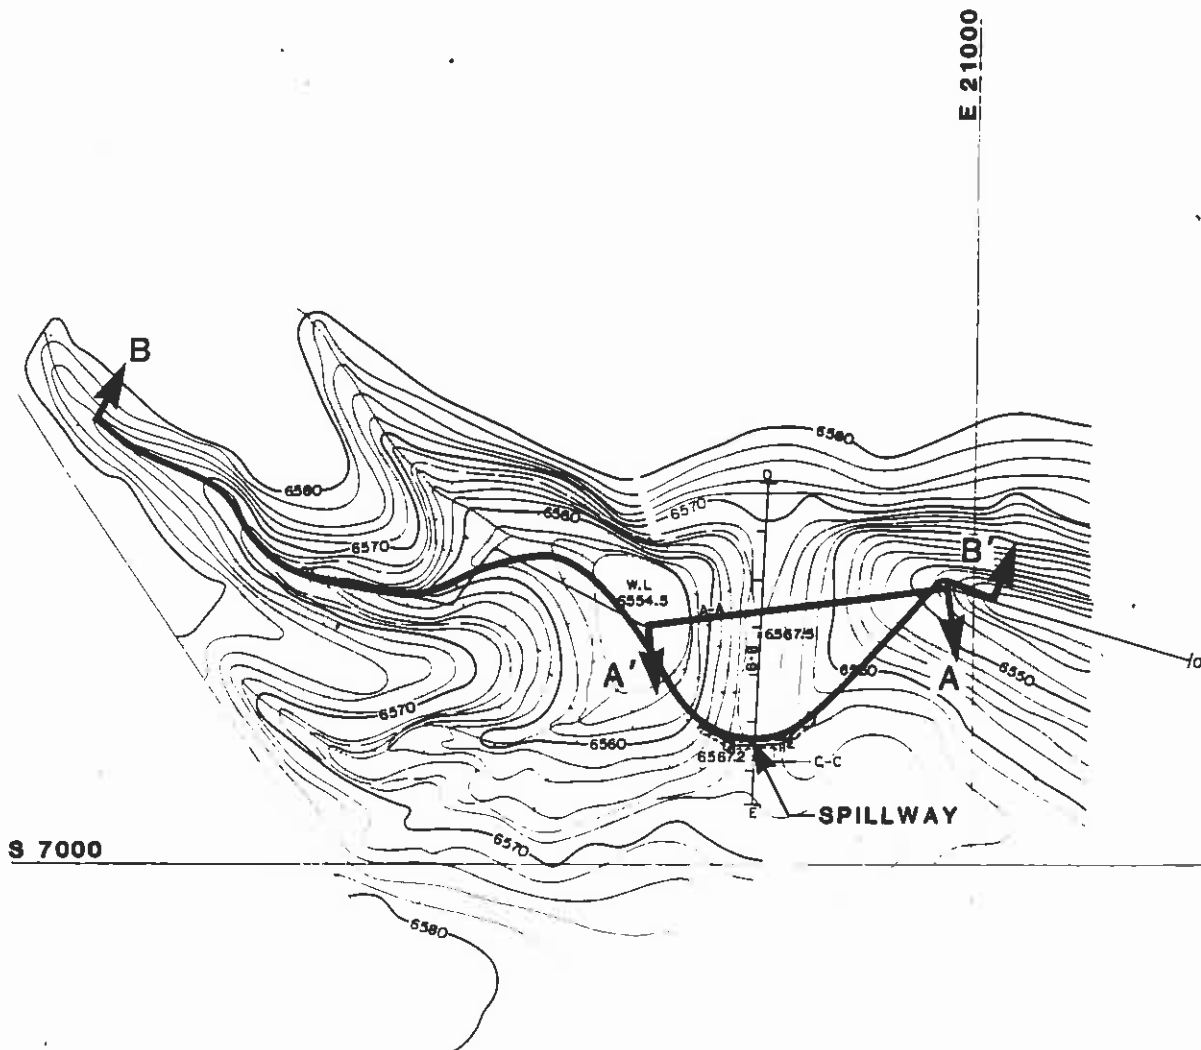
Plate 1

SITE PLAN KM-C

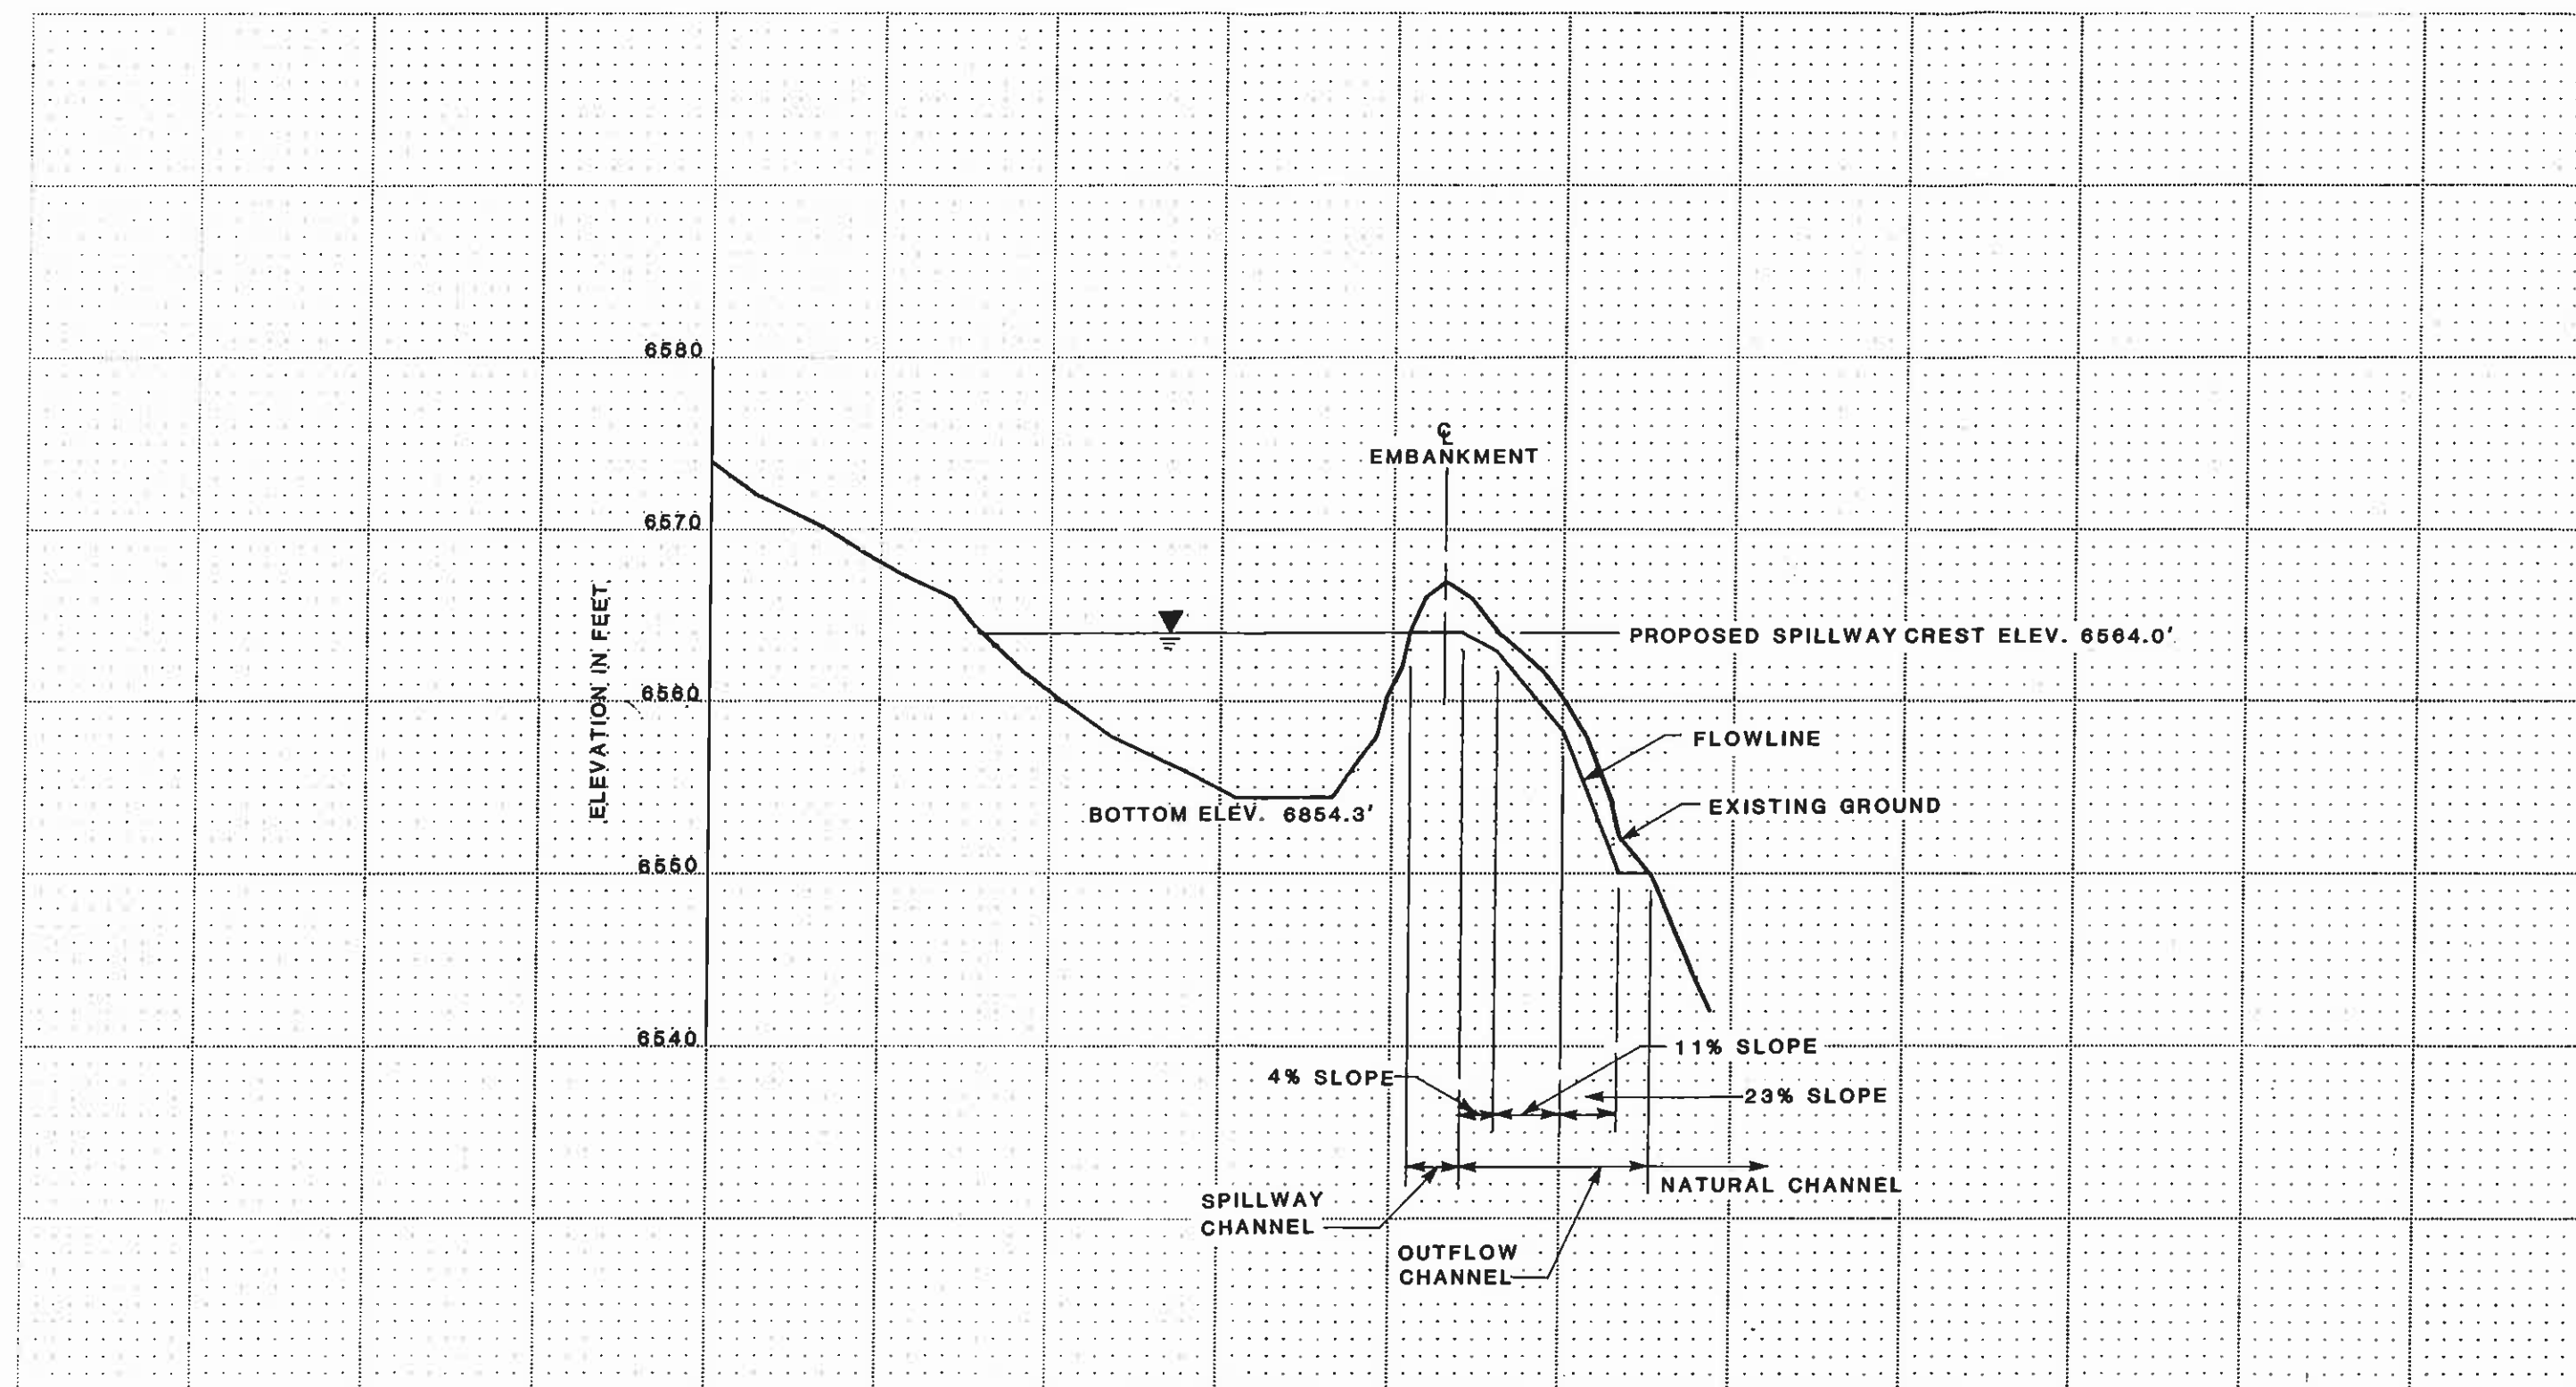
CHANNEL PROFILE B-B'
KM-C

Structure KM-C has sufficient storage capacity but it does not have a spillway or outflow channel. A trapezoidal spillway channel should be constructed at elevation 6564.0 feet. The dam crest should be raised to elevation 6566.6 feet. A trapezoidal outflow channel with the same bottom width as the spillway should be constructed along the alignment shown in Plate 1. The spillway and outflow channel profile is shown in Plate 4 and the required dimensions are shown in Plate 5. Both the spillway and outflow channel should be protected against erosion using geotextile and riprap as shown in Plate 5.
