INSPECTION REPORT
Sedimentation Structure
N1-AC
Kayenta Mine
Navajo County, Arizona
for
PEABODY COAL COMPANY

Dames & Moore
10139-011-22

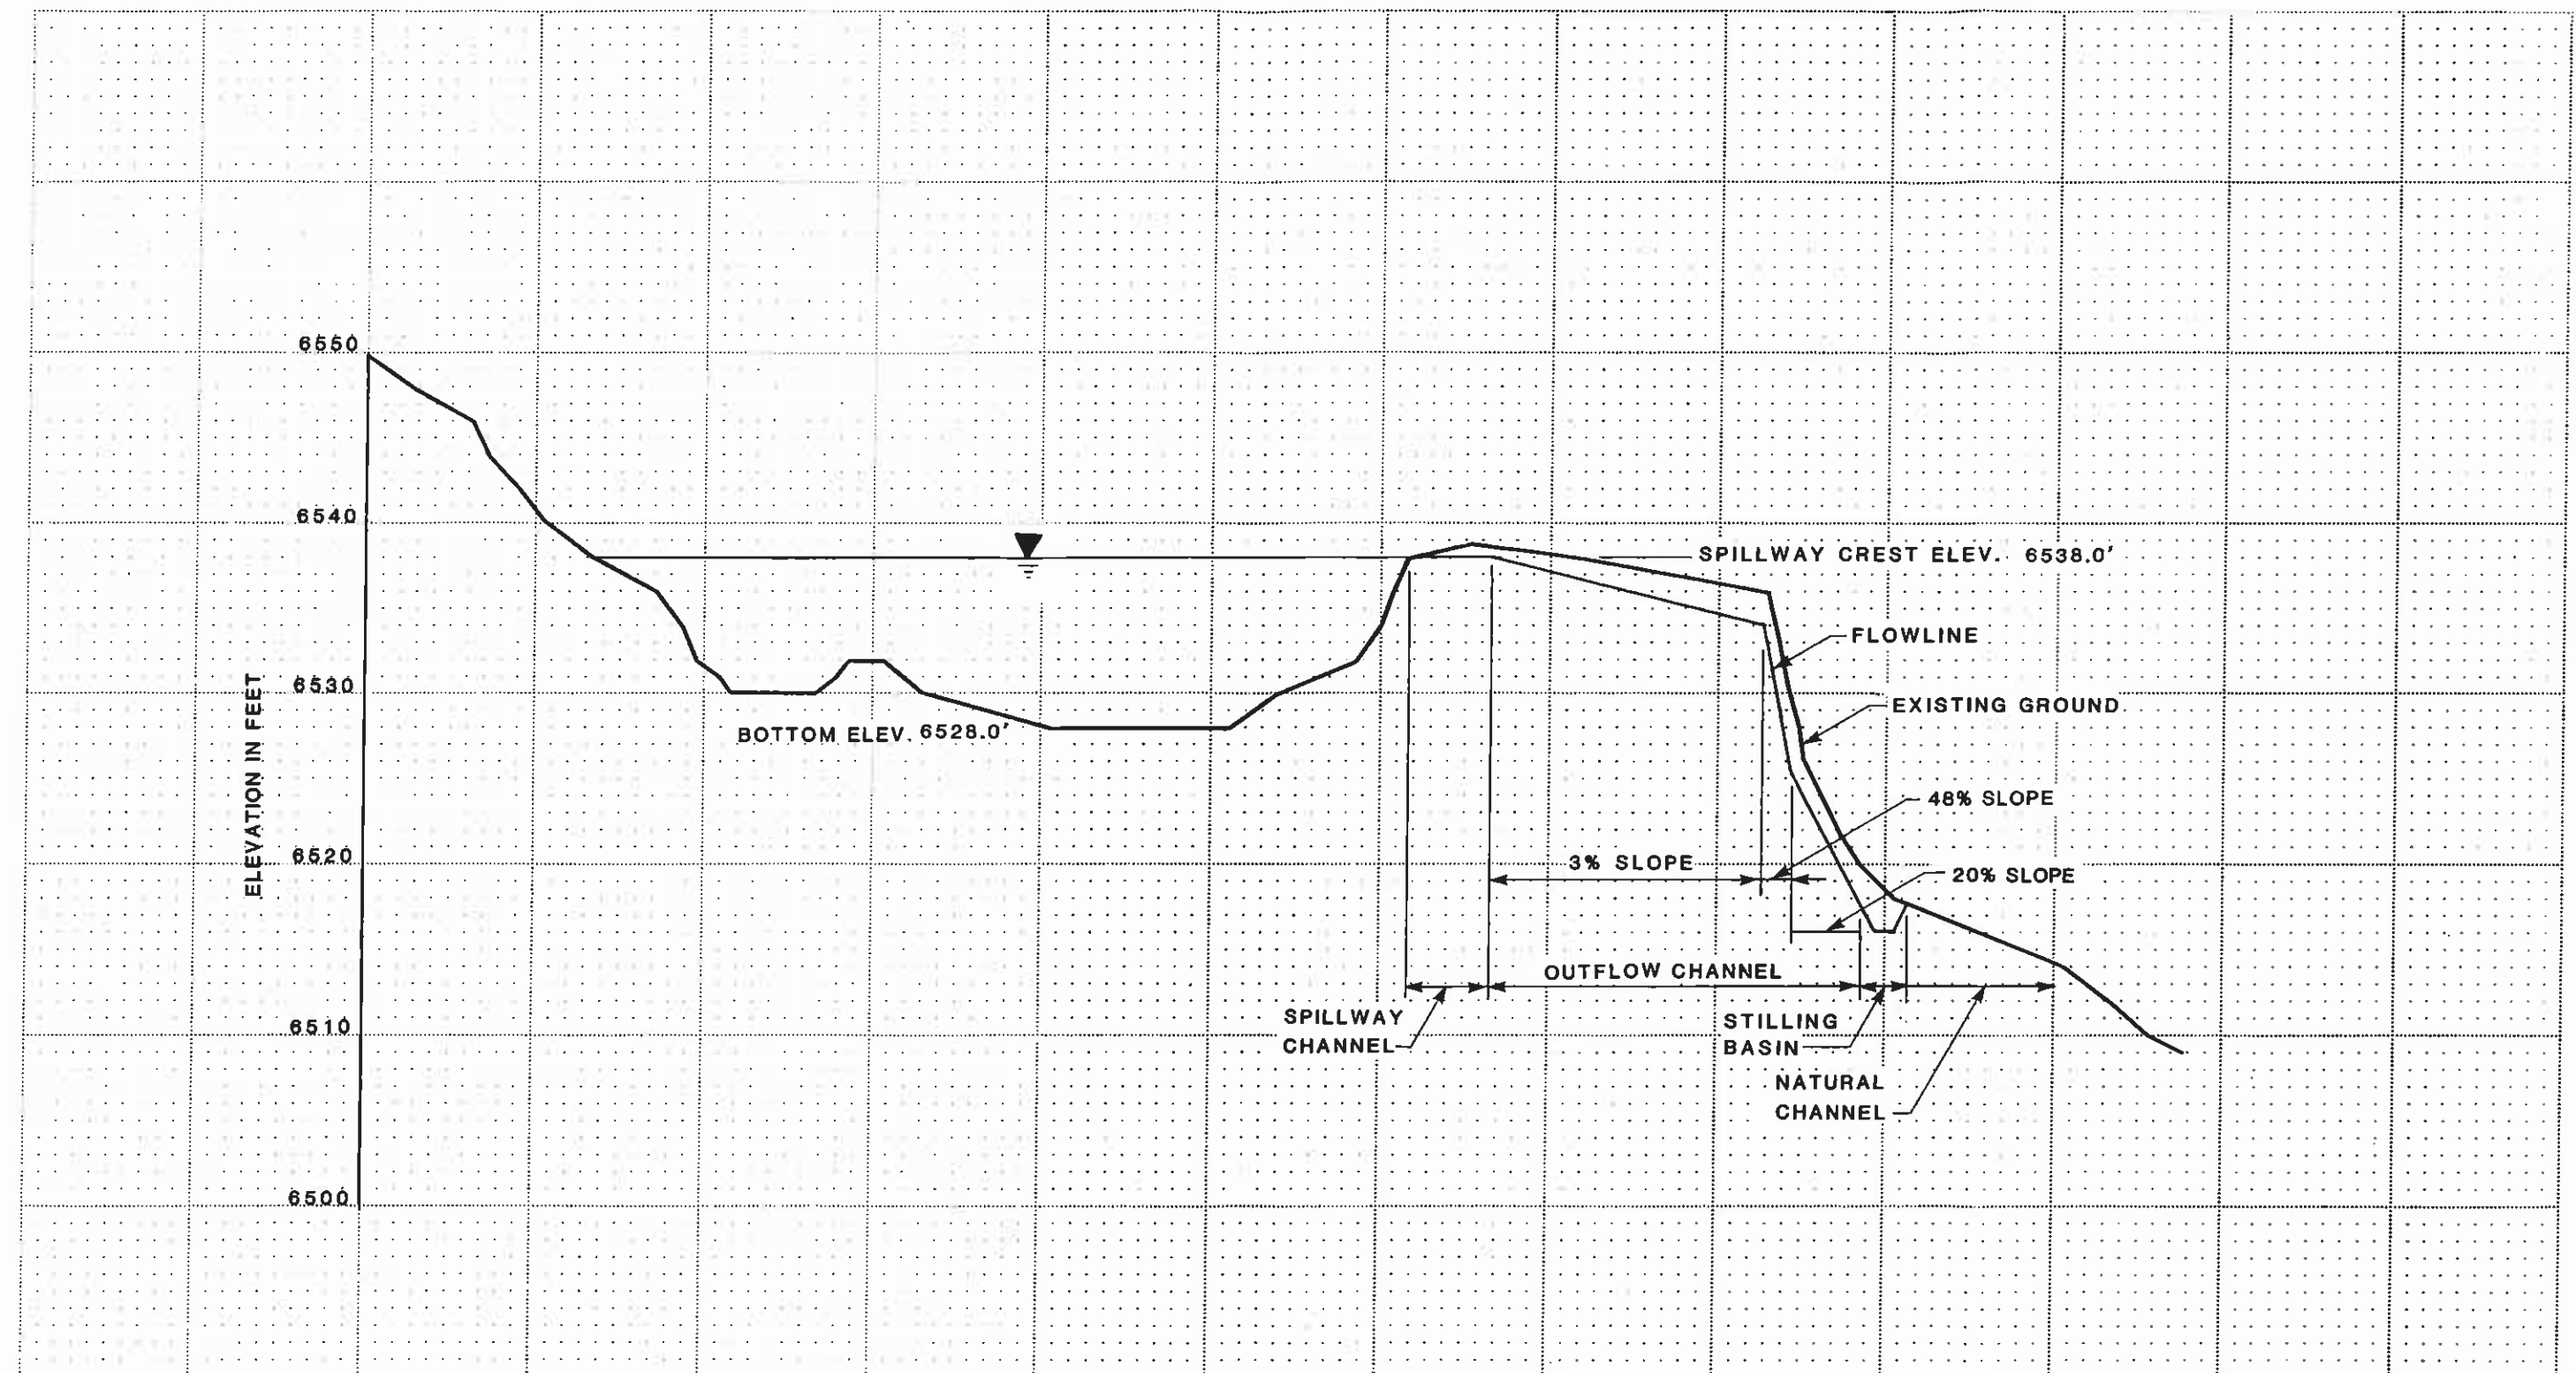
CHANNEL PROFILE B-B'
N1-AC

The storage capacity of Structure N1-AC is adequate but the spillway capacity is inadequate. The structure does not have an adequate outflow channel. The bottom elevation of the existing spillway channel should be lowered to elevation 6538.0 feet while maintaining the bottom width of 50 feet as shown on Plate 5. A trapezoidal outflow channel with the same bottom width as the spillway should be constructed along the alignment shown in Plate 1. The channel profile is shown in Plate 4 and required dimensions are shown in Plate 5 and Plate 6. The spillway, outflow channel and stilling basin should be protected against erosion using geotextile and riprap as shown in Plate 5.
