INSPECTION REPORT
Sedimentation Structure
N1-M
Kayenta Mine
Navajo County, Arizona
for
PEABODY COAL COMPANY

Dames & Moore
10139-011-22

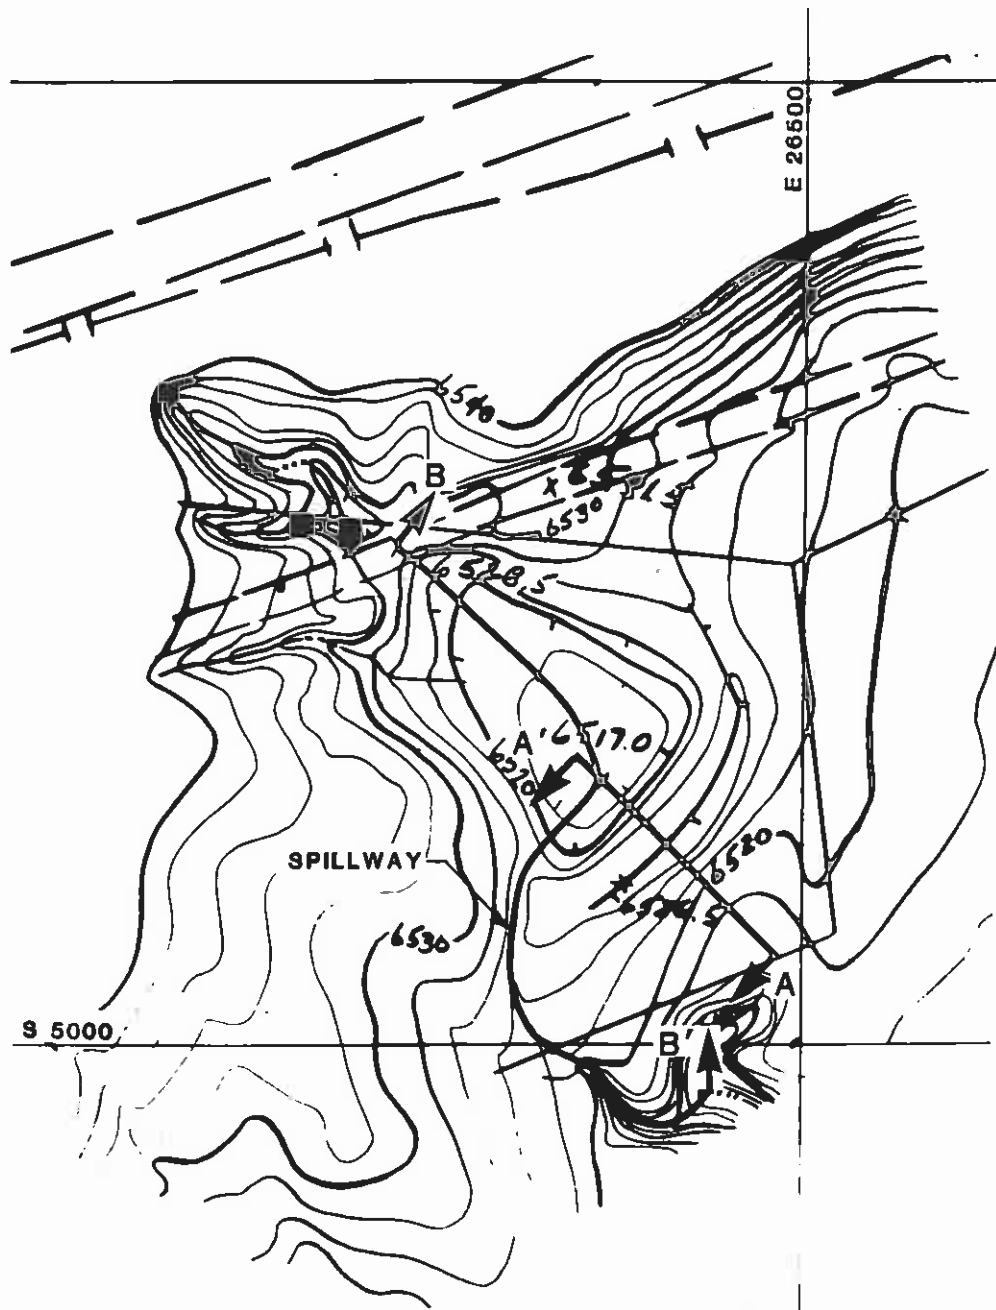
**SITE PLAN
N1-M**

Sedimentation Structure N1-M is an earthen embankment, designed and constructed in 1980 by Peabody Coal Company as a temporary sedimentation structure to control runoff and sediment from the disturbed mining areas of the Kayenta Mine. The location of Structure N1-M is shown on Plate 1, Site Plan.
