INSPECTION REPORT
Sedimentation Structure
N6-C
Black Mesa Mine
Navajo County, Arizona
for
PEABODY COAL COMPANY

Dames & Moore
10139-011-22

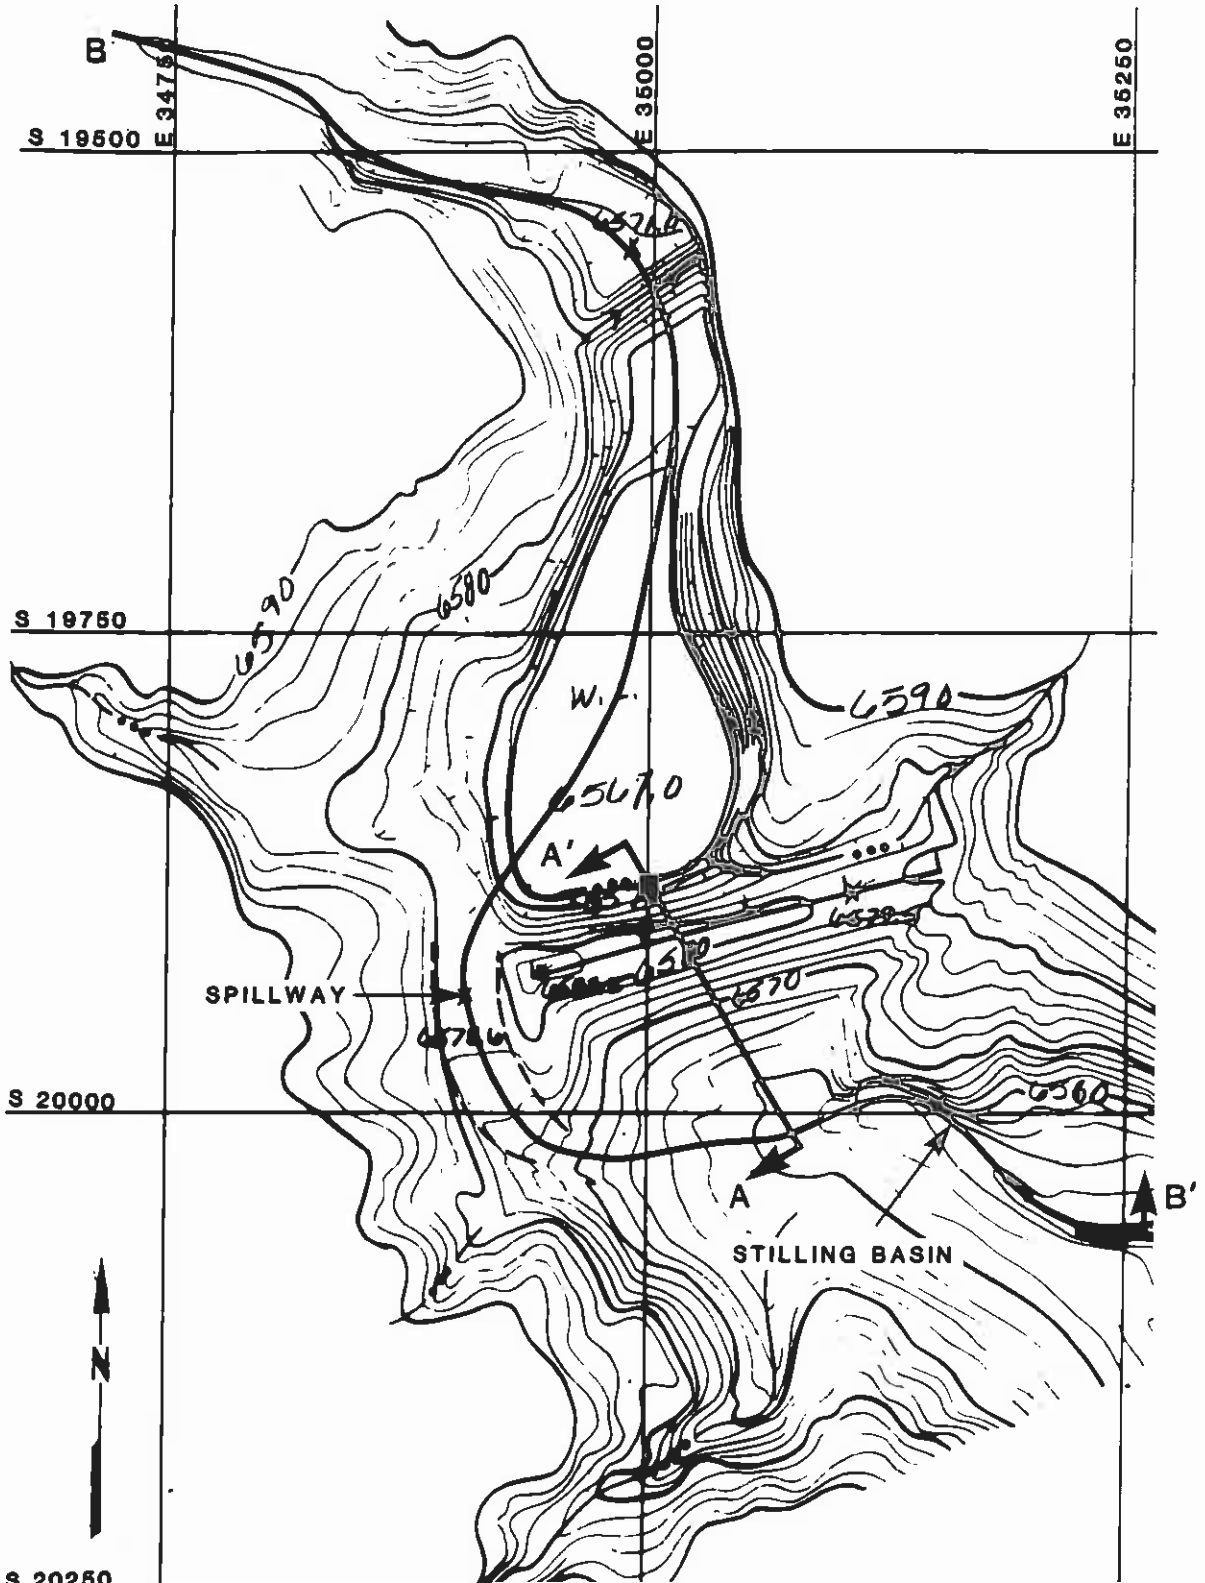
**SITE PLAN
N6-C**

Sedimentation Structure N6-C is an earthen embankment, designed and constructed in 1979 by Peabody Coal Company as a temporary sedimentation structure to control runoff and sediment from the disturbed mining areas of the Black Mesa Mine. The location of Structure N6-C is shown on Plate 1, Site Plan.

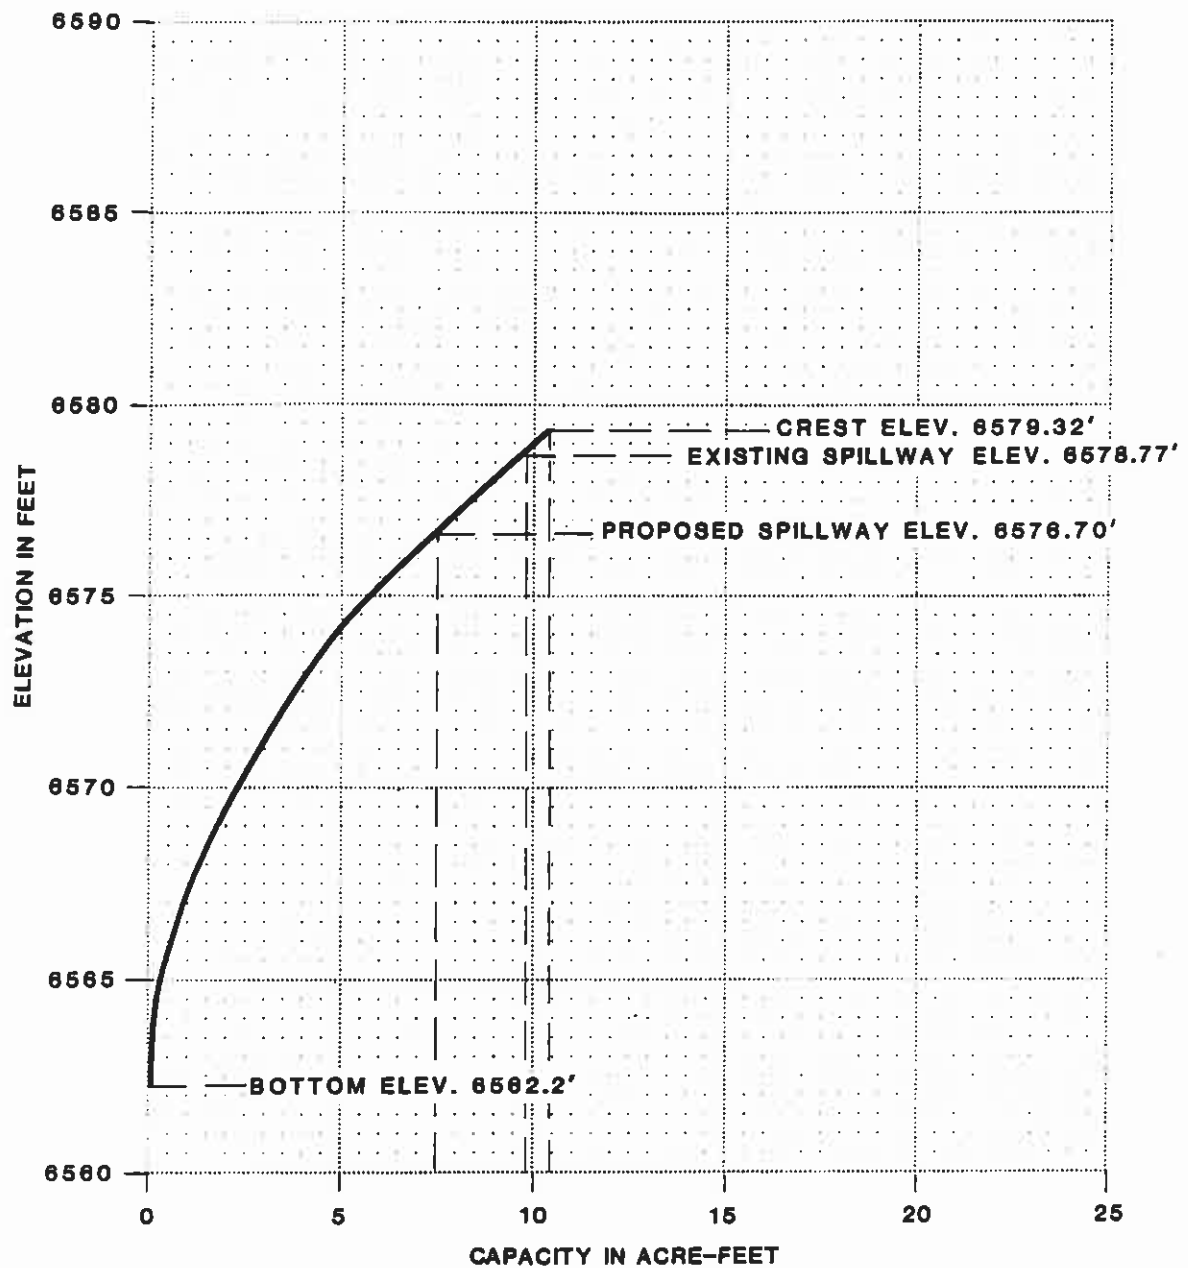
**VOLUME-ELEVATION
 CURVE
 N6-C**

The impoundment volume-elevation curve is based on site specific surveys conducted for Peabody Coal Company's August 1984 inspection, and 1985 resurveys, where available. Additionally, the most current topographic maps available were used in developing Plate 3, Volume-Elevation Curve, N6-C.
