INSPECTION REPORT
Sedimentation Structure
N5-E
Black Mesa Mine
Navajo County, Arizona
for
PEABODY COAL COMPANY

Dames & Moore
10139-011-22

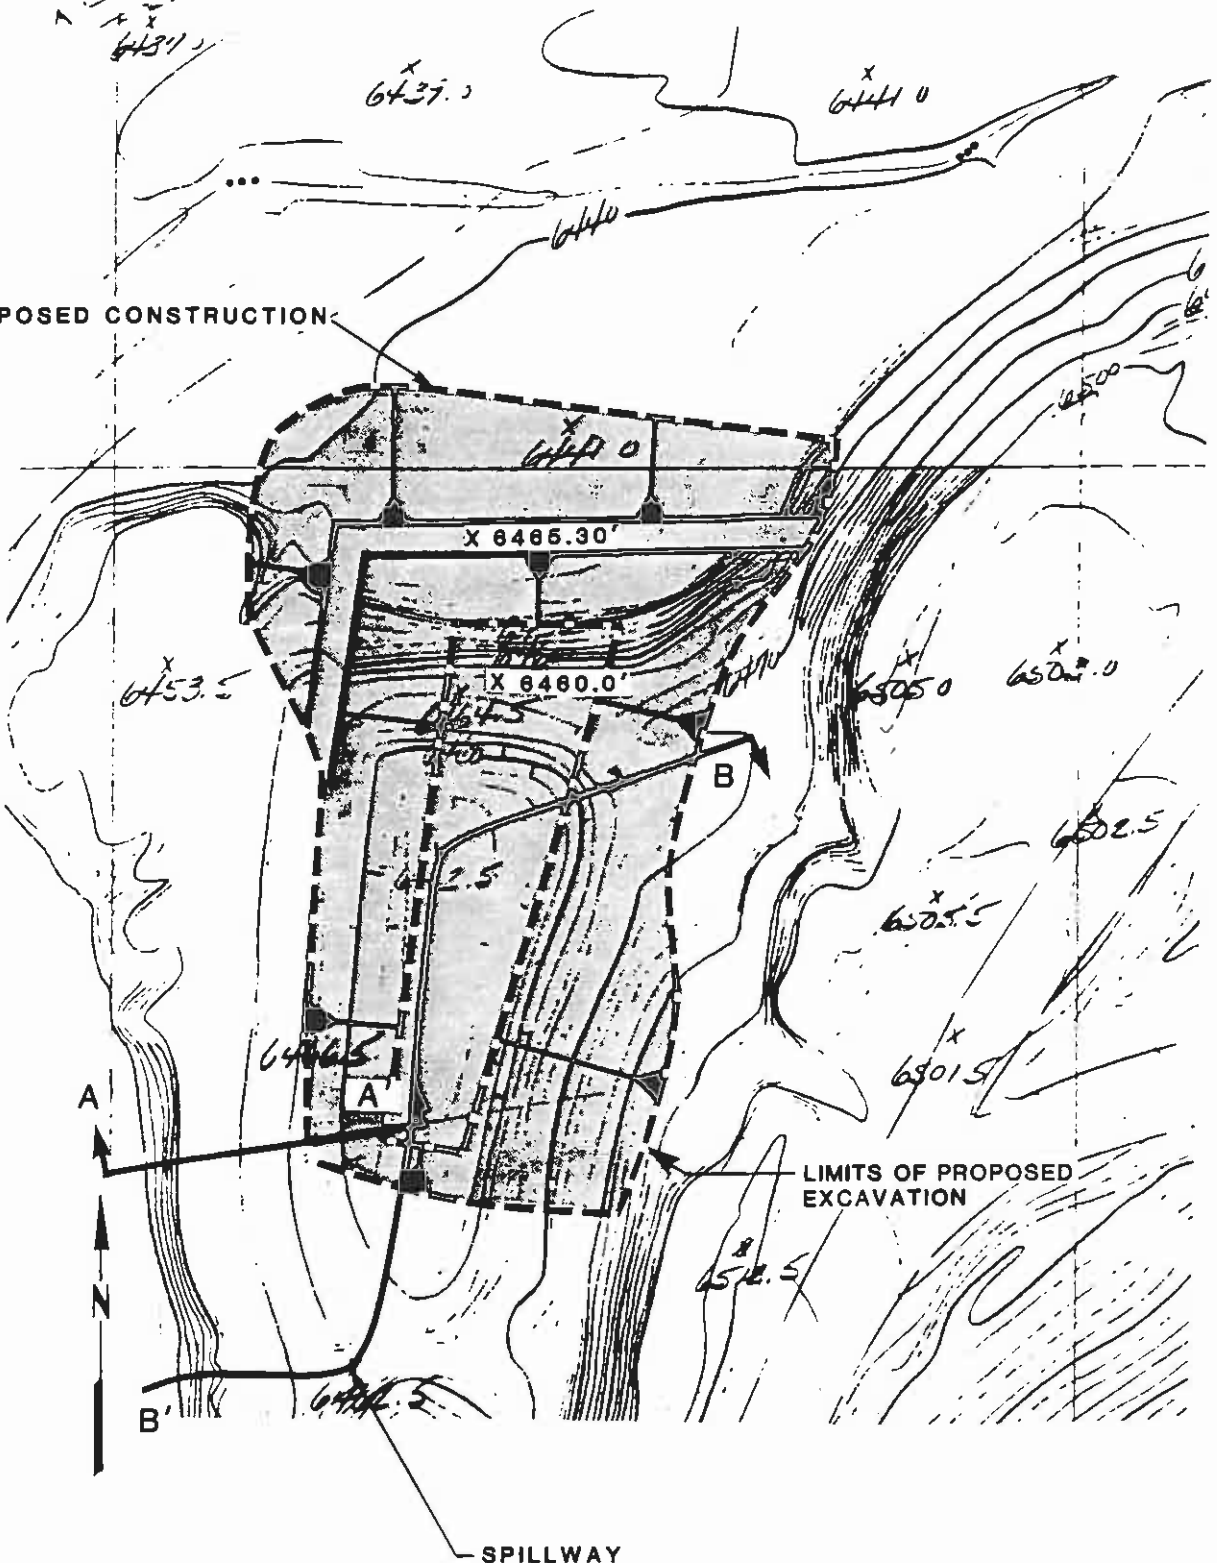
SITE PLAN N5-E

The storage capacity and spillway capacity of Structure N5-E are inadequate. The structure does not have an outflow channel. The storage capacity should be increased to 8.7 acre-feet by excavating the pond as shown on Plates 1 and 4. The embankment crest should be raised to elevation 6465.30 feet. A trapezoidal outflow channel should be constructed along the alignment shown in Plate 1. The channel profile is shown in Plate 4 and the required dimensions are shown in Plate 5. Both the spillway and outflow channel should be protected against erosion using geotextile and riprap as shown in Plate 5.
