INSPECTION REPORT
Sedimentation Structure
N6-E
Black Mesa Mine
Navajo County, Arizona
for
PEABODY COAL COMPANY

Dames & Moore
10139-011-22

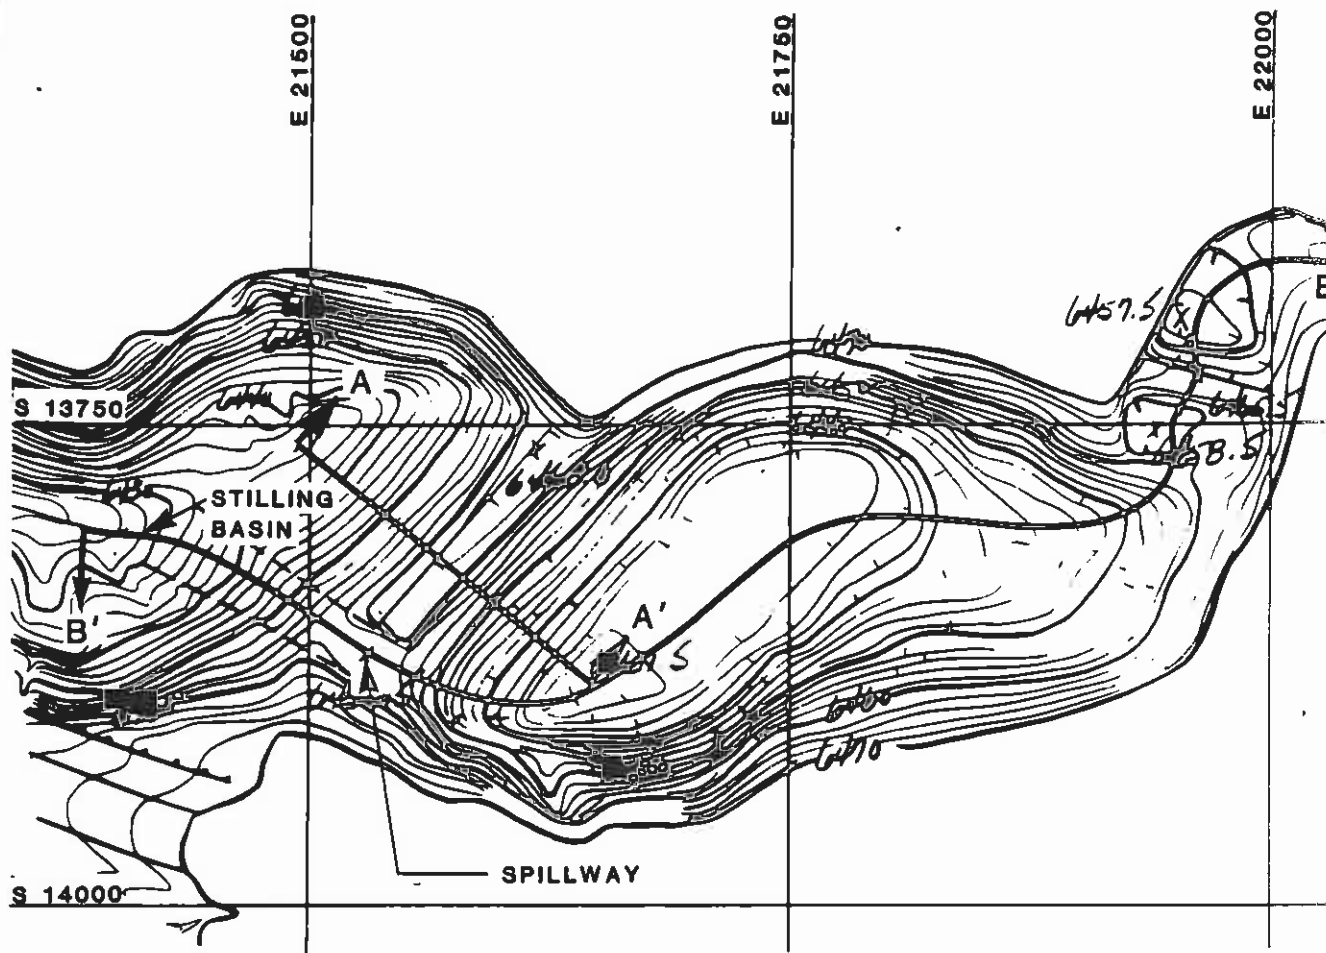
SITE PLAN
N6-E

Sedimentation Structure N6-E is a partially incised structure with an earthen embankment, designed and constructed in 1982 by Peabody Coal Company as a temporary sedimentation structure to control runoff and sediment from the disturbed mining areas of the Black Mesa Mine. The location of Structure N6-E is shown on Plate 1, Site Plan.

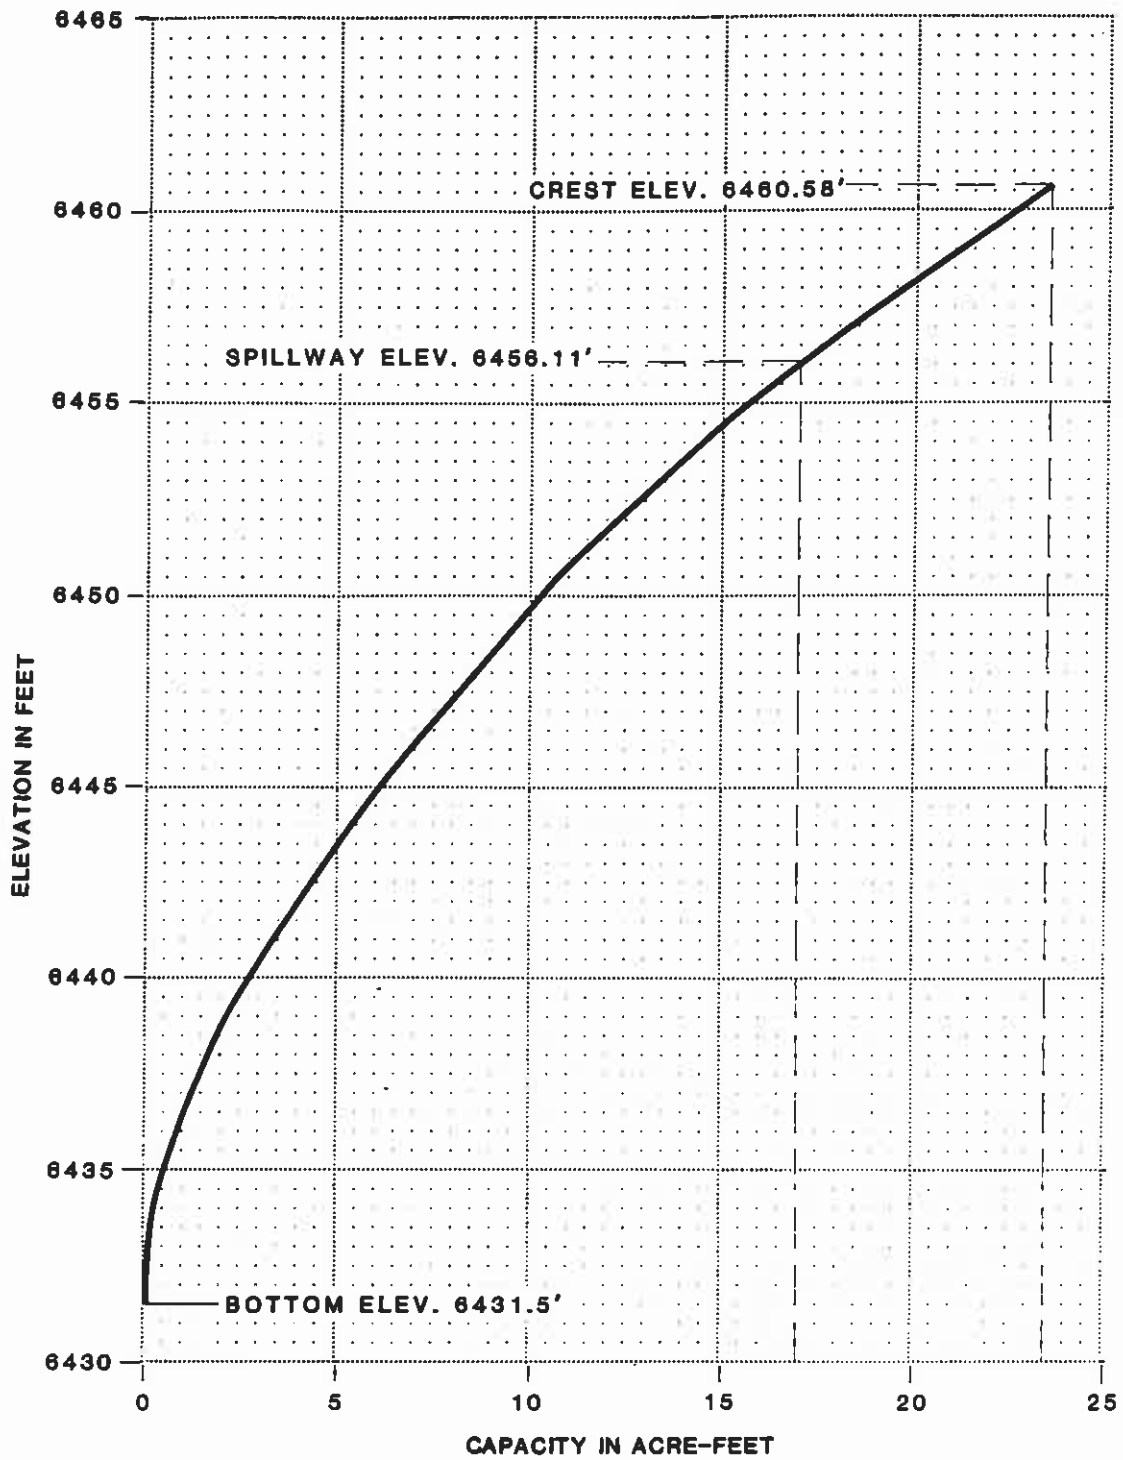
VOLUME-ELEVATION
CURVE
N6-E

The impoundment volume-elevation curve is based on site specific surveys conducted for Peabody Coal Company's August 1984 inspection, and 1985 resurveys, where available. Additionally, the most current topographic maps available were used in developing Plate 3, Volume-Elevation Curve, N6-E.
