INSPECTION REPORT
Sedimentation Structure
N6-F
Black Mesa Mine
Navajo County, Arizona
for
PEABODY COAL COMPANY

Dames & Moore
10139-011-22

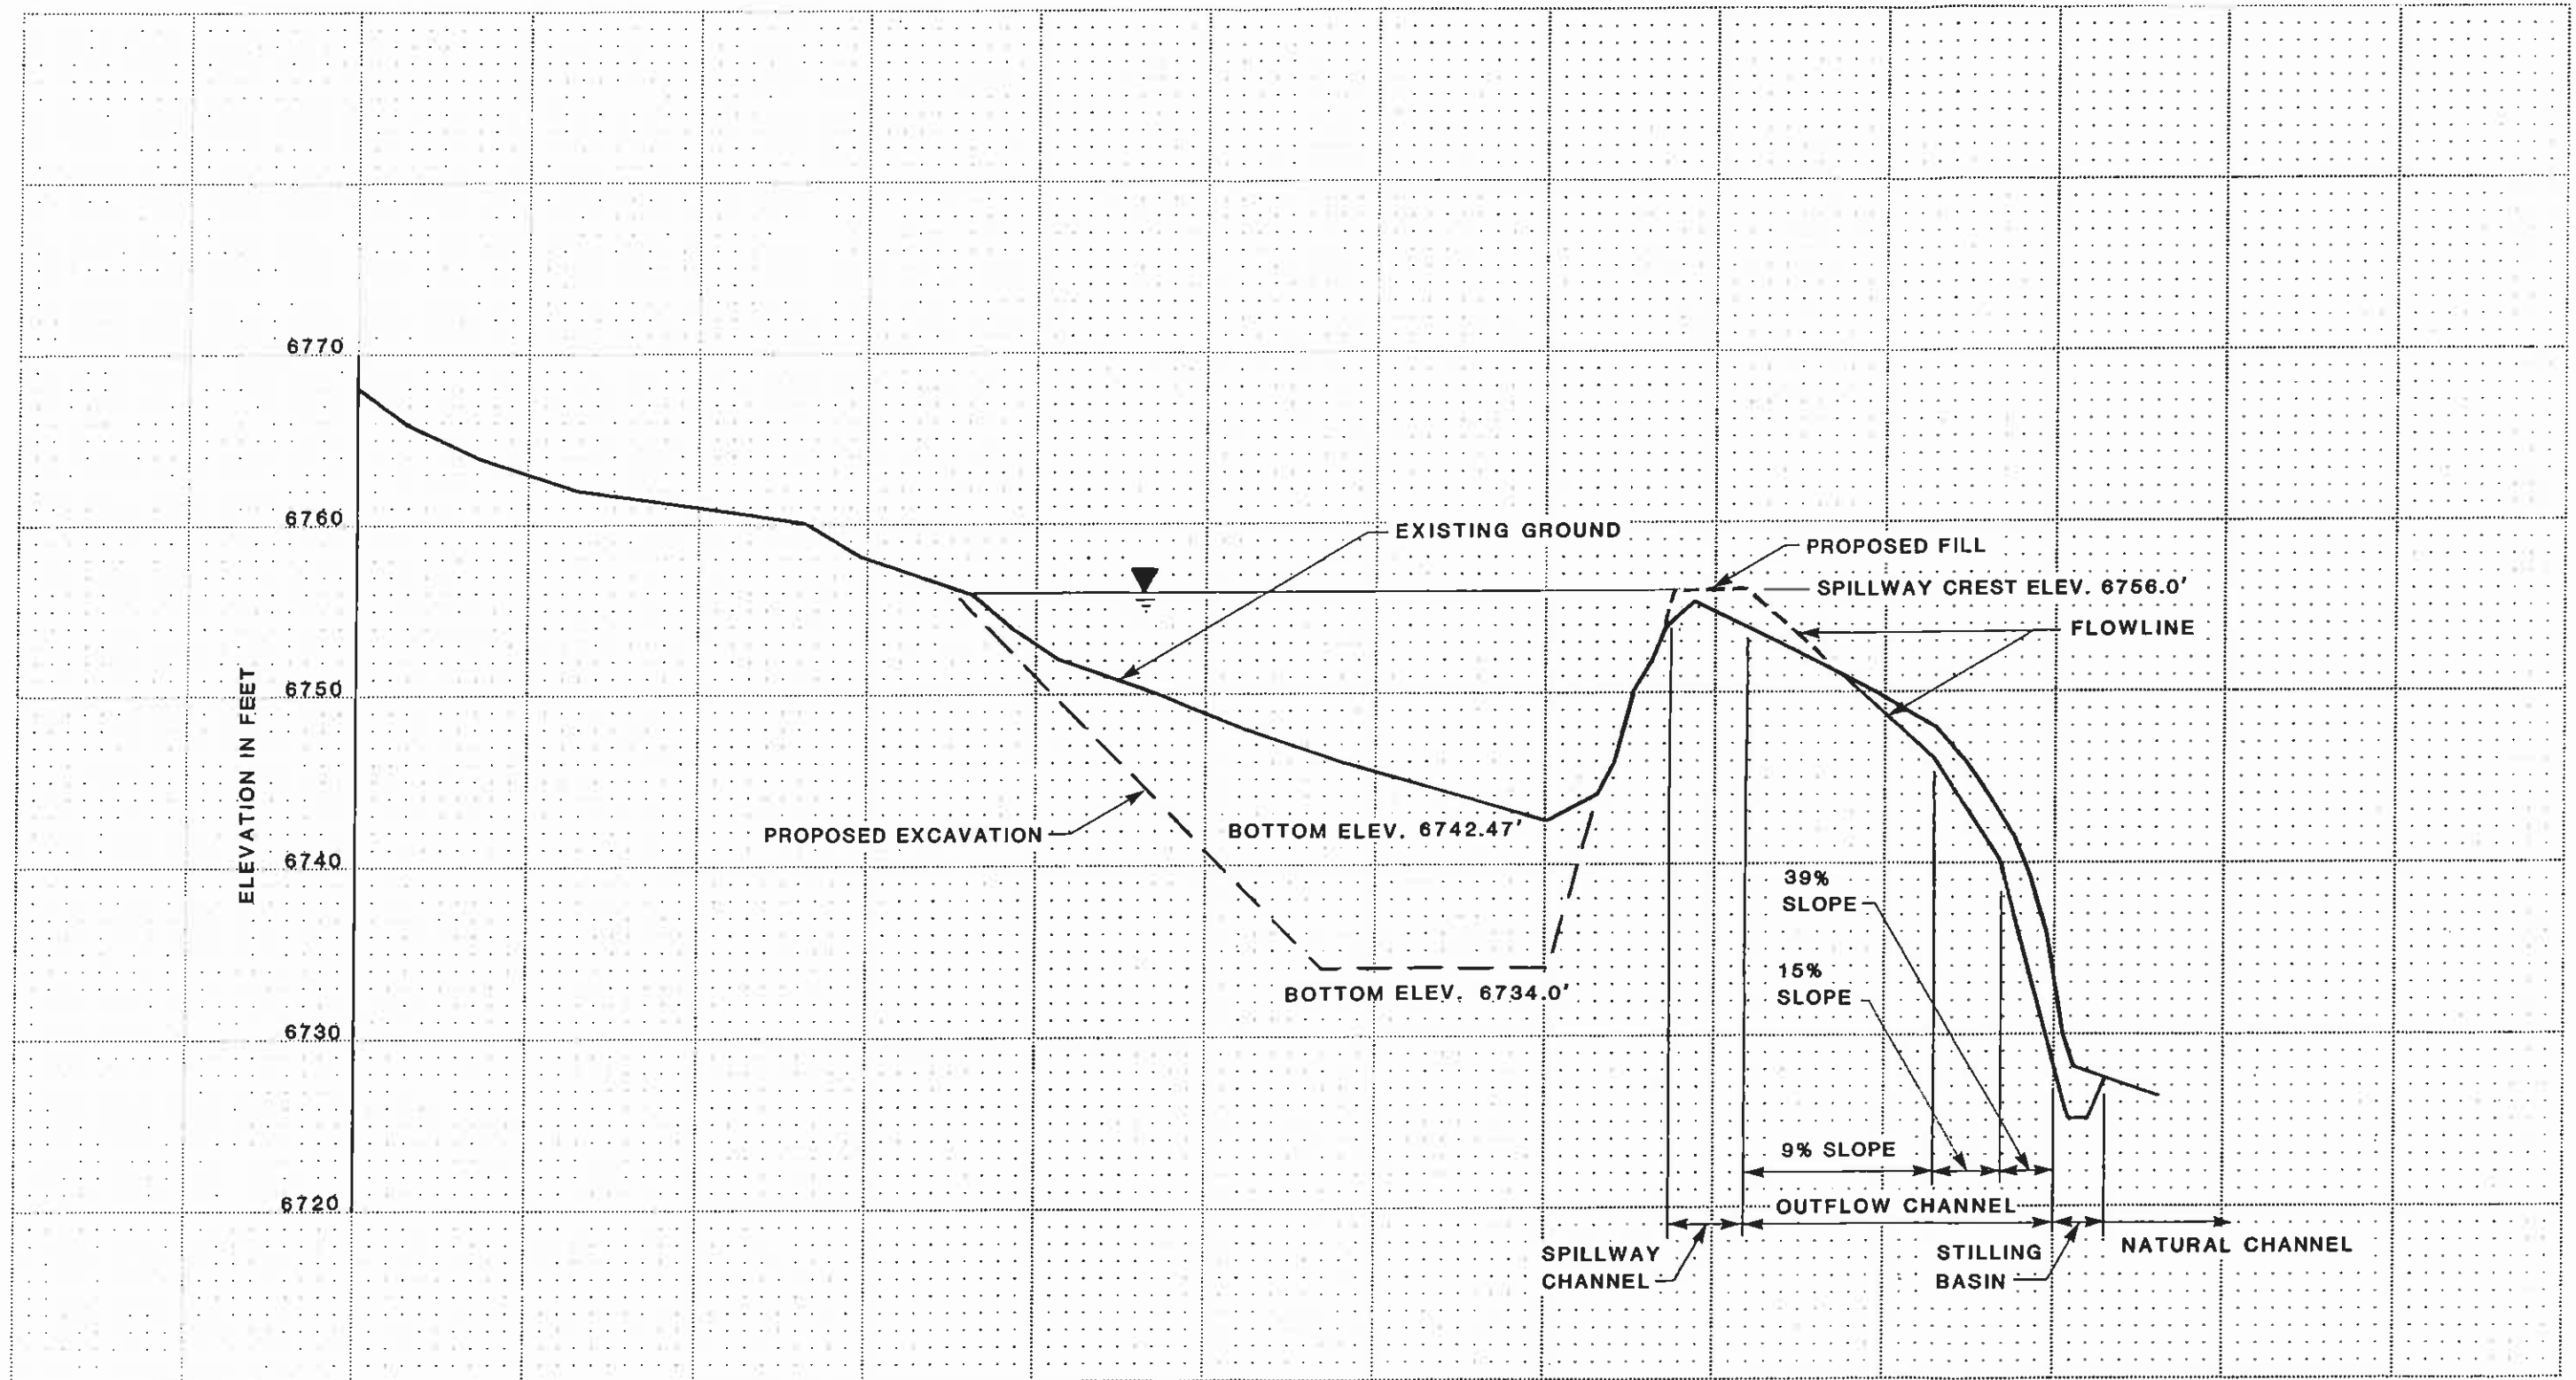
VOLUME-ELEVATION CURVE N6-F

The spillway capacity of Structure N6-F is adequate but the storage capacity is inadequate. The structure does not have an adequate outflow channel. The storage capacity should be increased to 10.49 acre-feet by raising the spillway crest elevation to 6756.0 feet and by excavating the pond as shown on Plates 1 and 4. A trapezoidal outflow channel and stilling basin should be constructed along the alignment shown in Plate 1. The channel profile and stilling basin are shown in Plate 4 and the required dimensions are shown in Plate 5 and Plate 6. The spillway, outflow channel and stilling basin should be protected against erosion using geotextile and riprap as shown in Plate 5.

Enlarging the storage capacity to 10.49 acre-feet gives additional sediment storage. The analysis of these conditions is summarized in the following table.
