INSPECTION REPORT
Sedimentation Structure
N10-A
Kayenta Mine
Navajo County, Arizona
for
PEABODY COAL COMPANY

Dames & Moore
10139-011-22

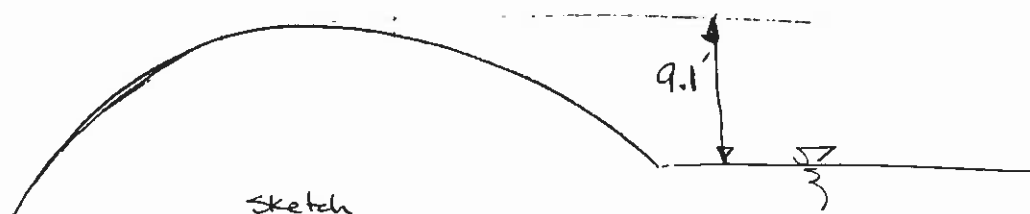
The inspection of Structure N10-A indicated that geotechnical problems consist of rill erosion on the upstream and downstream slopes and a 30-foot-long crack on the crest and downstream slope of the embankment near the left abutment. Correction of erosion is considered a periodic maintenance task and does not require remedial action. Extensive reconstruction of the embankment is recommended to repair the cracking evident near the left abutment. At that time the embankment can be classified and safe slopes selected.

Bottom of Arroyo near D.S. toe - water present
 Potential Seepage thru SS or thru dam.

Crack 30' Long transverse near L.A. in d.s. Slope up toward crest.
