INSPECTION REPORT  
Sedimentation Structure  
N12-M  
Kayenta Mine  
Navajo County, Arizona

for  
PEABODY COAL COMPANY

Dames & Moore  
10139-011-22

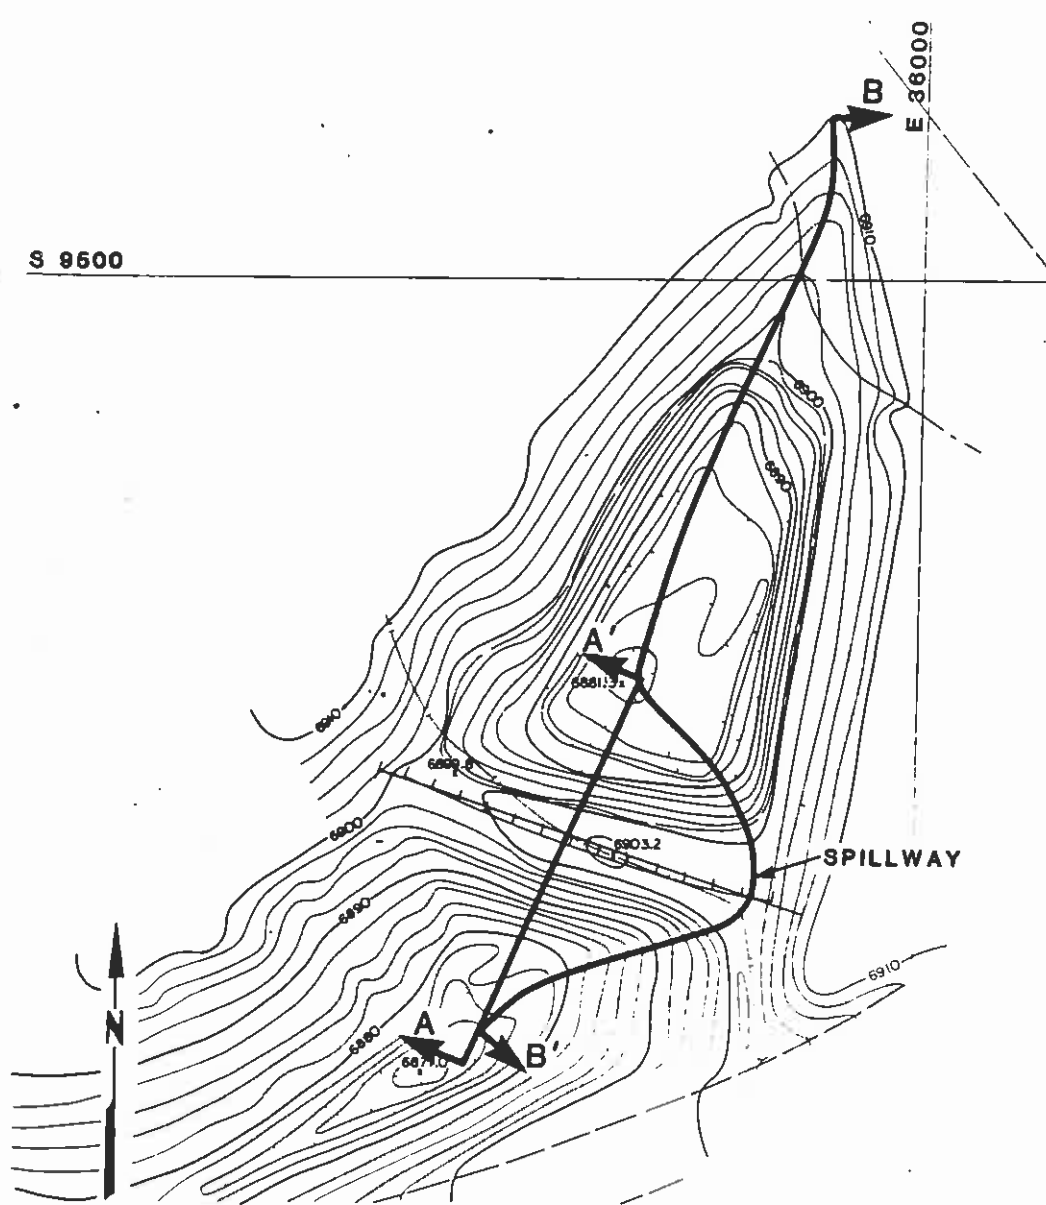
# SITE PLAN N12-M

Sedimentation Structure N12-M is an earthen embankment, designed and constructed in 1981 by Peabody Coal Company as a temporary sedimentation structure to control runoff and sediment from the disturbed mining areas of the Kayenta Mine. The location of Structure N12-M is shown on Plate 1, Site Plan.
