INSPECTION REPORT
Sedimentation Structure
N12-N
Kayenta Mine
Navajo County, Arizona
for
PEABODY COAL COMPANY

Dames & Moore
10139-011-22

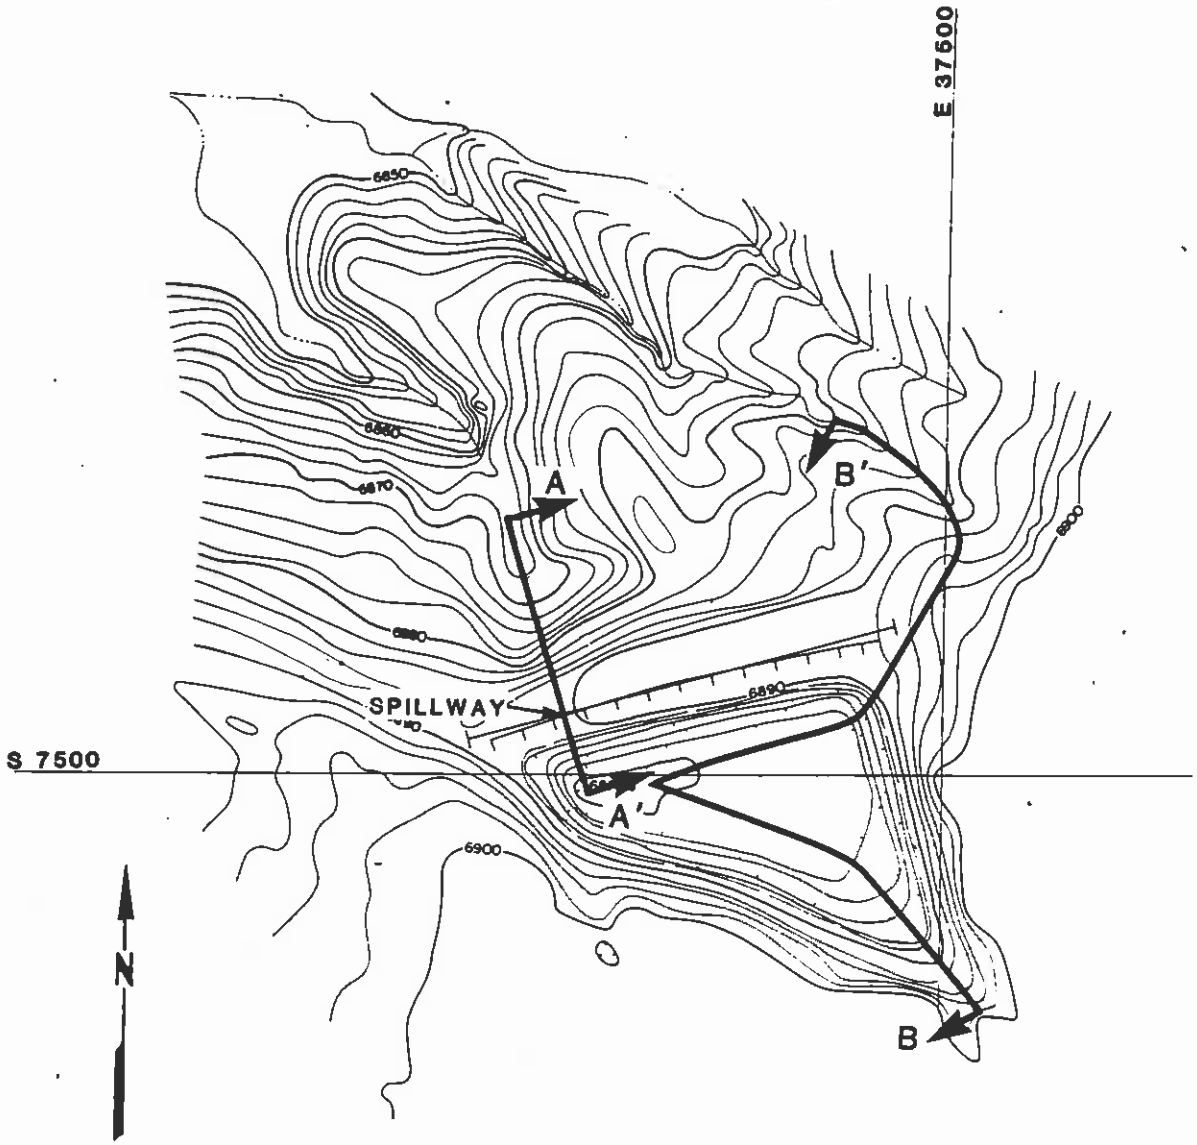
**SITE PLAN
N12-N**

Sedimentation Structure N12-N is an earthen embankment, designed and constructed in 1981 by Peabody Coal Company as a temporary sedimentation structure to control runoff and sediment from the disturbed mining areas of the Kayenta Mine. The location of Structure N12-N is shown on Plate 1, Site Plan.

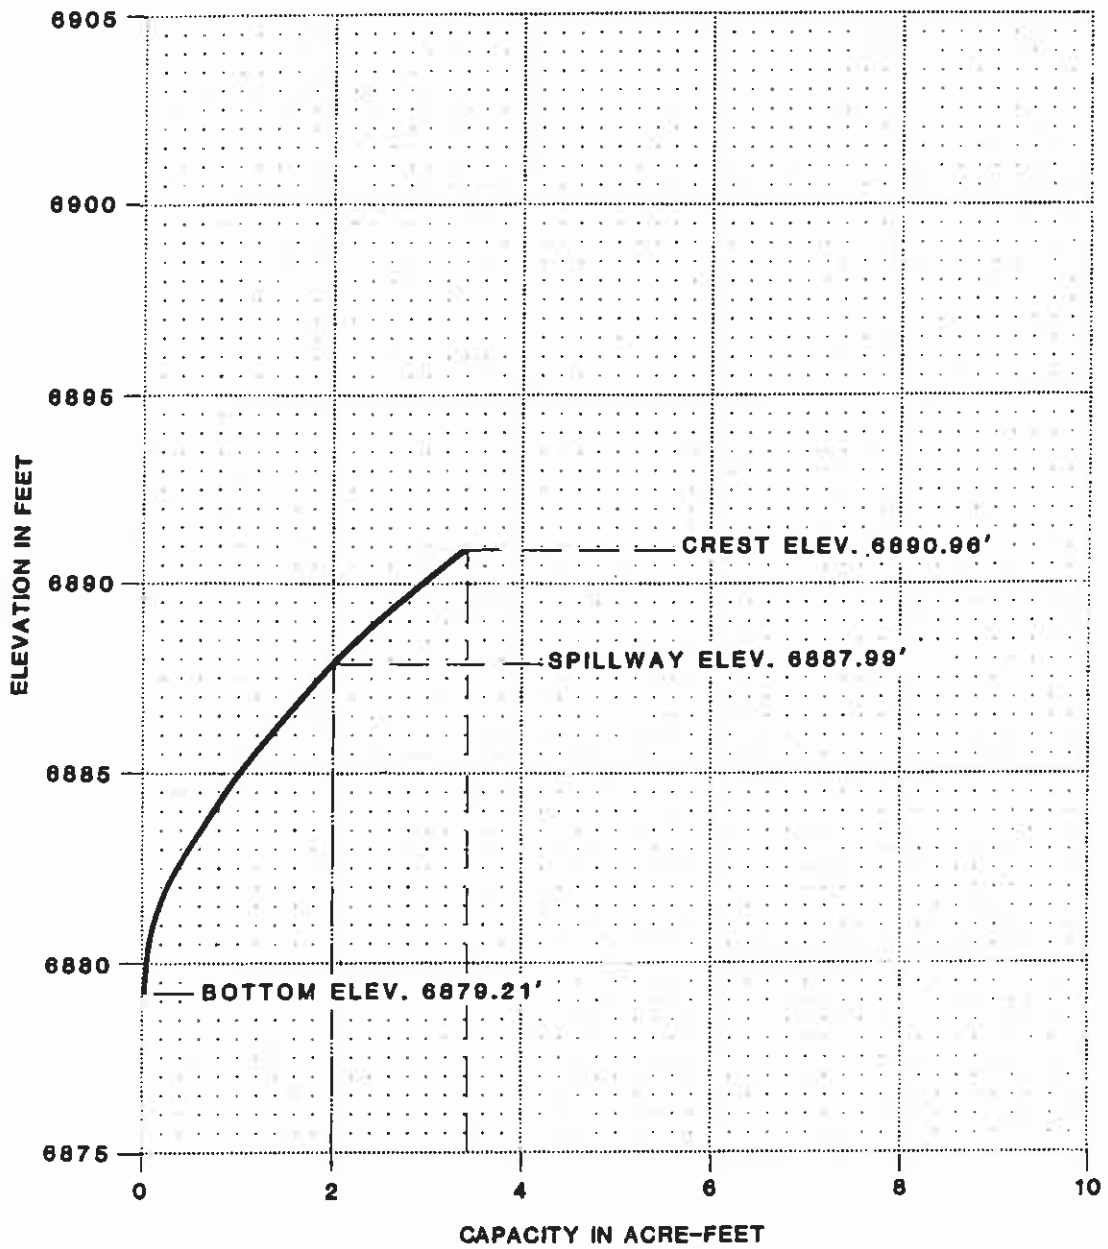
VOLUME-ELEVATION
CURVE
N12-N

The impoundment volume-elevation curve is based on site specific surveys conducted for Peabody Coal Company's August 1984 inspection, and 1985 resurveys, where available. Additionally, the most current topographic maps available were used in developing Plate 3, Volume-Elevation Curve, N12-N.
