INSPECTION REPORT
Sedimentation Structure
N14-M
Kayenta Mine
Navajo County, Arizona
for
PEABODY COAL COMPANY

Dames & Moore
10139-011-22

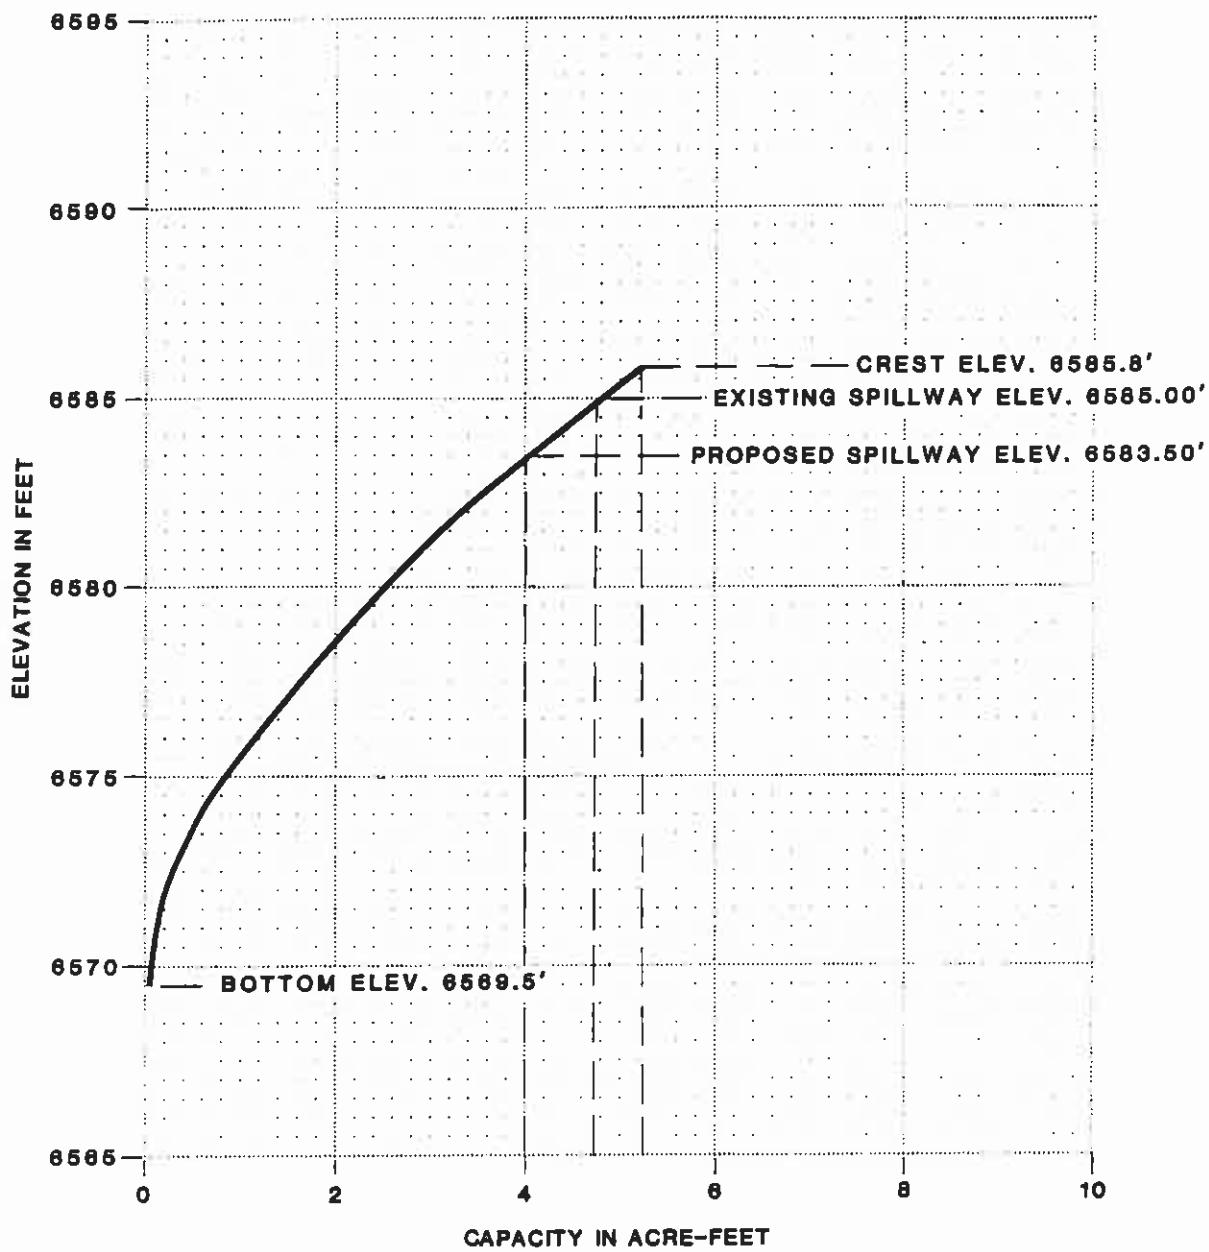
VOLUME-ELEVATION
 CURVE
 N14-M

The impoundment volume-elevation curve is based on site specific surveys conducted for Peabody Coal Company's August 1984 inspection, and 1985 resurveys, where available. Additionally, the most current topographic maps available were used in developing Plate 3, Volume-Elevation Curve, N14-M.
