INSPECTION REPORT
Sedimentation Structure
N14-Q
Kayenta Mine
Navajo County, Arizona

for
PEABODY COAL COMPANY

Dames & Moore
10139-011-22

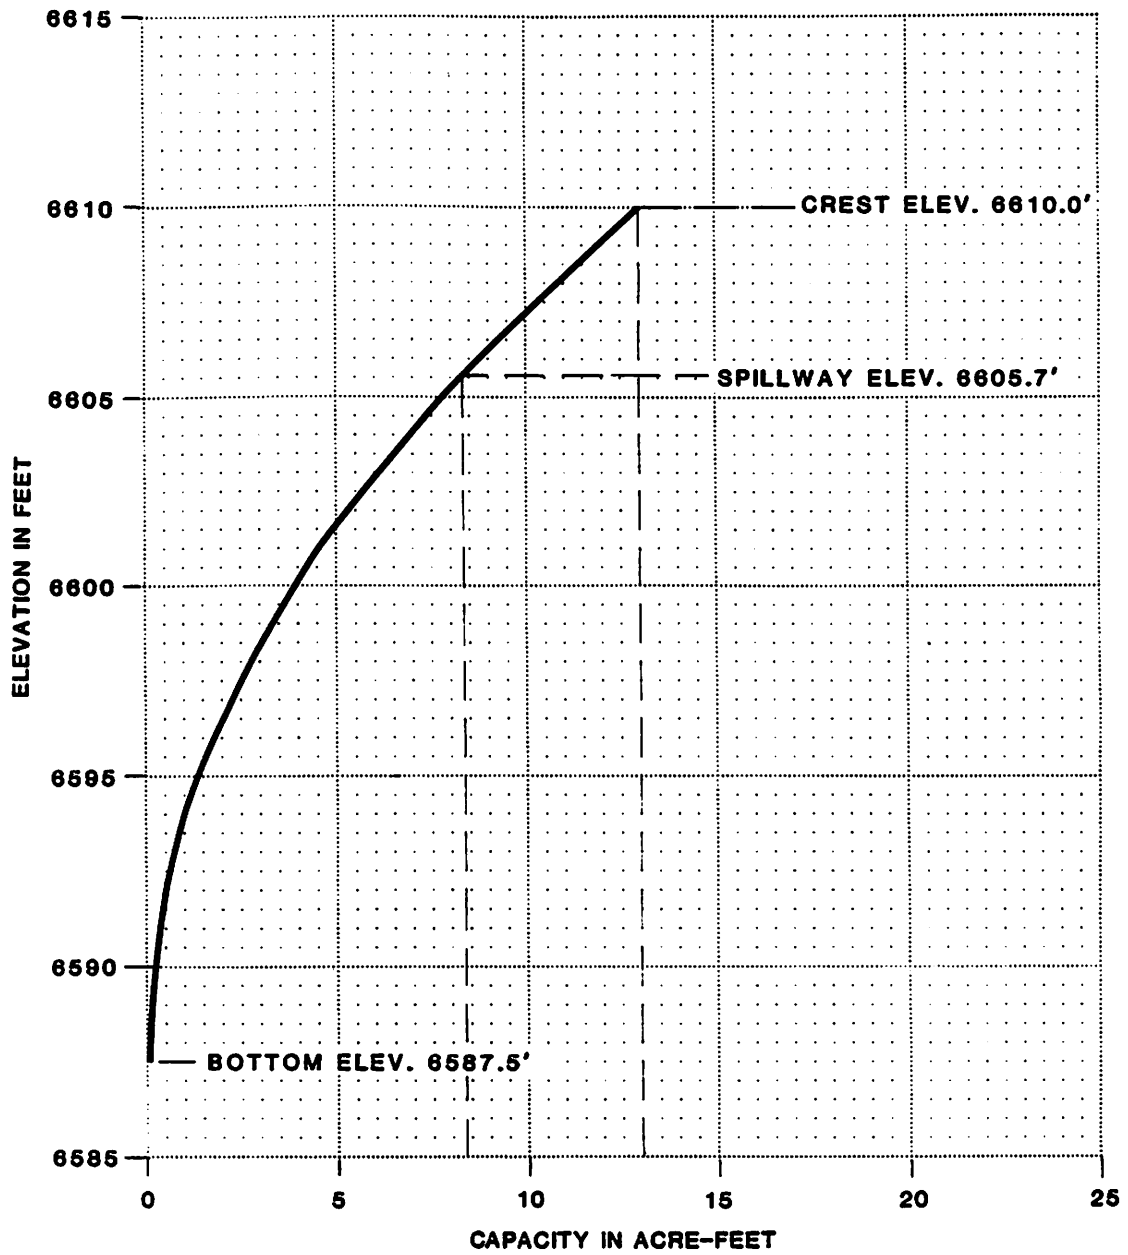
Plate 2

A cross-section of the embankment is shown on Plate 2, Existing Maximum Cross Section N14-Q, A-A'. Grass provides erosion protection on the upstream and downstream slopes of the embankment.

1. Maximum height = 20 ft
2. Maximum upstream slope = 2.0 H : 1 V
3. Maximum downstream slope = 4.0 H : 1 V
4. Normal pool with steady seepage saturation conditions
