INSPECTION REPORT
Sedimentation Structure
WW-3
Black Mesa Mine
Navajo County, Arizona
for
PEABODY COAL COMPANY

Dames & Moore
10139-011-22

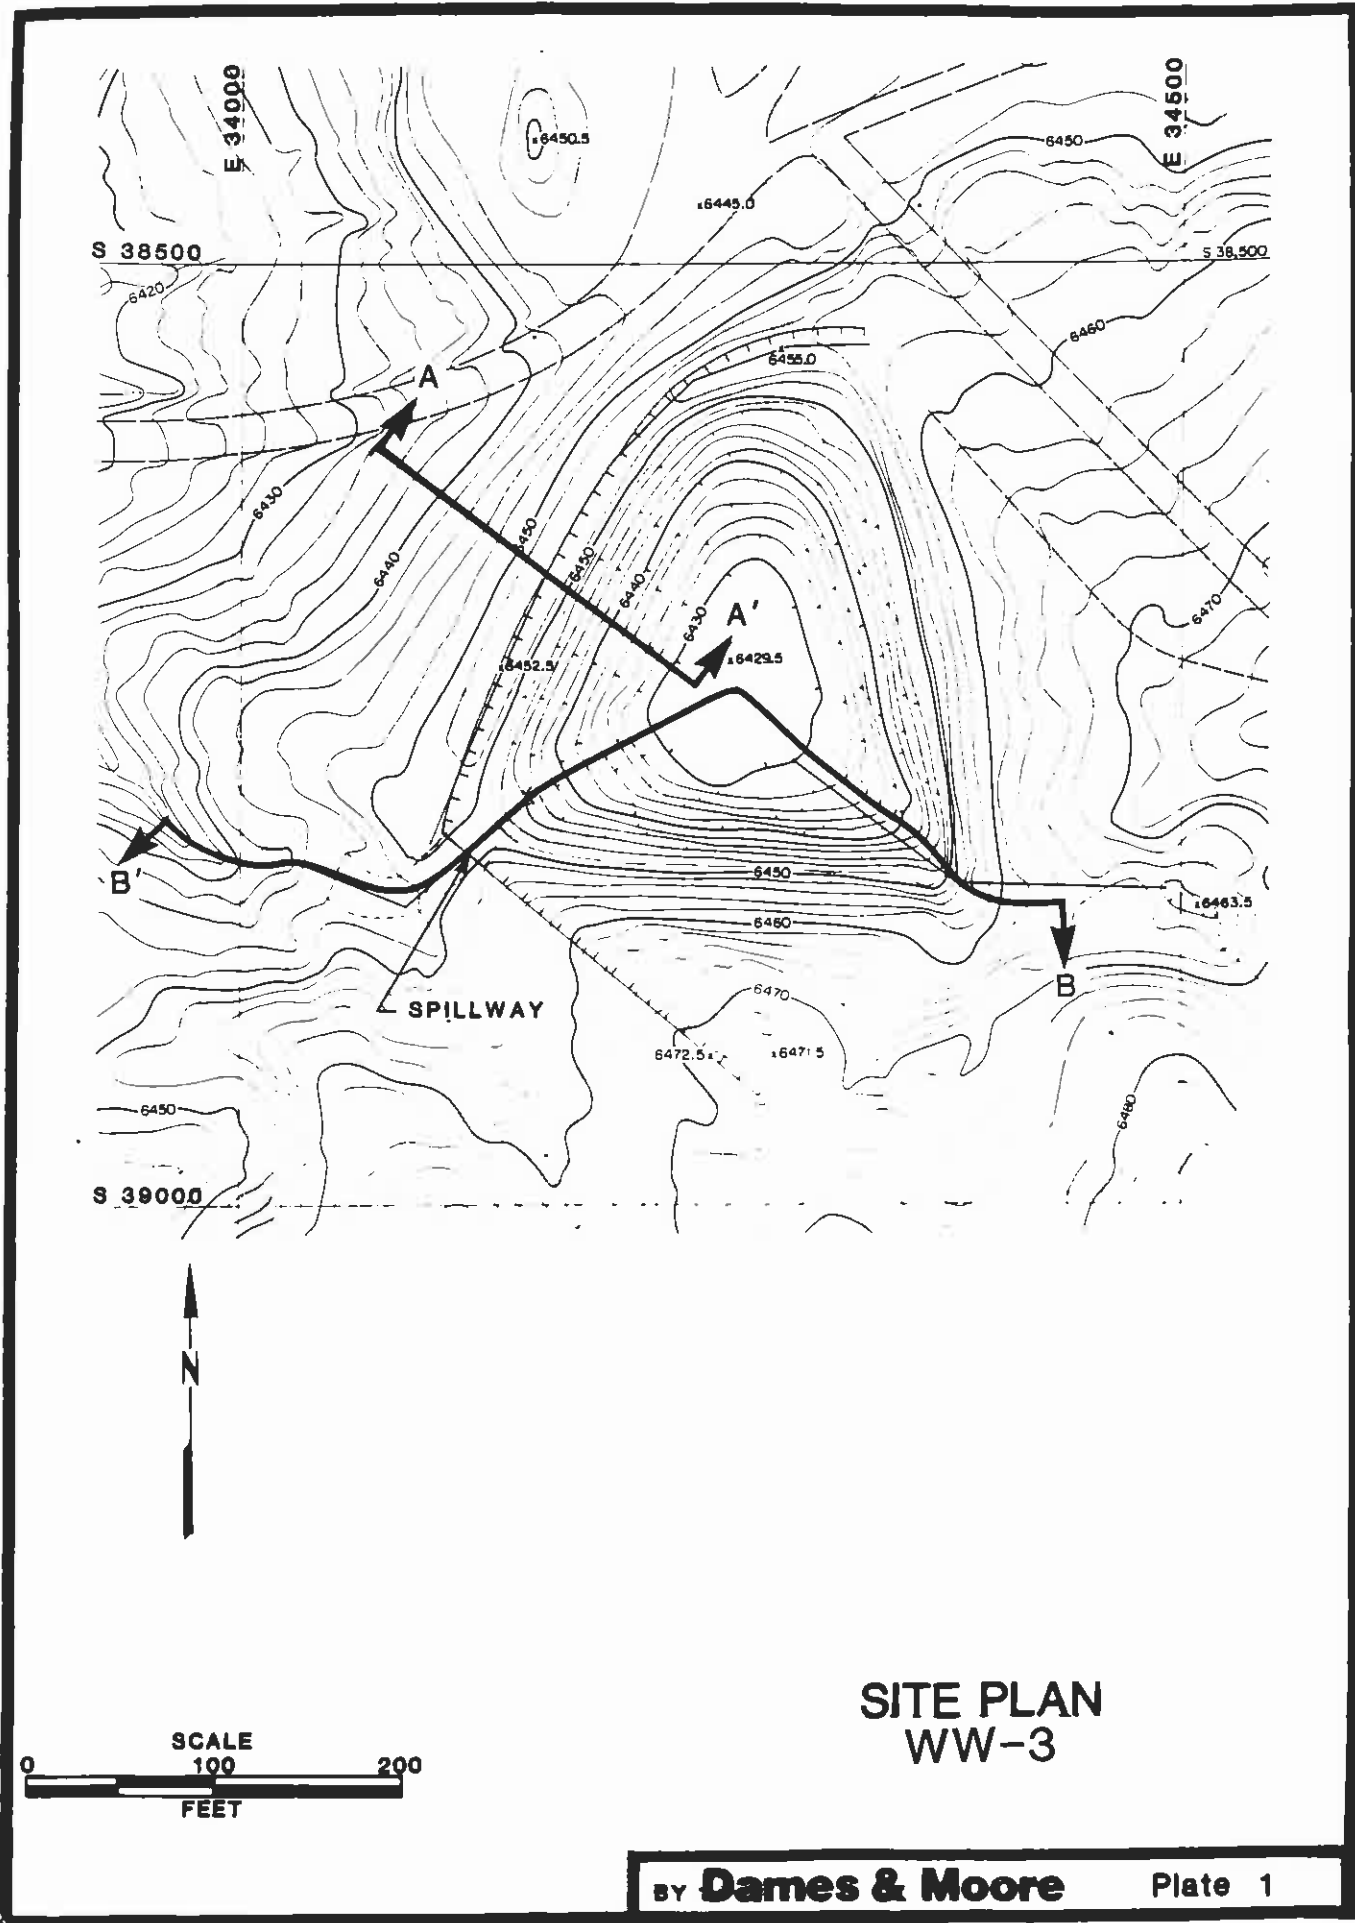
**SITE PLAN
WW-3**

Sedimentation Structure WW-3 is an earthen embankment, designed and constructed in 1981 by Peabody Coal Company as a temporary sedimentation structure to control runoff and sediment from the disturbed mining areas of the Black Mesa Mine. The location of Structure WW-3 is shown on Plate 1, Site Plan.

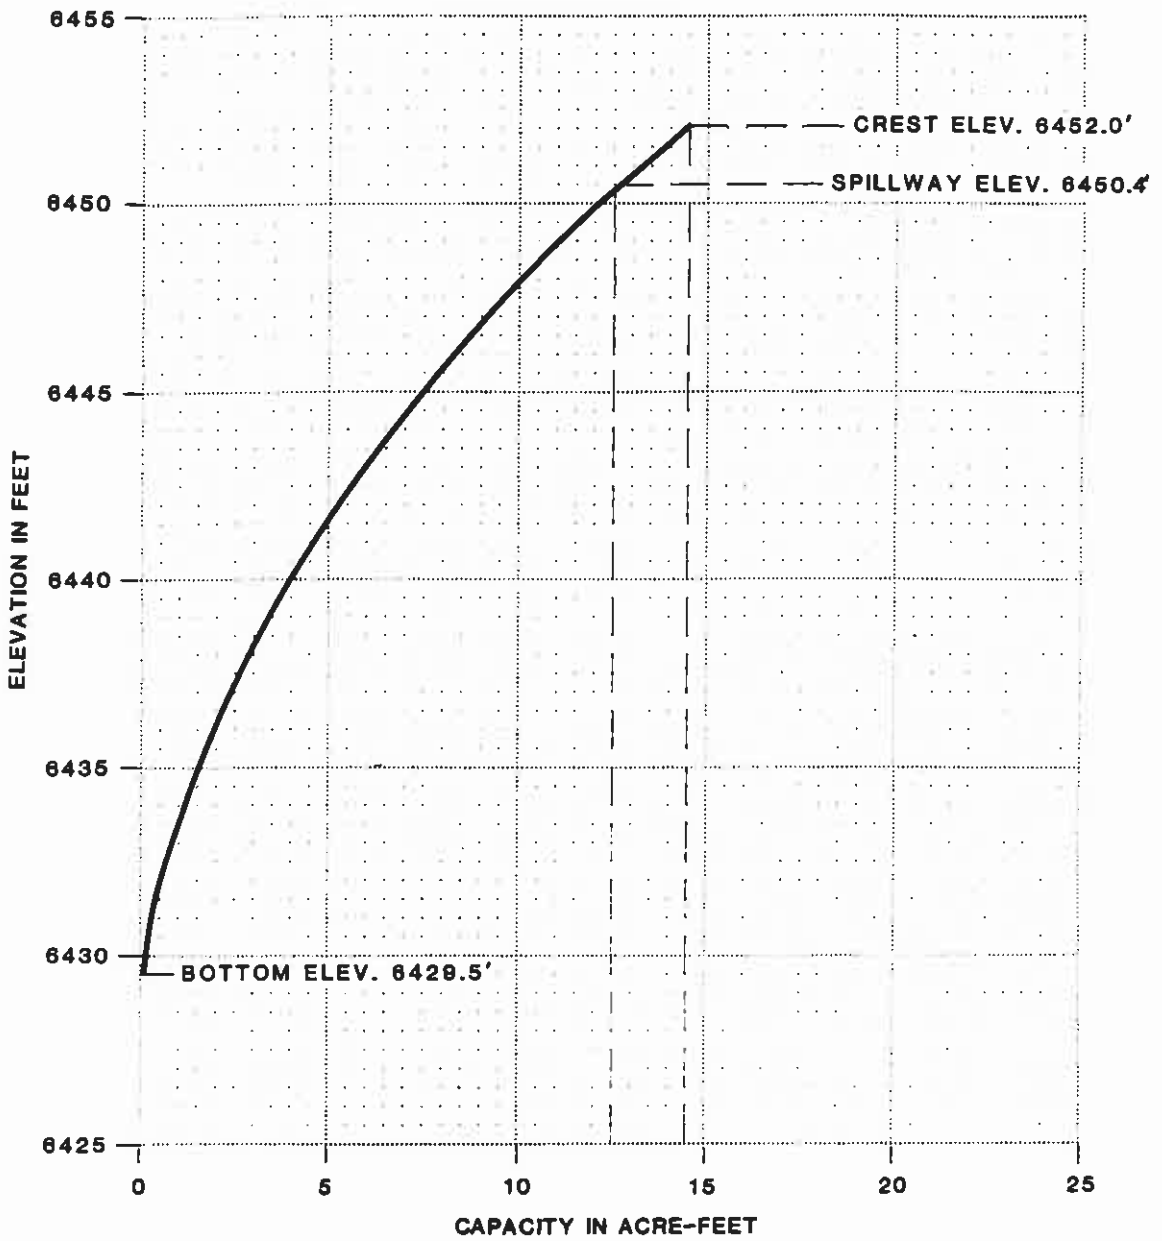
VOLUME-ELEVATION
CURVE
WW-3

The impoundment volume-elevation curve is based on site specific surveys conducted for Peabody Coal Company's August 1984 inspection, and 1985 resurveys, where available. Additionally, the most current topographic maps available were used in developing Plate 3, Volume-Elevation Curve, WW-3.
