INSPECTION REPORT  
Sedimentation Structure  
WW-6  
Black Mesa Mine  
Navajo County, Arizona  
for  
PEABODY COAL COMPANY

Dames & Moore  
10139-011-22

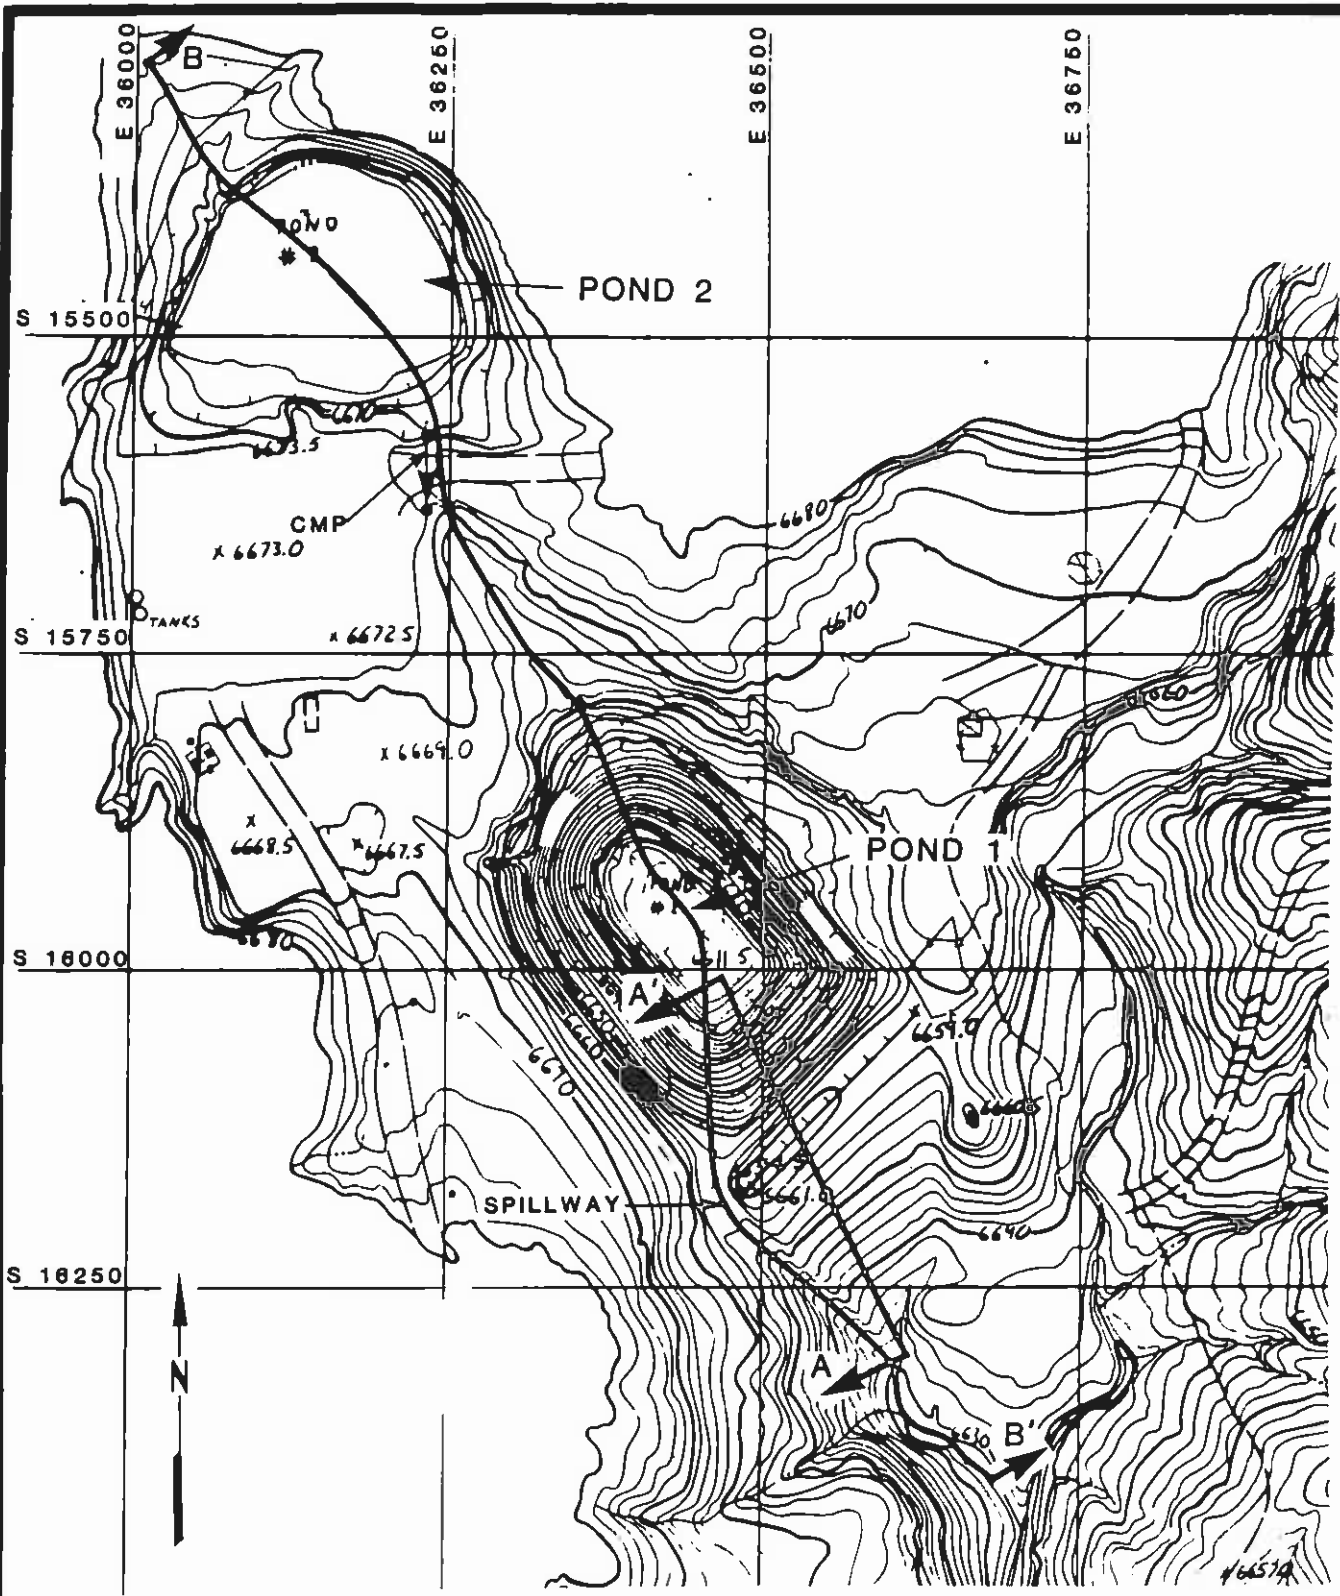
SITE PLAN  
WW-6

Sedimentation Structure WW-6 is an earthen embankment, designed and constructed in 1981 by Peabody Coal Company as a temporary sedimentation structure to control runoff and sediment from the disturbed mining areas of the Black Mesa Mine. The location of Structure WW-6 is shown on Plate 1, Site Plan.

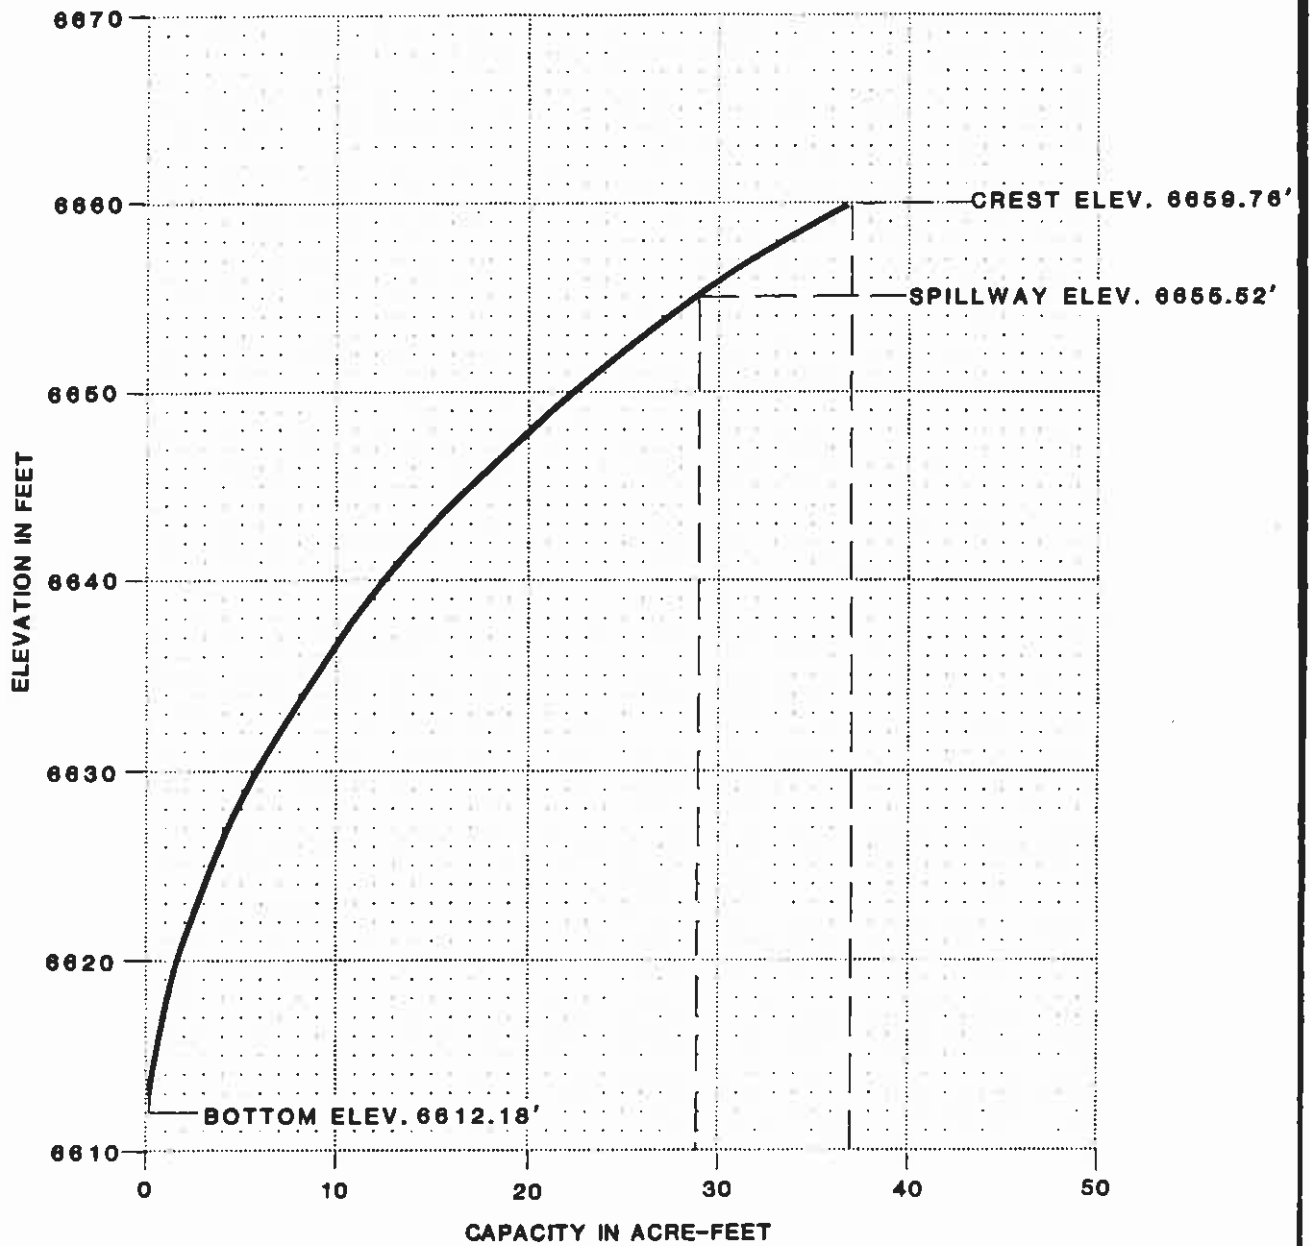
VOLUME-ELEVATION  
 CURVE  
 WW-6  
 POND # 1

The impoundment volume-elevation curve is based on site specific surveys conducted for Peabody Coal Company's August 1984 inspection, and 1985 resurveys, where available. Additionally, the most current topographic maps available were used in developing Plate 3A and 3B, Volume-Elevation Curve, WW-6.
