INSPECTION REPORT
Sedimentation Structure
WW-9
Black Mesa Mine
Navajo County, Arizona
for
PEABODY COAL COMPANY

Dames & Moore
10139-011-22

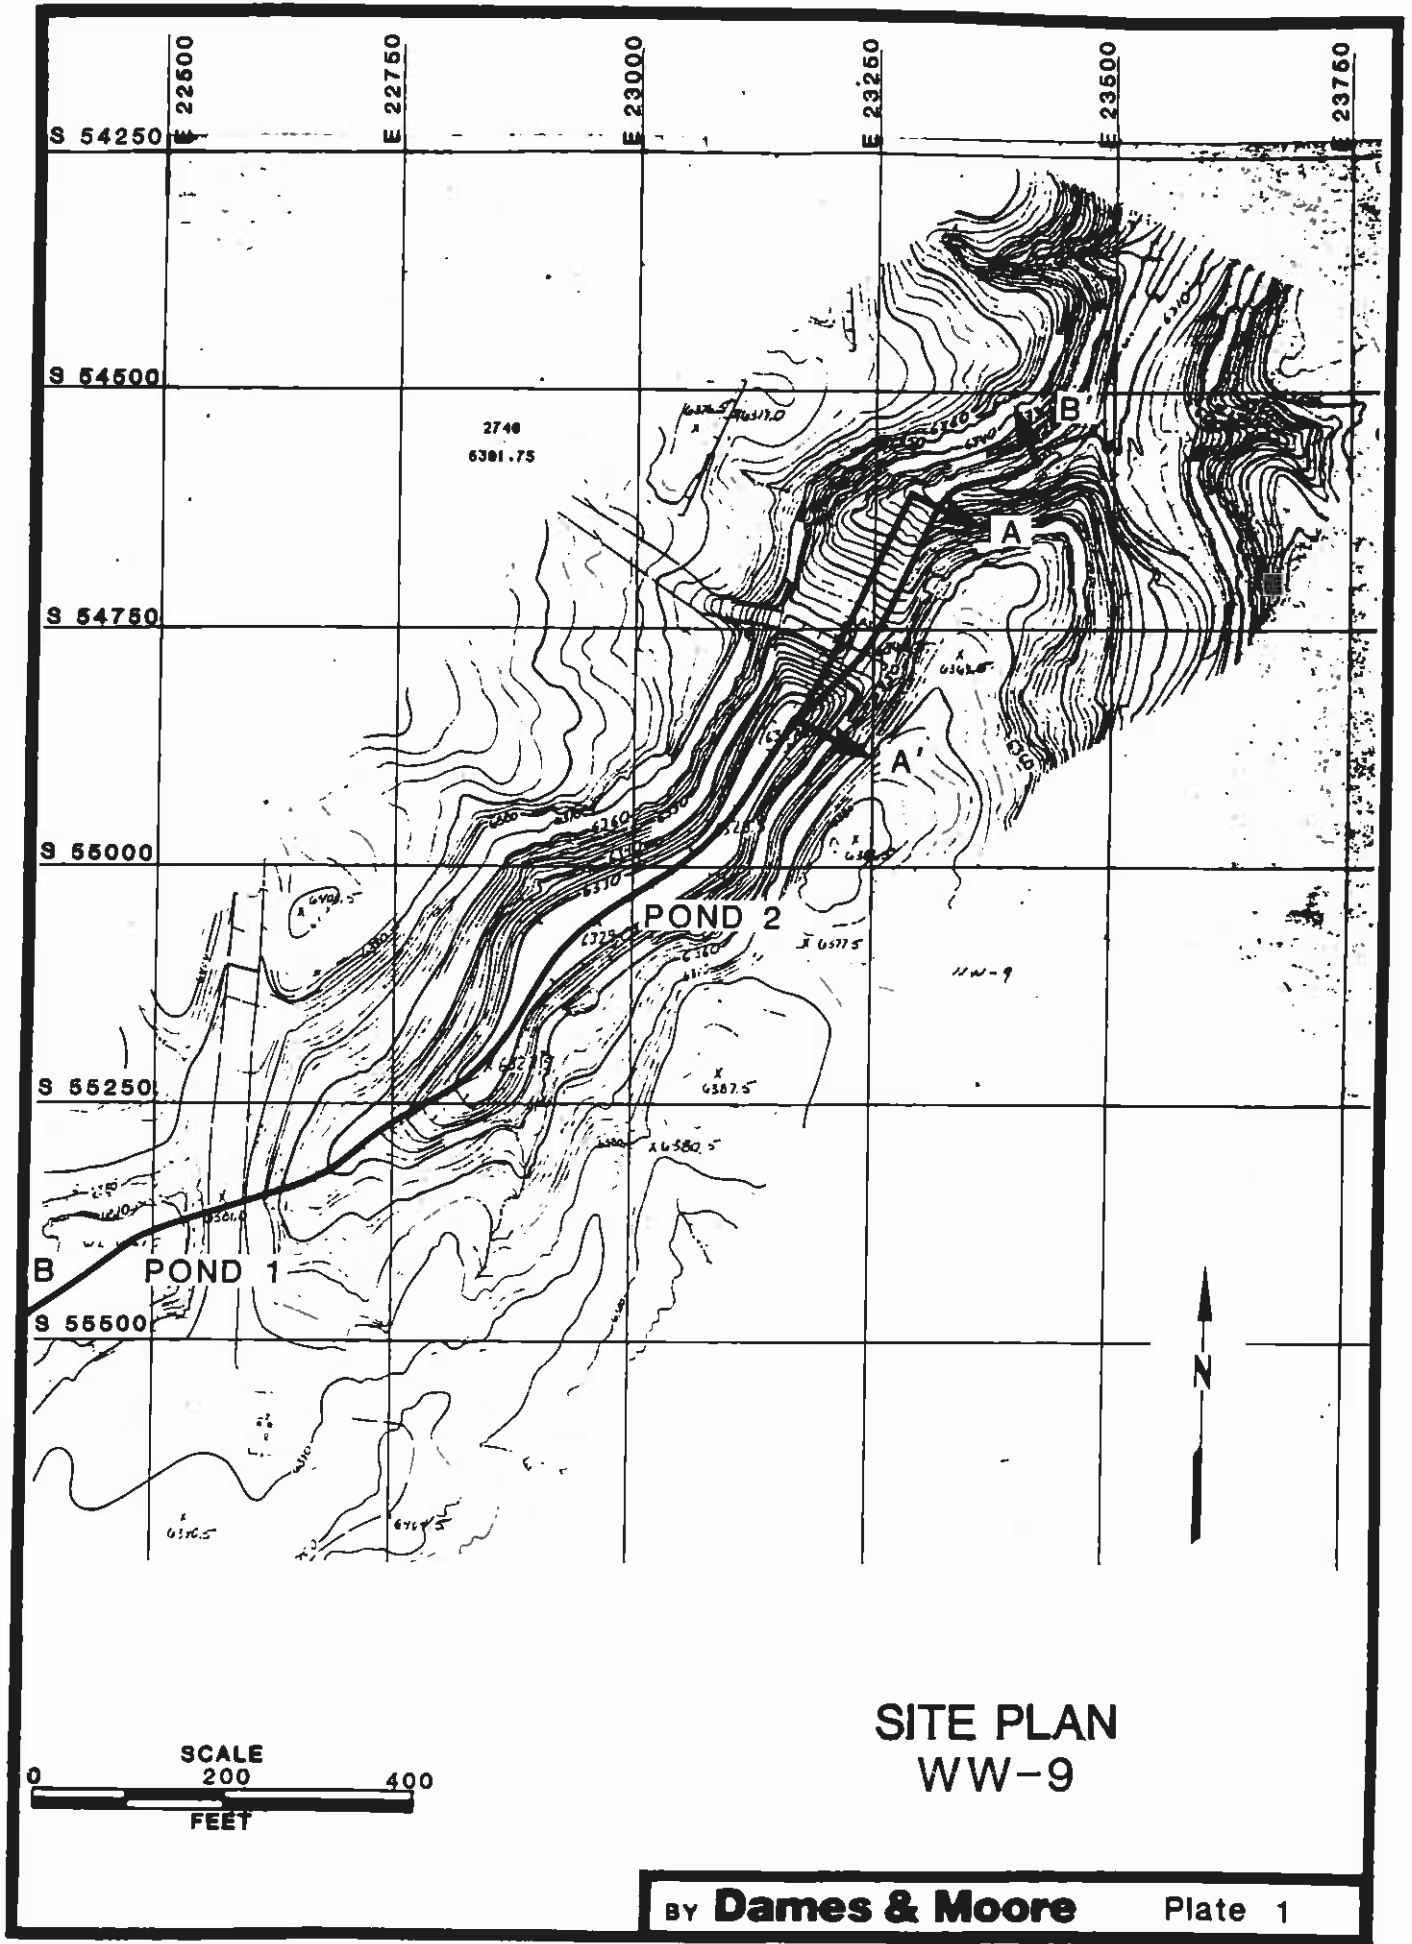
**SITE PLAN
WW-9**

Sedimentation Structure WW-9 is an earthen embankment, designed and constructed in 1983 by Peabody Coal Company as a temporary sedimentation structure to control runoff and sediment from the disturbed mining areas of the Black Mesa Mine. The location of Structure WW-9 is shown on Plate 1, Site Plan.

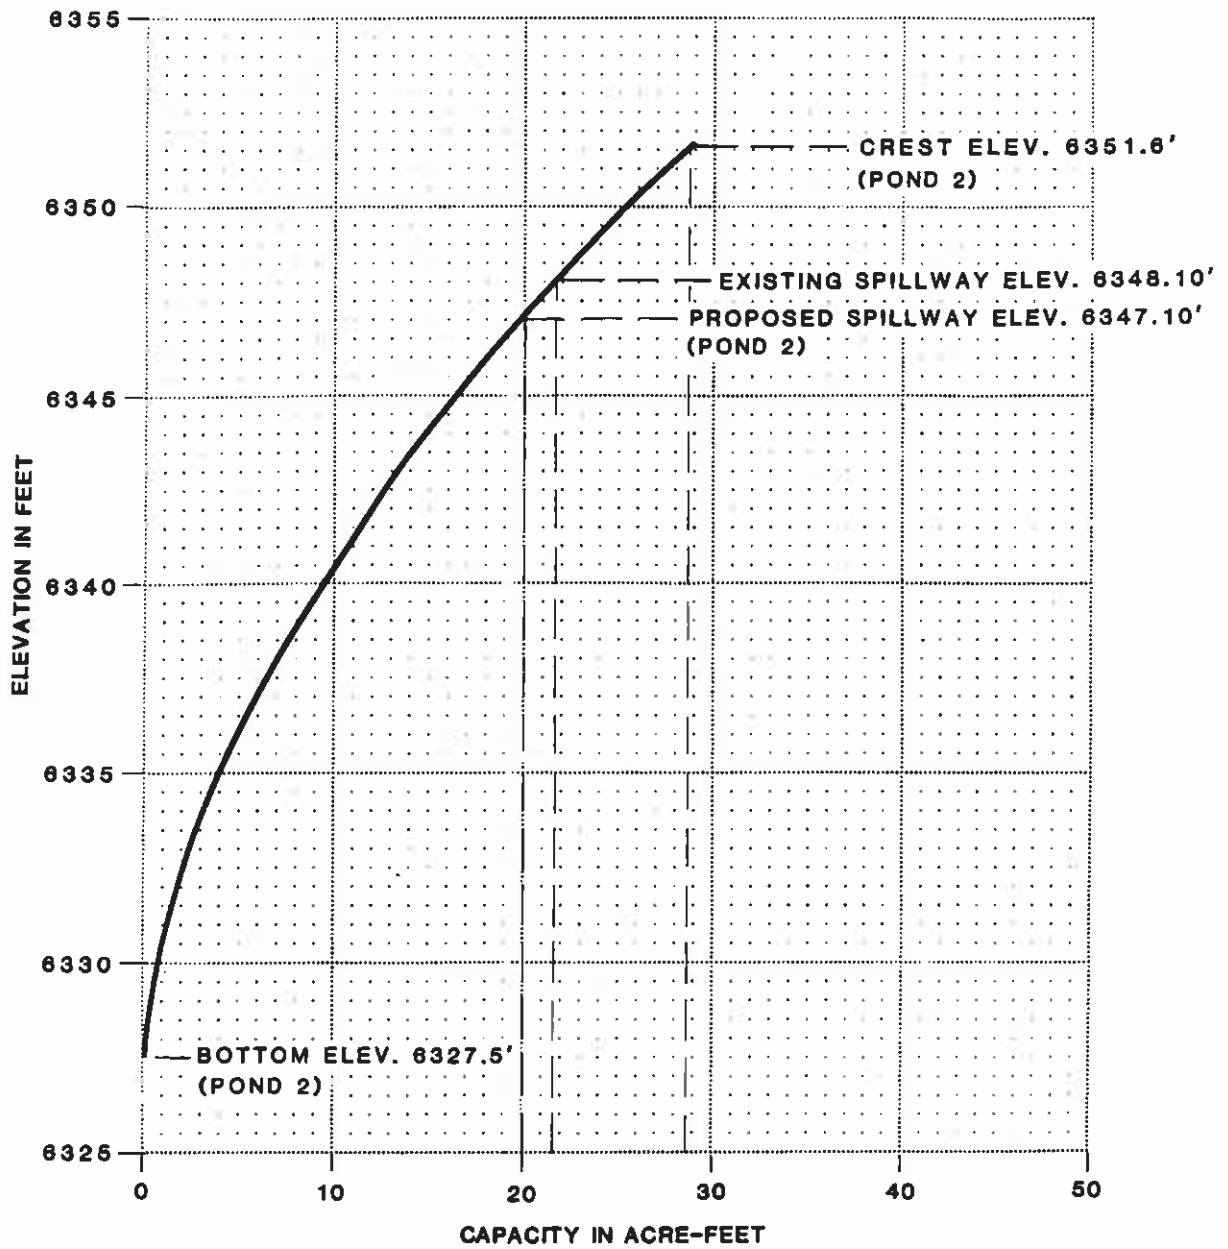
VOLUME-ELEVATION
CURVE
WW-9

The impoundment volume-elevation curve is based on site specific surveys conducted for Peabody Coal Company's August 1984 inspection, and 1985 resurveys, where available. Additionally, the most current topographic maps available were used in developing Plate 3, Volume-Elevation Curve, WW-9.

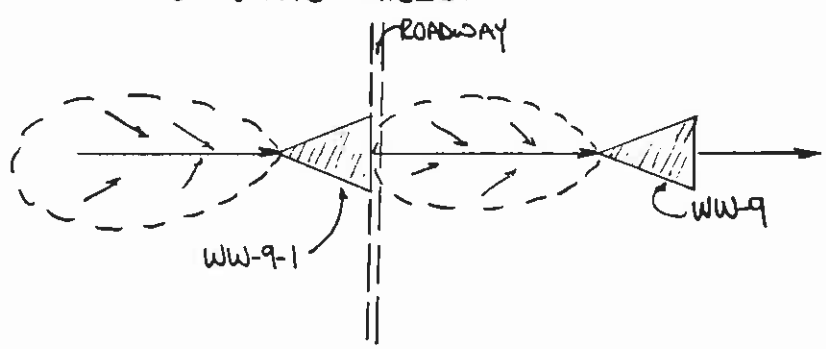
SET UP THE MODEL WITH TWO RESERVOIR > AND TWO WATERSHEDS.

NOTE: FLOODING AREA WEST OF ROAD CALLED WW-9-1

1. CALCULATE INFLOW HYDROGRAPH TO WW-9-1
2. ROUTE INFLOW THROUGH WW-9-1
3. CALCULATE INFLOW TO WW-9 FROM DRAINAGE BASIN
4. COMBINE OUTFLOW FROM WW-9-1 AND INFLOW FROM DRAINAGE BASIN TO GET COMBINED INFLOW TO WW-9.
5. ROUTE COMBINED INFLOW THROUGH WW-9 TO GET SPILLWAY FLOW AND MAX WATER LEVEL.
