INSPECTION REPORT  
Sedimentation Structure  
WW-9B  
Kayenta Mine  
Navajo County, Arizona  
for  
PEABODY COAL COMPANY

Dames & Moore  
10139-011-22

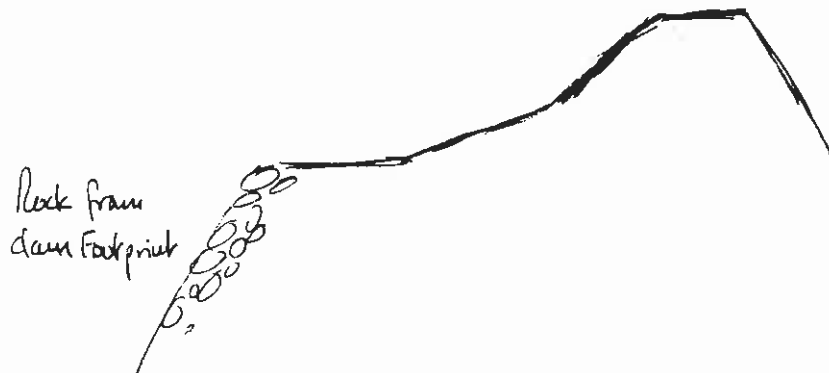
Sketch

Water in impoundment,  
Sagebrush/grass 85% gravel road 15%  
ground cover - Good  
Canopy cover - 20%
